**JOB AID  
FOR  
SPECIAL SERVICE CAMPAIGN K0B  
MILLIMETER WAVE RADAR SENSOR**

**CERTAIN:  
2018 – 2019 TACOMA  
2018 – 2019 TUNDRA**

## **VEHICLES WITH MODIFICATIONS**

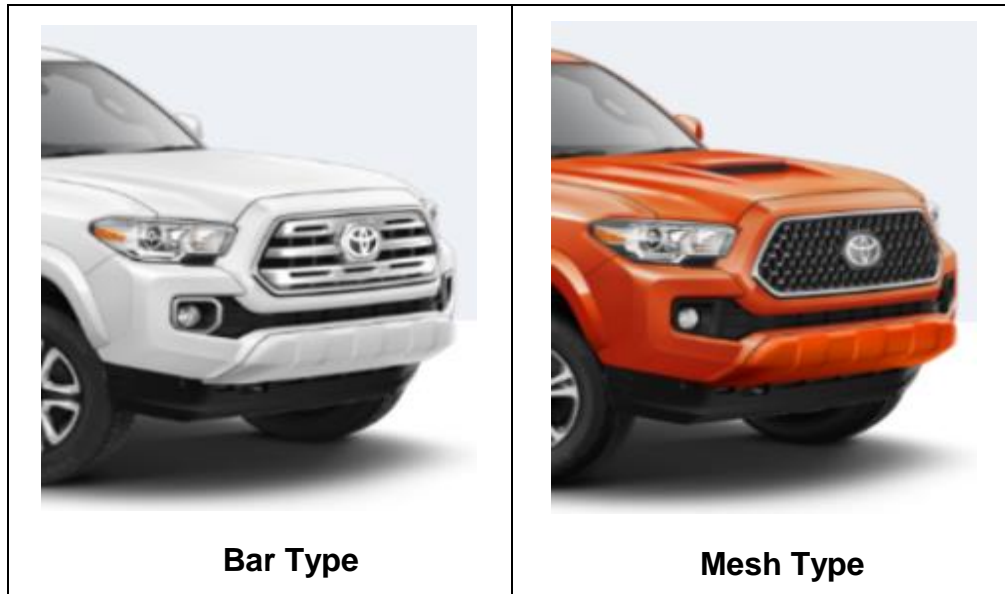
TACOMA - Repair A vehicles will have radiator grilles of these designs:

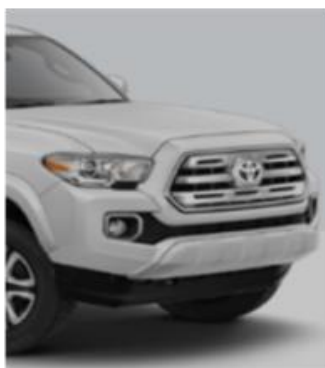
**Note:** This application will use P/N **88278-0C010**. (75mm x 150mm x 5mm)

This process is only for Tacoma's with the Bar type grille:

Recommended temperature for adhesion is 50° F and above.  
Keep stock at room temperature.

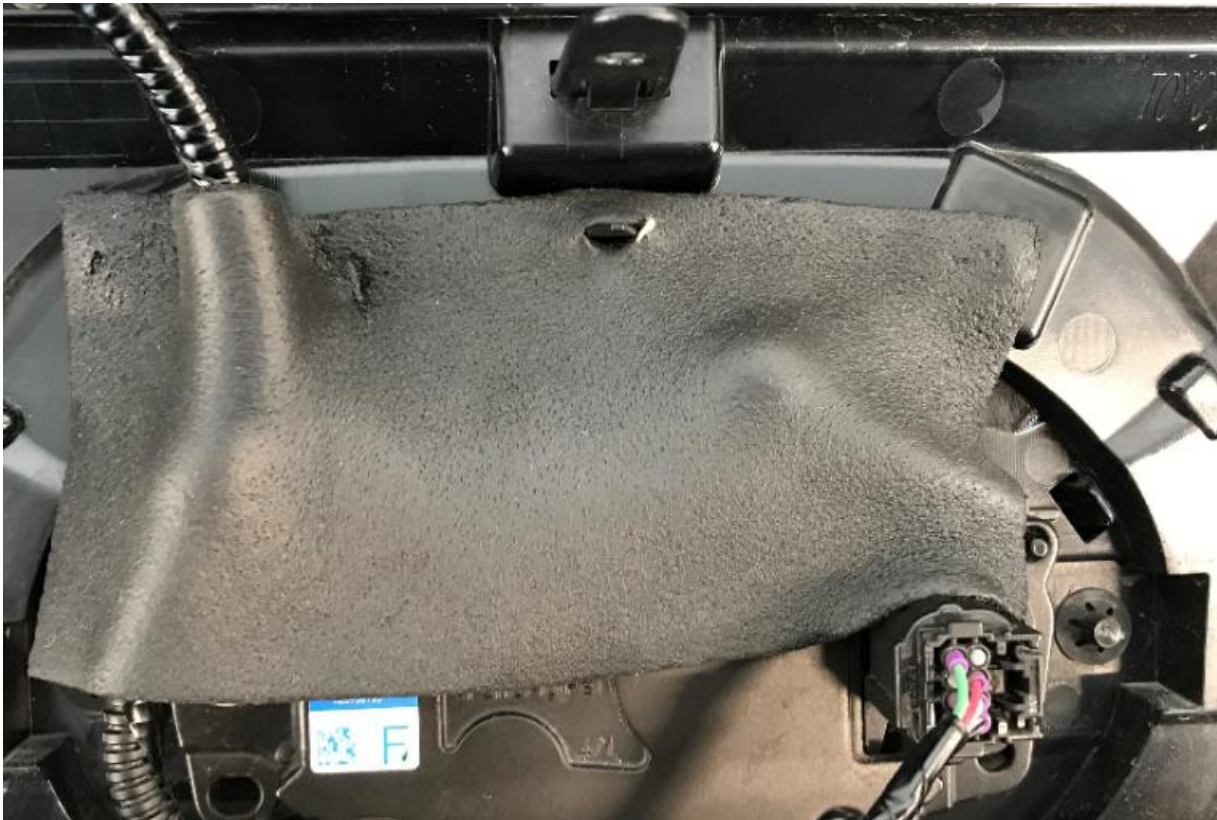
- a. Apply the EPT Sealer to the back side of the MWRS in the position shown below:
- Start applying the EPT Sealer sheet to the vertical surface of the radiator grille, just above the MWRS.
  - It will be necessary to push the EPT Sealer into the plastic tab at the top, creating a hole in the sealer.
  - Wrap the EPT Sealer around the wire harness, as shown.
  - Using heavy finger pressure, thoroughly press the entire surface of the EPT sealer to securely adhere it to all contact surfaces of the MWRS and grille.

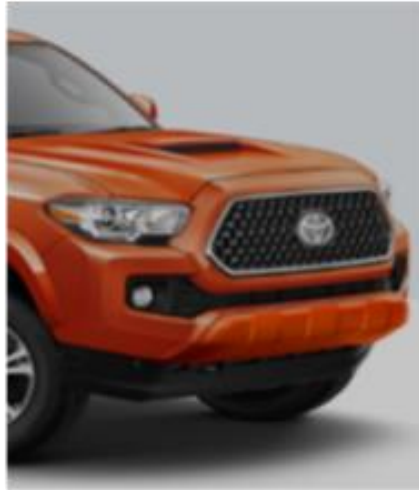
**Note:** This application will use P/N **88278-0C010**. (75mm x 150mm x 5mm)

This process is only for Tacoma's with the Mesh type grille:

a. Apply the EPT Sealer to the back side of the MWRS in the position shown below:

Recommended temperature for adhesion is 50° F and above.  
Keep stock at room temperature.

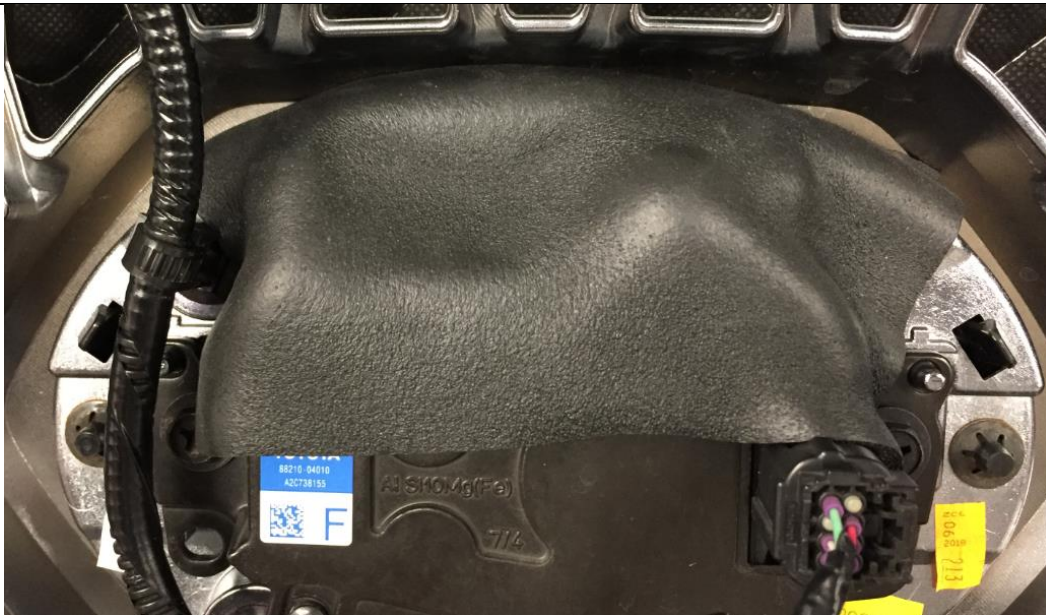
- Start applying the EPT Sealer sheet to the horizontal lip of the radiator grille to create a waterproof shield over the top of the sensor.
- Using heavy finger pressure, thoroughly press the entire surface of the EPT sealer to securely adhere it to all contact surfaces of the MWRS.

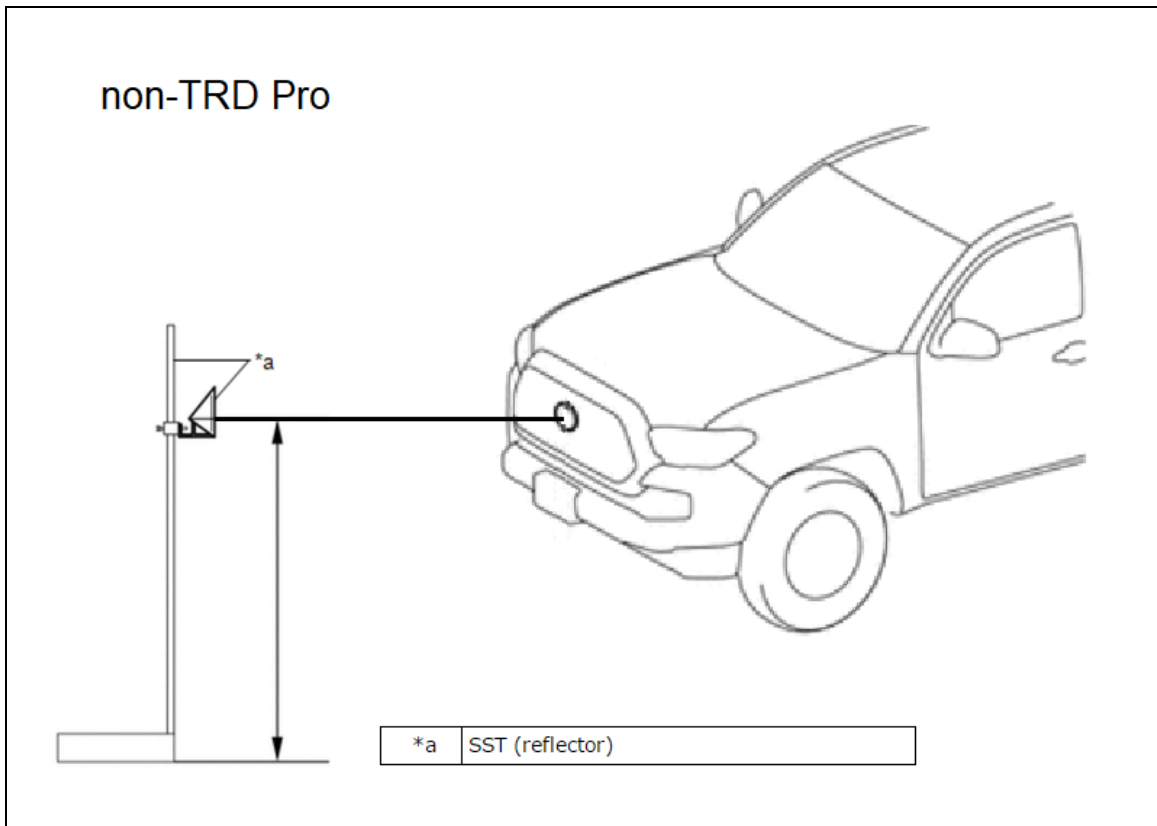
Because the modifications on this vehicle have changed the height of the MWRS from its original condition, it will be necessary to adjust the SST reflector height to match the height of the MWRS. When following the MWRS Adjustment procedure in the Repair Manual, change the height of the SST reflector to match the center of the MWRS in the grille.

- a. Adjust the height of the SST reflector to the center of the MWRS in the grille.
- b. Follow the Repair Manual procedure to properly calibrate the MWRS:

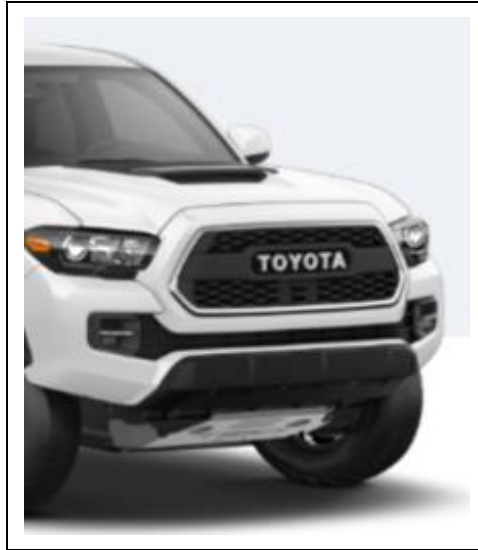
TACOMA Repair B vehicles will have a radiator grille of this design:

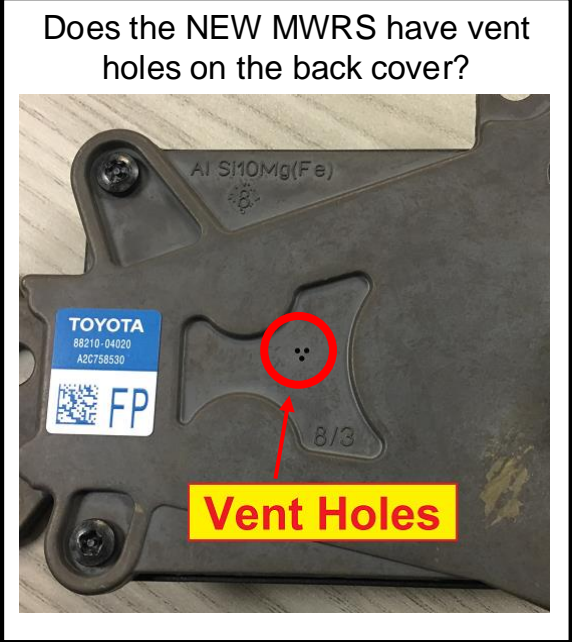
Does the NEW MWRS have vent holes on the back cover?

NO → EPT-Sealer will be necessary. Proceed to Step #5. on p. 17

Yes → EPT-Sealer WILL NOT be necessary. Proceed to Step #9 on p. 20

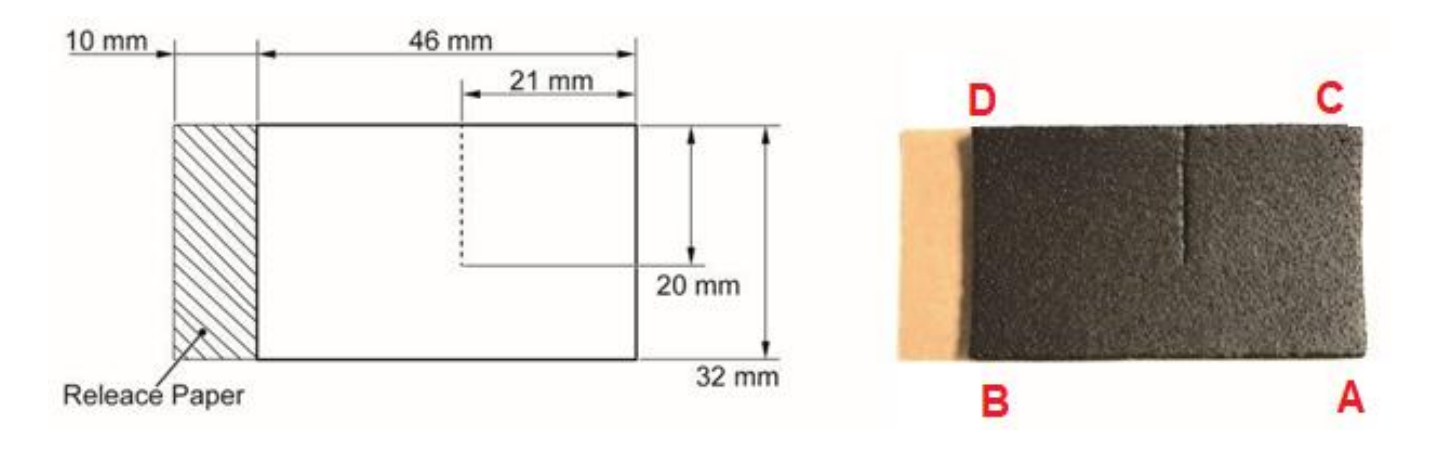
The EPT-Sealer will be applied in a specific way, using the following points for orientation. Please note the arrangement of corners A, B, C, D.

10 mm      46 mm      21 mm

20 mm      32 mm

Release Paper

**Note:** A diagram of the EPT sealer can be found on page 14.

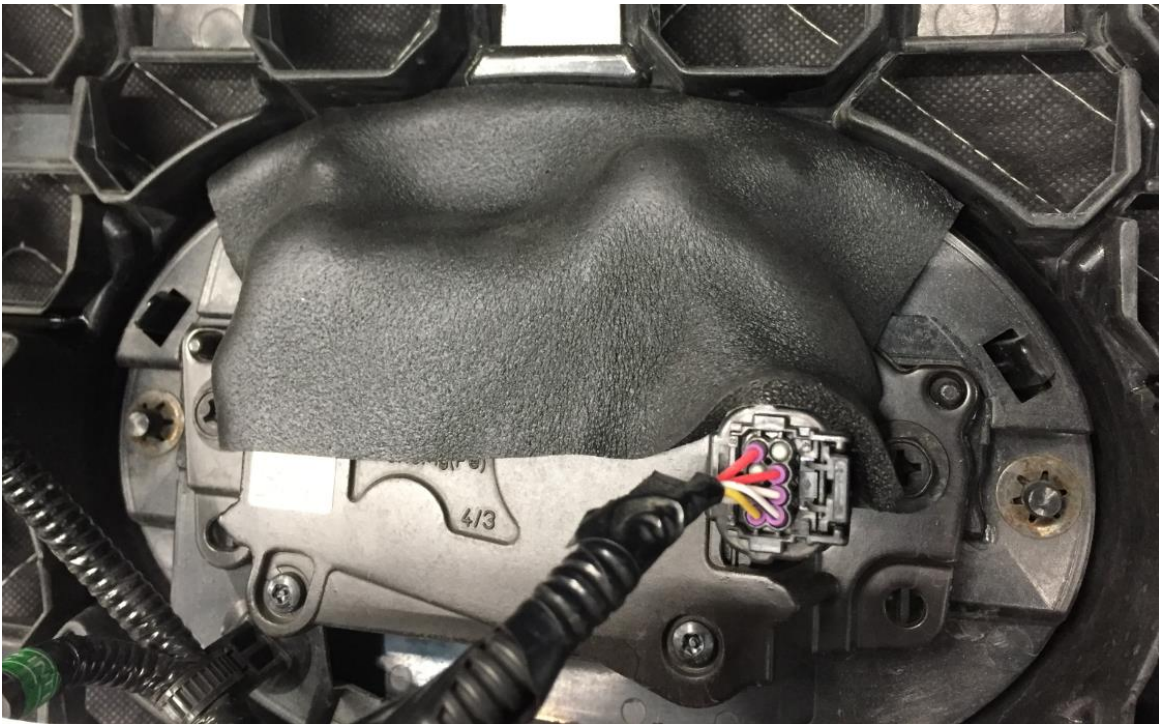
- a. Apply the EPT Sealer to the back face of the MWRS in the position shown below.
- b. Roll the EPT sealer onto the inside lip of the radiator grille to create a waterproof shield over the top of the sensor.
- c. Using finger pressure, thoroughly press the entire surface of the EPT sealer to securely adhere it to all contact surfaces.

Recommended temperature for adhesion is 50° F and above.  
Keep stock at room temperature.

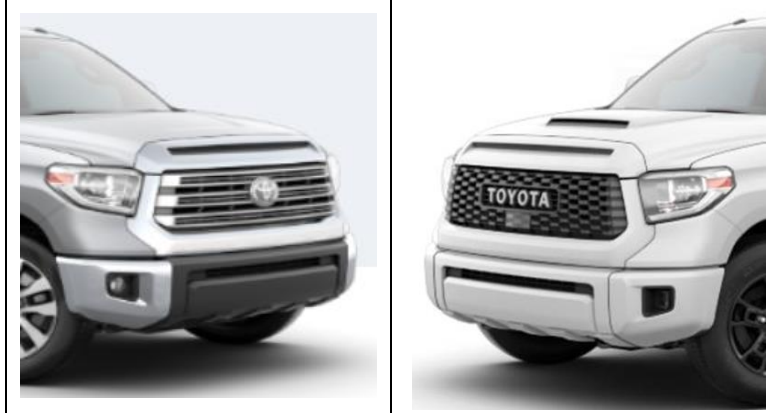
TUNDRA Repair B vehicles will have radiator grilles of these designs:

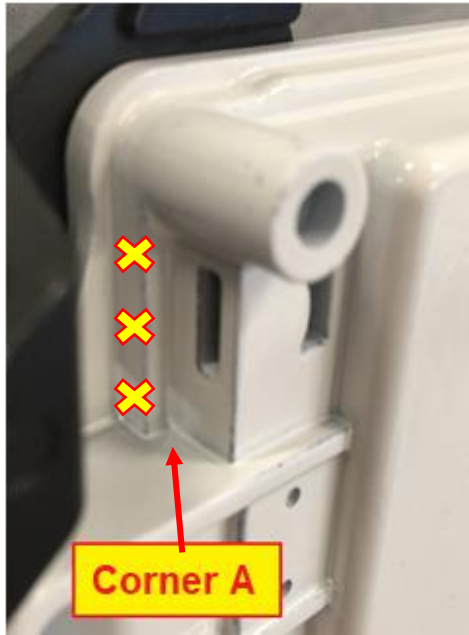
Left Side

Note: The MWRS housing has been painted white in these photos to provide more contrast in the pictures. The actual MWRS housings will be black.

- a. Wear Nitrile Gloves to prevent adhesive contamination.
  - b. Apply the EPT-Sealer to the left side of the MWRS to the following standard:
    - **Left Side View:** Corner "A" of the EPT-Sealer should be placed at the inner corner of the MWRS as indicated.
    - **Top View:** Place the EPT-Sealer on the surface of the side vent hole (it is ok to cover the side vent hole). **DO NOT place the EPT Sealer on top of the ridge**, as indicated with the yellow X's.
- Note:** A diagram of the EPT sealer can be found on page 15.
- c. Press the EPT sealer firmly into place in this area to seat it thoroughly. Use flathead screw driver or trim tool if necessary to reach the corner.

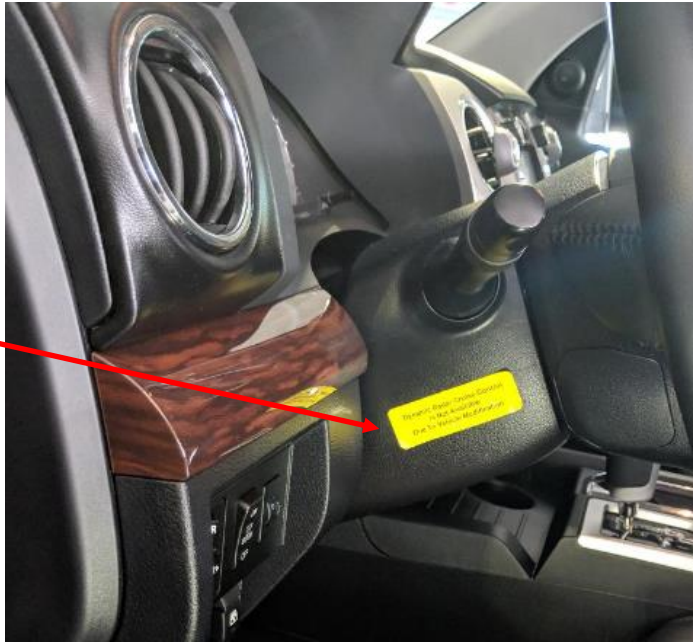
Apply the K0B Modified Vehicle Label to the left side of the steering column
