Warranty Extension: MIL Comes On With DTCs P0301 thru P0304

Supersedes 13-081, dated December 20, 2018, to revise the information highlighted in **yellow**.

Year	Model	Trim	VIN Range
2011-13	Odyssey	ALL	Check the iN VIN status for eligibility.

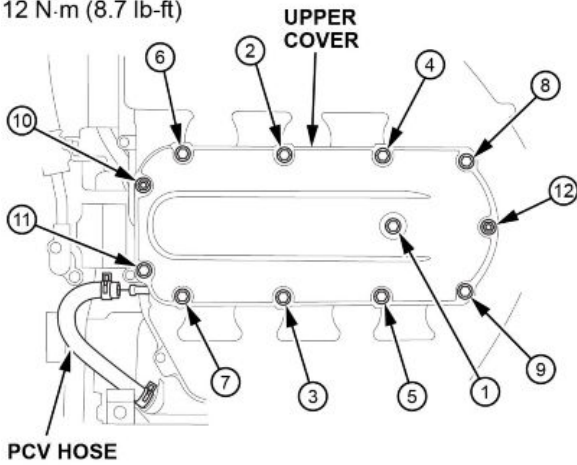
28. Remove the engine intake upper cover and PCV hose.

SPECIFIED TORQUE
6 x 1.0 mm
12 N·m (8.7 lb-ft)

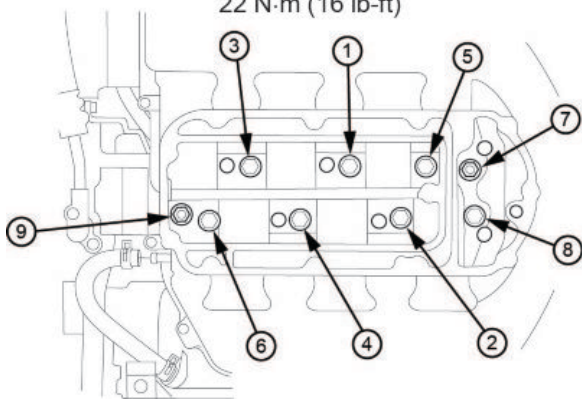
29. Remove the intake manifold bolts and nuts in three steps, then remove the intake manifold.

SPECIFIED TORQUE
22 N·m (16 lb-ft)

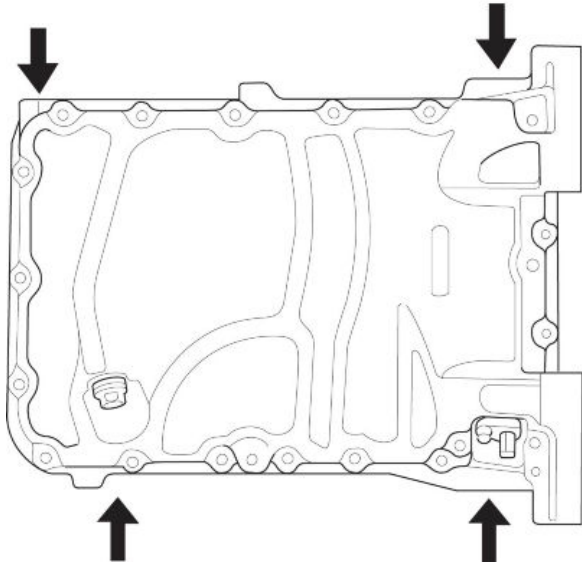
46. Using a flat blade screwdriver, separate the oil pan from the engine block in the areas shown.

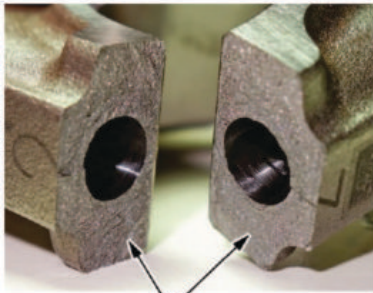
The uneven mating surfaces are uniquely matched and not interchangeable.

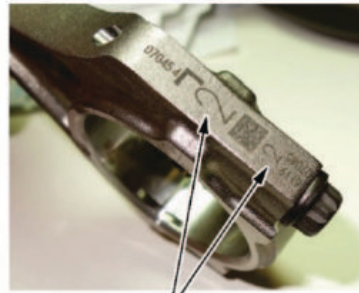
These are manufacturing marks, and do not indicate the cylinder number.

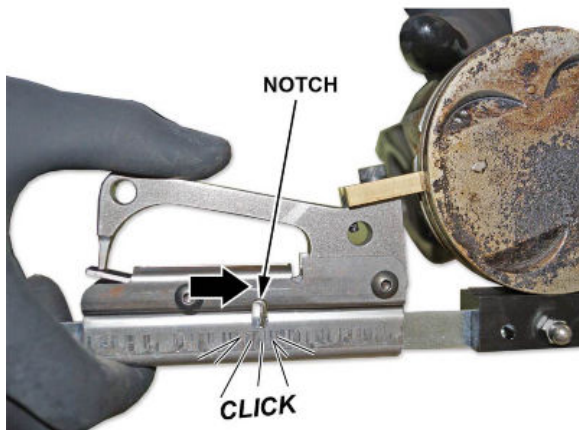
5. Once the cleaning bit is in the appropriate ring grooves of the piston, make sure the tool handle clicks in to place.

There is only one notch on the tool for the handle to engage.

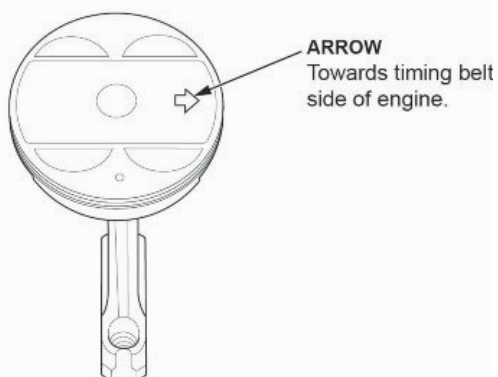
13. Install the piston/connecting rod assembly into the cylinder bore with the arrow on top of the piston facing the timing belt side of the engine.

Be careful not to damage the cylinder wall when installing the piston.
