## QUARANTINE NOTICE

<b>Reference number:</b>	QN-03-1159V2	<b>Issued:</b> 7 May, 2019
<b>Subject:</b>	Bonnet-Vent Water Shields	
<b>Model(s):</b>	DB11 V12	
<b>VIN Range:</b>	Refer to the separately published list of affected Vehicle Identification Numbers (VINs)	
<b>Applicable to:</b>	All Dealers	
<b>Distribute to:</b>	After Sales Manager Executive Manager Service Manager Sales Manager	Warranty Staff Technician(s) Parts Staff

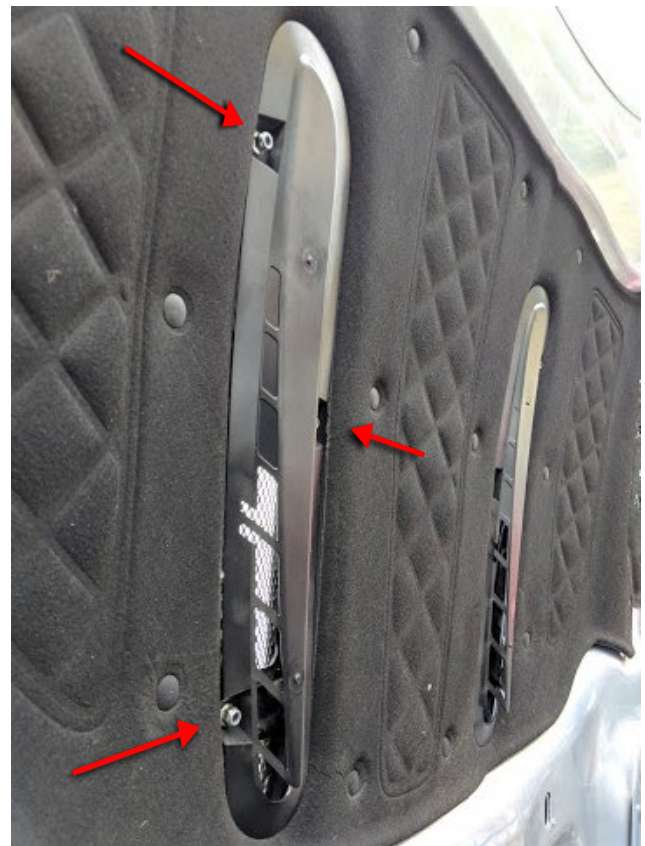
Figure 1

There can be a problem when DB11 V12 is parked in rain. Water can go into the bonnet vents and collect on the coil pack seal. The water can then go into the breather pipe for the spark plug cavity as the engine temperature decreases. When water touches the HT leads it can cause a misfire.

3. Attach the left side water shield to the bonnet with three nuts (refer to Figure 1).

1. Open the bonnet.
2. Remove the three nuts at the bottom of the left side vent.

4. Repeat the procedure for the right side.
