| HYUNDAI Technical Service Bulletin | GROUP AUTOMATIC TRANSMISSION | NUMBER 19-AT-003H-1 |
| | DATE MAY, 2019 | MODEL(S) SONATA (YFa) |
| SUBJECT: | AUTOMATIC TRANSMISSION 2-3 SHIFT FLARE | |

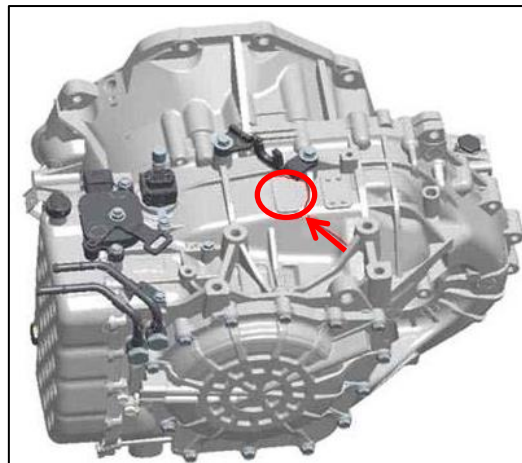
Locate the 12 digit Serial Code of the removed transmission at the location shown in the image.

1. Remove the air filter box and locate the Serial Code on top of the transmission. Refer to the Parts Information to determine the correct transmission.

Refer to Parts Information to confirm the installed transmission was the correct part number according to the first 4 digits of the serial code. If the installed transmission was:

- Incorrect ATM, install the correct ATM.
- Correct ATM, replace the ECU according to the Parts Information below.
