Technical Service Bulletin

| GROUP ELECTRICAL | NUMBER 19-BE-010H |

SUBJECT: CLEARING DIAGNOSTIC CODE(S) FROM THE BLUE LINK SYSTEM (GEN 1)

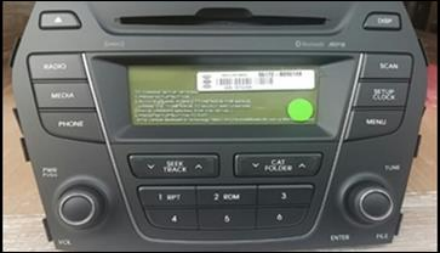
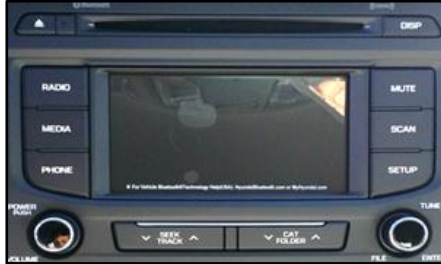
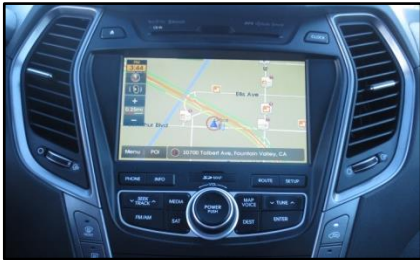
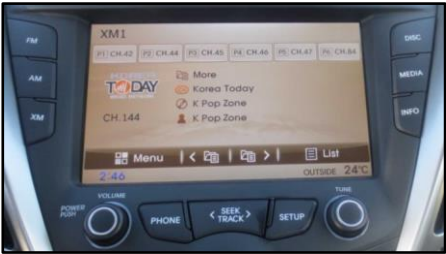
Head Unit type reference:

| Audio 3.0A / 3.0B | AVN 3.0 | LG Audio |
| <p style="text-align: center;">3.0A</p> <p style="text-align: center;">3.0B</p> | | |

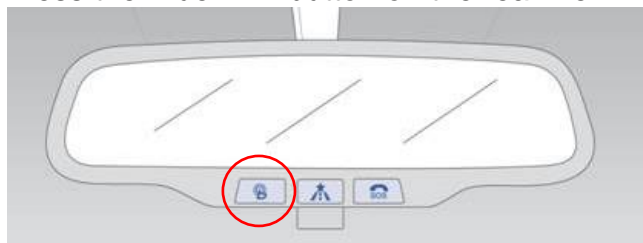
3. Allow engine to idle for at least 10 seconds, and then proceed to the next step.
4. Press the Blue Link button on the rear view mirror.

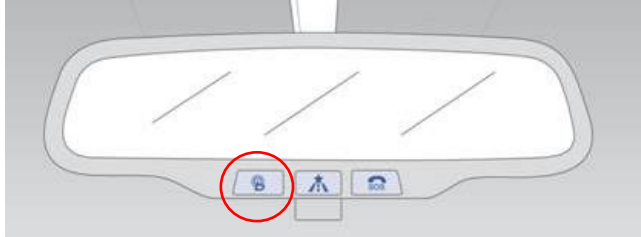
5. Press the Blue Link button on the rear view mirror.

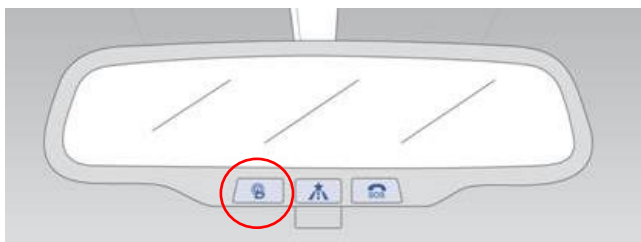
6. Wait for the system to prompt “Please say the name of the service”, and then say “**Vehicle Report**”. System will confirm by stating “Vehicle Report Submitted”.
7. After confirmation, the system will prompt “Please say the name of the service”, and then say “**Goodbye**”. Blue Link system will then disconnect and end the call.
8. **LEAVE ENGINE RUNNING FOR A MINIMUM OF 3 MINUTES**, and then turn the engine off.
9. Turn Engine **ON** and press the Blue Link button on the rear view mirror.

10. Verify “**A possible condition**” message is no longer heard.

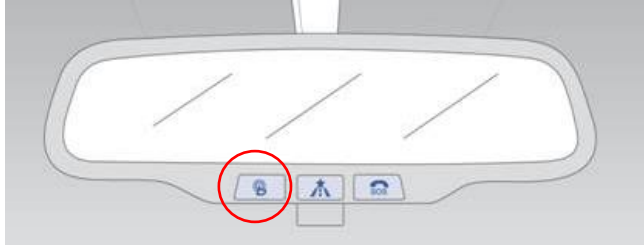
5. Press the Blue Link button on the rear view mirror.

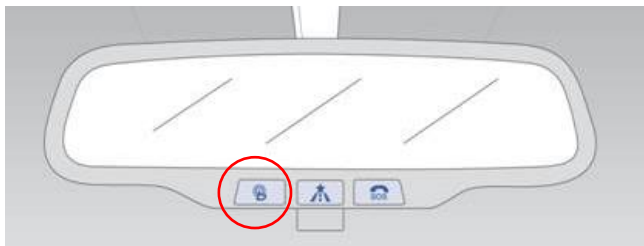
6. Wait for the system to prompt “Please say the name of the service”, and then say “**Vehicle Assist**”.
7. System will confirm by stating “Vehicle Assist, you can say roadside assistance, agent assistance, service link, quick tip, or main menu”. Then say “**Blue Link Service Complete**”. This is a hidden command, so the Blue Link interactive voice will not list it as an available option.
8. System will confirm by stating “Service complete please say Main Menu or Goodbye”, then say “**Goodbye**”. Blue Link system will then disconnect and end the call.
9. **LEAVE ENGINE RUNNING FOR A MINIMUM OF 3 MINUTES**, and then turn the engine off.
10. Turn Engine ON and press the Blue Link button on the rear view mirror

11. Verify “**A possible condition**” message is no longer heard.
