Service Campaign Bulletin

Campaign No. 2019040015, May 2019

SUBJECT: **Model A-Class (177 platform)**
Model Year 2019

Apply wax as preservation agent to jack support points

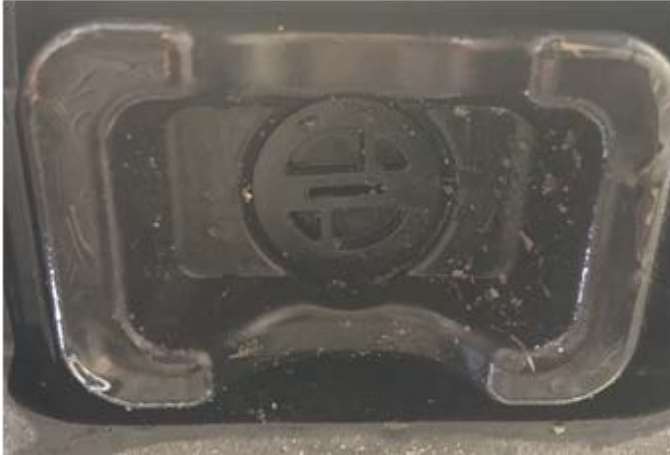
Figure 1

1. Drive vehicle onto drive-on lifting platform.
i The work can also be performed above a pit.
2. Remove jack support point grommets (**4 pieces**).
i Remove the locking plug with a flat tip screwdriver

3. Rework body shell holes with wax
i Use a brush.
4. Assemble in reverse order.

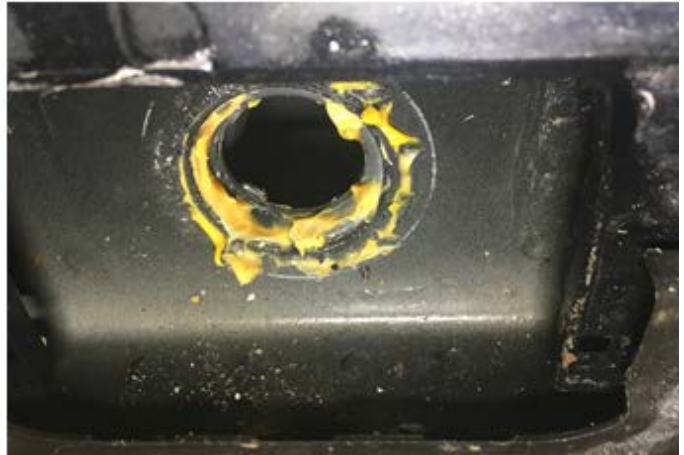
Figure 2 example of correct wax application
