## Head-up display (HUD, code 463) - lines on the display, display flickers

Topic number	LI54.30-P-069742
Version	1
Function group	54.30 Instrument cluster, display instruments, hazard warning device
Date	05-02-2019
Validity	Model series 205 with code 808+463 and not 464 Model series 253 with code 808/809+463 and not 464
Reason for change	
Reason for block

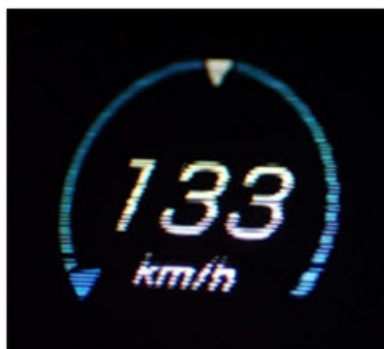
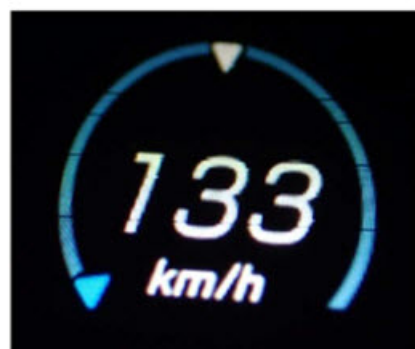
HUD image quality complaint.jpg:

The image in the head-up display (HUD) flickers and/or has lines on it. See attachment for details.

Attachments	
File	Description
HUD image quality complaint.jpg	Picture of complaint

Signal from instrument cluster (IC entry) to head-up display not within specification.

Please replace the instrument cluster. Do not replace the head-up display or any other parts.
