WORK DESCRIPTION FOR FIELD MEASURE

Code: 19P3397002

Check spring link of left and right front axle, replace if necessary

Models 205, 238 and 253 (AMG and 4MATIC)

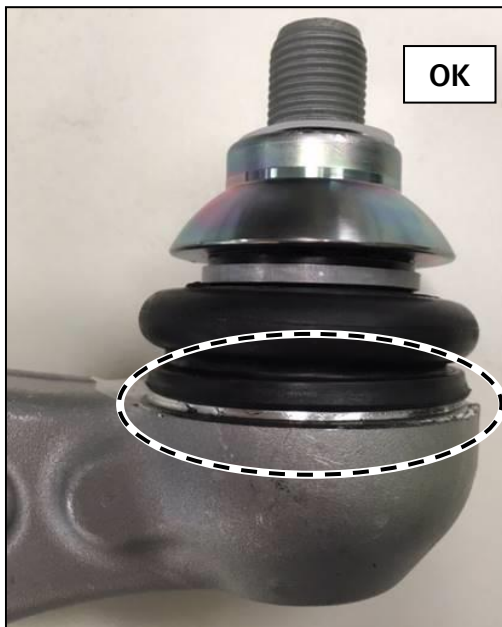
Figure 1

1. Lift vehicle with vehicle lift.
i For basic data, see AR00.60-P-1006A.
2. Check rubber bellows of the ball joint on the left and right front axle spring link for proper seating.
i The rubber bellows must be seated flush on the spring link (figure 1)!
i Figure 2 shows an **image that is not OK!**

- a. **Rubber bellows** of the ball joint on the spring link **not** OK:
Carry out **work procedure**.
- b. **Rubber bellows** of the ball joint on the spring link **OK**:
End measure.
