**\*\* SOLUTION \*\***

| Title | Volvo Chassis - Equipped With An Automated Manual Transmission <b>Model D or F ( I-Shift, AMT-D, AMT-F )</b> - Transmission Oil Leakage From Transmission Input Shaft Seal Or Output Shaft Seal - <b>US10 And Newer Emissions, Common Model Years 2010 And Newer</b> |

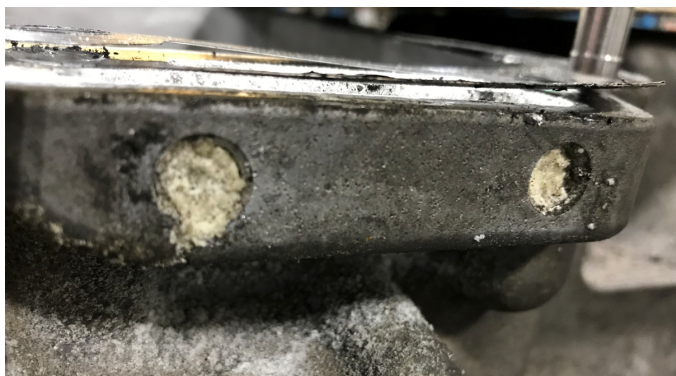
Accumulation of debris in the left side vent ports of the transmission main case (corrosion, road salt, dirt, etc) may result in oil leaks present at the transmission input and output shaft seals.

Blockage of these ports allows pressure to build to a point that it forces oil past the input and output shaft seals. In extreme cases, the pressure buildup can be high enough that operation can be affected. Excessive internal pressure caused by blocked vents may result in slow or sluggish gear shifts.

1. Check the vent ports on the upper left side of the the main gearbox housing for any sort of blockage or obstruction.

Clogged vent ports

2. Clean out any debris that is observed during the inspection.
3. Check the transmission oil level in the gearbox.
  - **If the lube level is excessively low:** Proceed to the next section.
  - **If the lube level is at an acceptable level:** Fill the transmission oil to the correct level and check operation.
