Subject Entune Update Pop-up Message On Every Key Cycle		Market USA
Service Category Audio/Visual/Telematics	Section Navigation/Multi Info Display	
Applicability All Applicable Models

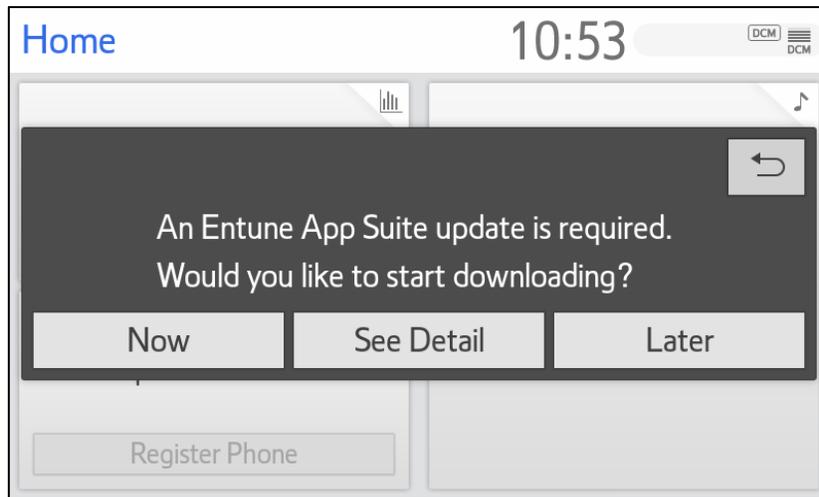
Some customers may experience an Entune™ update pop-up message after every key cycle.

This is due to an incomplete or corrupt Entune™ update download. Delete personal data on the head unit, then apply the Entune™ update.

To apply the update, do the following:

If the vehicle is equipped with a DCM, select the “Now” button. If the vehicle is not equipped with a DCM, connect a phone with latest Entune™ 3.0 App installed, then select the “Now” button.
