23-17-06 - MIL ON, No Start, or Rough Running with DTCs P0087, P0088 or P0191 (TDI ONLY)

Release date: 7/2/2019

Applicable Vehicles					
Model(s)	Year	Eng. Code	Trans. Code	VIN Range From	VIN Range To
Golf, Jetta, Jetta SportWagen	2009-2012	2.0L TDI (CBEA, CJAA)	All	All	All

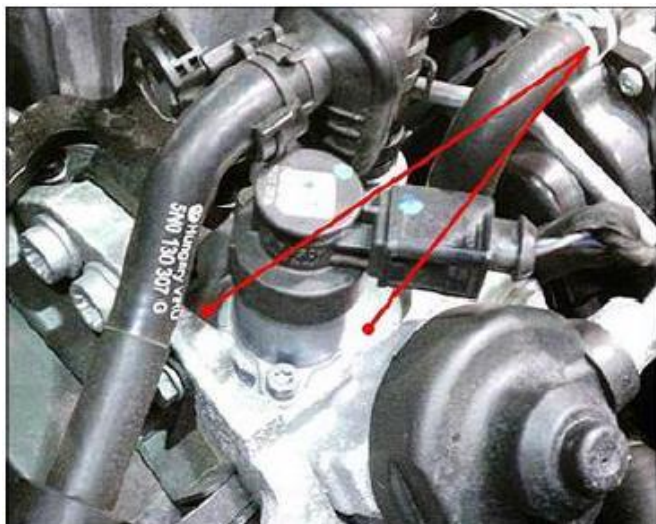
Figure 2. Surrounding Area

Prior to removing the **-N290-** Fuel Metering Valve, the area surrounding the valve (Figure 2) must be clean and dried with compressed air to remove ALL debris from the area. See Repair Manual Group 20 Fuel Supply, General Information, Clean Working Conditions in Elsa.

If debris enters the fuel system, components may be damaged.

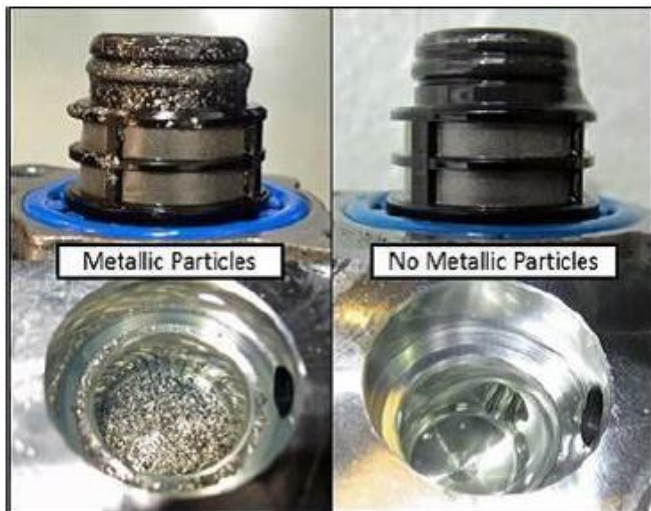
Figure 3. N290 Fuel Metering Valve and Valve Bore

1. Remove the **-N290-** Fuel Metering Valve and inspect the valve and valve bore for the presence of metallic particles (see Figure 3).

2. If metallic particles are found on the **-N290-** Fuel Metering Valve or in the valve bore, replacement of the high pressure fuel pump and major components in the fuel system is necessary. (See High Pressure Fuel Pump Replacement and Fuel System Repair section below).

3. If no metallic particles are found on the **-N290-** Fuel Metering Valve or in the valve bore, do not replace the high pressure fuel pump. Open a VTA case and contact the Volkswagen Technician's Helpline for further assistance diagnosing the vehicle, this bulletin does not apply.

High Pressure Fuel Pump Replacement and Fuel System Repair

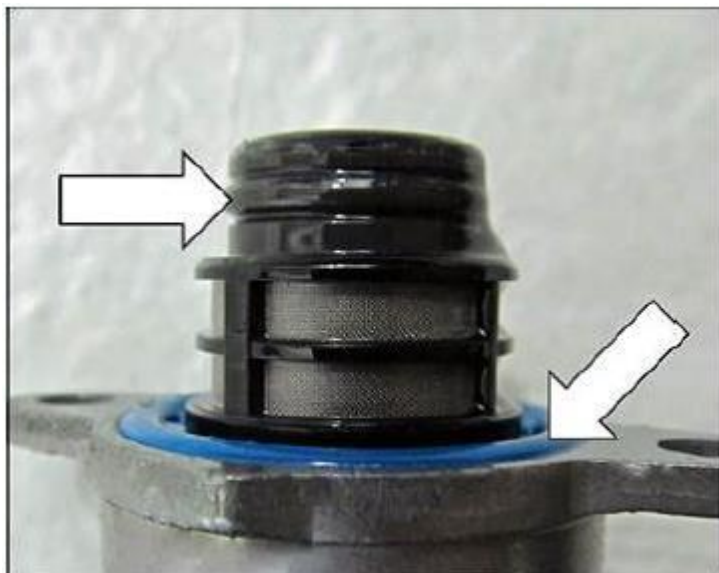
Figure 4. N290 Fuel Metering Valve O-rings

To prevent fuel system damage, ensure that the **-N290-** Fuel Metering Valve is free of any contaminants before reinstalling.

Prior to reinstallation of the **-N290-** Fuel Metering Valve, ensure that both O-rings are not damaged. If they are damaged, the high pressure fuel pump must be replaced.

To prevent damaging the O-rings when reinstalling the **-N290-** Fuel Metering Valve, lubricate the O-rings with diesel fuel (see Figure 4).

4. Install the **-N290-** Fuel Metering Valve into the valve bore using light pressure.
 5. Install and hand tighten both M5 fasteners, ensuring that the threads are clean and dry.
- Pre-tighten to 2 Nm, then to 6.5 – 7 Nm.
