SERVICE BULLETIN

Bulletin No.: 2019-0037

Aerotech (Ford E-series Chassis) – 2012MY – 2019MY

To add repair cracks and add support to the second unit body outrigger.
This repair is for raised/flat floor vehicles only.

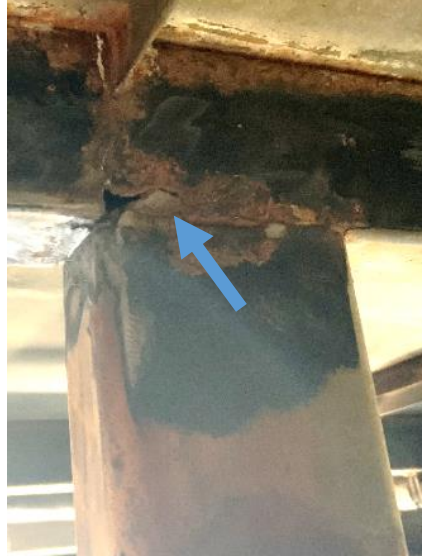
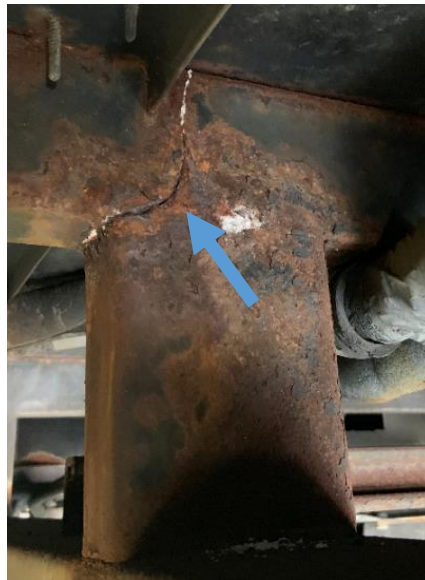
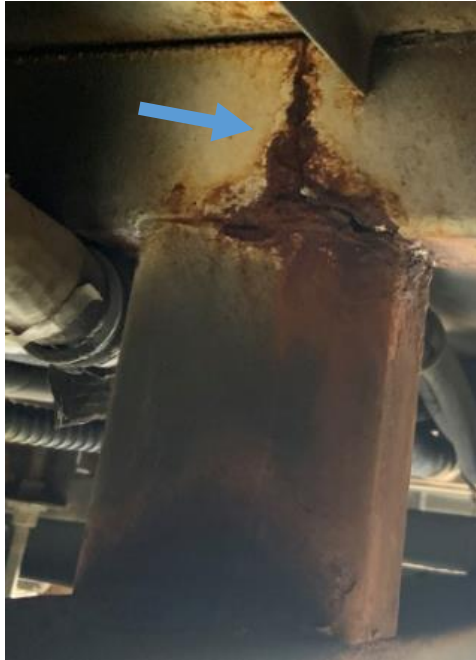
1. Inspect the underside of the second unit body for cracks in the outriggers of the floor assembly. Reference Photo #1 thru Photo #3 for examples.

2. Identify the number of cracks in the floor assembly outriggers and order the corresponding quantity of Plates, Cross Member Reinforcement, part numbers 0039828 & 0039829.
Note: Reinforcement Plates will be installed on both sides of the outrigger that are damaged.
