TITLE:
ECM-P04F000, Evap System, High Pressure Purge Line

REF NO: TJ 34857.1.0	ISSUING DEPARTMENT: Technical Service	CAR MARKET: United States and Canada	
PARTNER: 3 US 7510 Volvo Car USA		ISSUE DATE: 2019-06-17	STATUS DATE: 2019-06-20
FUNC GROUP: 2340	FUNC DESC: Fuel tank, fuel lines, evaporator system	Page 1 of 3

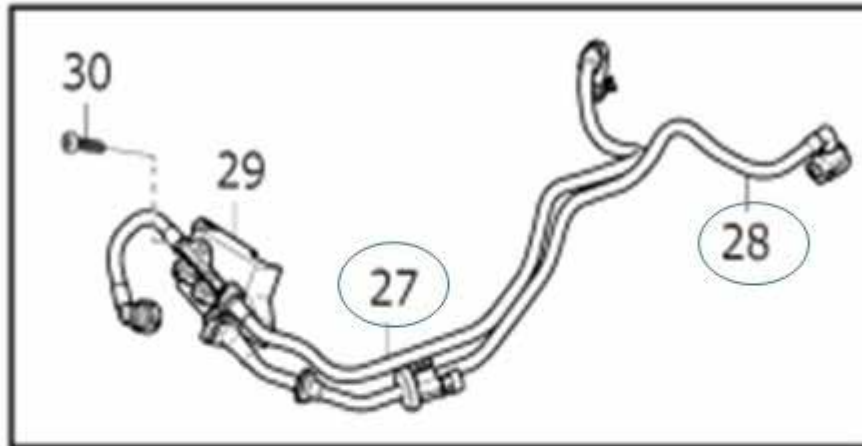
TJ 34857

If check engine light is on and ECM-P04F000 is set, please follow advise under “service”.

Replace both evaporator pipes according to VIDA. See position 27 & 28 in attachment TJ 34857.

It's important to replace both evaporator pipes at the same to avoid repeat repair.

For latest part number on evaporator pipes, check VIDA.
