June 2019  
FL816A-F  
NHTSA #19V-367 (Non-School Bus)  
NHTSA #19V-368 (School Bus)  
Transport Canada #2019-227 (Non-School Bus)

## **Subject: Brake Caliper Mounting Bolts**

**Models Affected: Specific Freightliner 108SD, 114SD, Argosy, Business Class M2, Cascadia, and Columbia vehicles; Western Star 5700 vehicles; Freightliner Custom Chassis B2 school bus chassis (Thomas Built Buses Saf-T-Liner C2) and X-Line chassis manufactured August 20, 2018, through September 29, 2018, and equipped with air disc brakes.**

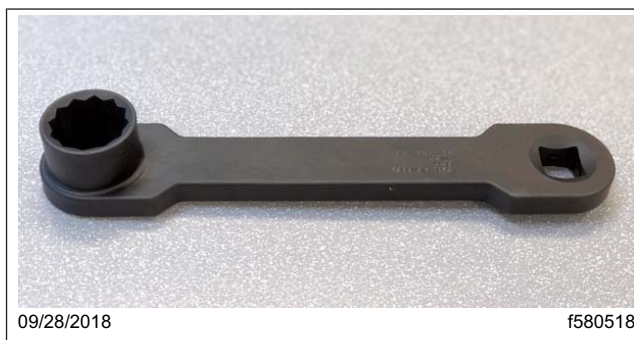
**Fig. 1, DDC DSNCHA018005 30mm Air Disc Brake  
Caliper Brake Bolt Torque Adaptor**

| Torque Check with 47 Inch (119 cm) Torque Wrench and Tool DDC DSNCHA018005 | | | |

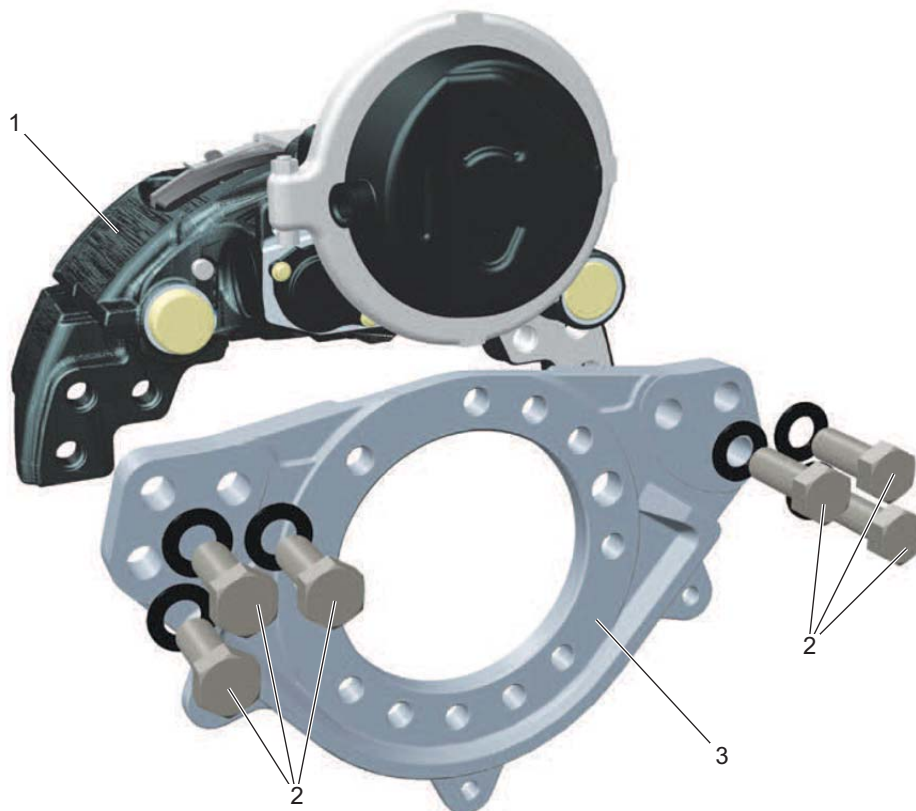
f422664

9. Align each caliper/carrier assembly with the rotor by pushing the caliper against the shelf on the torque plate, then install the caliper/carrier assembly using new caliper mounting bolts. See [Fig. 2](#).

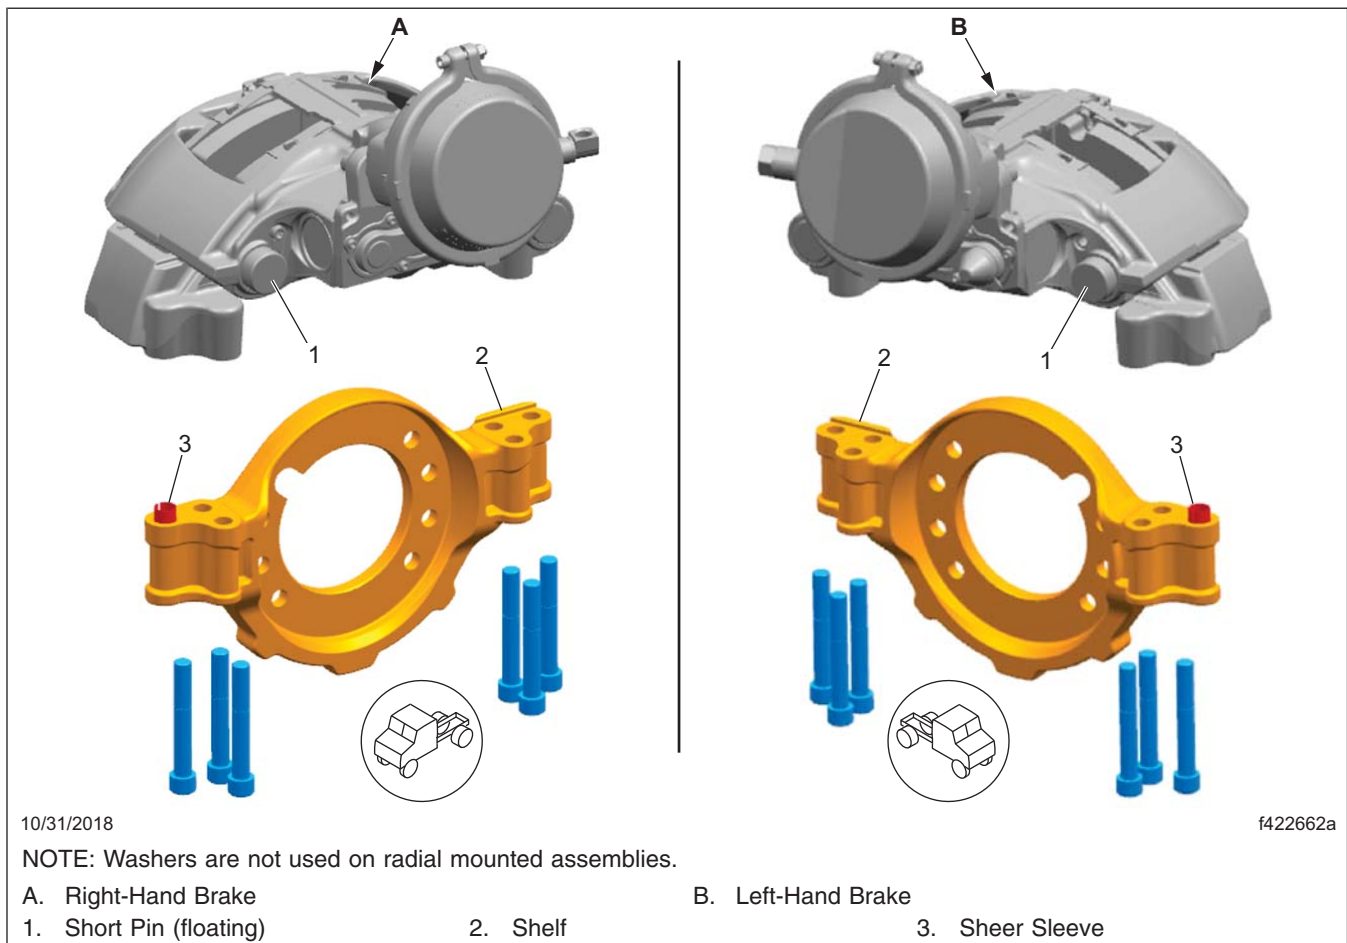
Fig. 4, Bendix Radial Mounted Caliper

9. Align each caliper/carrier assembly with the rotor by pushing the fixed pin side of the caliper against the shelf on the torque plate, then install the caliper/carrier assembly using new caliper mounting bolts. See [Fig. 4](#).

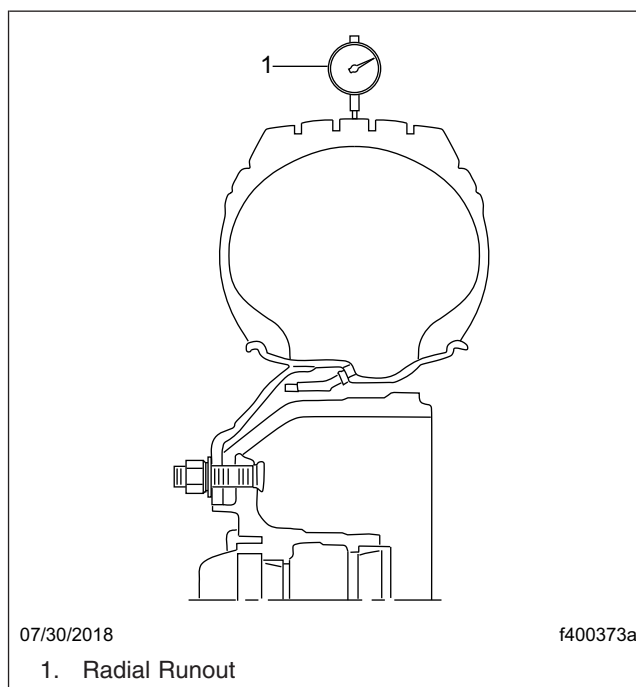
**Fig. 7, Radial Runout Check for Tires**

4. Beginning with the right-front wheel, use a tire runout gauge to check the radial runout. See [Fig. 7](#). Write down the measurement for later use to avoid vibration complaints.

16. Using a tire runout gauge, measure and record the radial runout of the tire and wheel assembly. Mark the highest point on the tire and wheel assembly. Rotate the tire and wheel assembly until the high spot is at the 12 o'clock position (without allowing the assembly to turn). Loosen all lug nuts to let the assembly settle, then tighten the lug nuts in the proper sequence. See **Group 40** of the applicable vehicle maintenance manual for the tightening sequence. The radial runout should be very close to what was recorded in step 3. If not, repeat this step. Record the "final" radial runout, note the wheel location, and include the information in the recall claim in OWL.

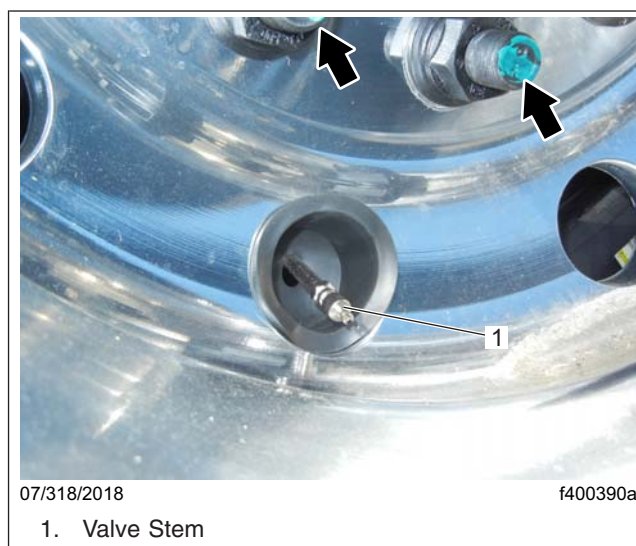
**Fig. 8, Marking Wheel Studs**

5. Mark the two studs closest to the valve stem as shown in [Fig. 8](#), for proper wheel assembly location when reinstalling the wheel assembly on the hub.
