## DAIMLER TRUCKS NORTH AMERICA AFTERMARKET

No.: 19TL-8  
July 1, 2019

SUBJECT: **Modification to Flywheel TDC Locating Pin Tool – W470589001500**

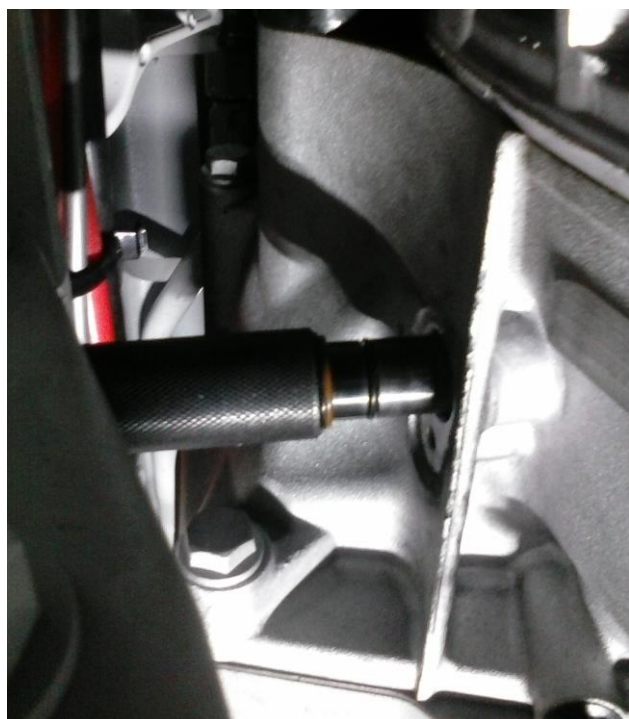
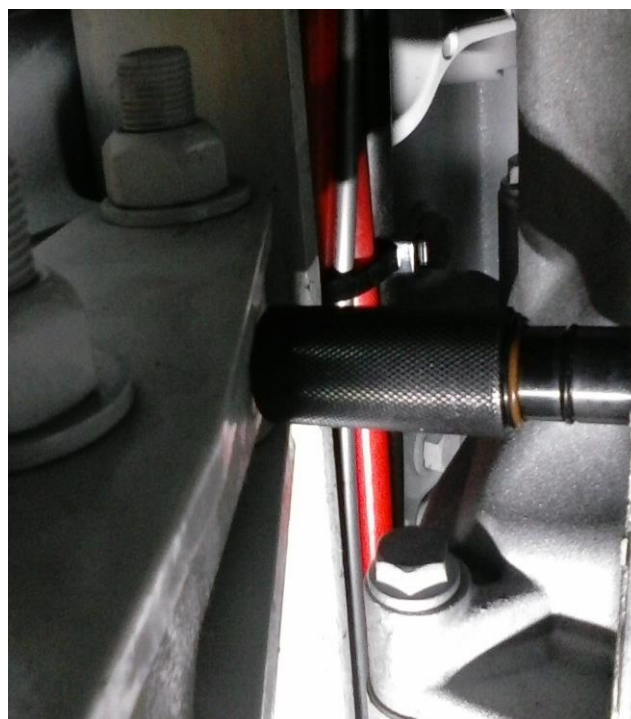
The crossmember mounting bracket of the “New Cascadia” prevents correct installation of the TDC locating pin tool through the crankshaft position sensor hole in the flywheel housing. There is a modification required to the standard tool for it to clear the crossmember mounting bracket in the “New Cascadia” and fit properly into the bore.

Using appropriate equipment, grind the knurled end of the W470589001500 tool to produce a beveled edge. The beveled edge of the flywheel TDC locating pin tool will provide adequate clearance between the crossmember mounting bracket and the flywheel housing.
