TECHNICAL SERVICE BULLETIN

DOCUMENT CREATION DATE:	6/20/2019
SERVICE CAMPAIGN SUBJECT:	Dash Wiring Retrofit
VINs or MODELS AFFECTED:	Service Specified Buses
SERVICE CAMPAIGN #:	SC-19-84

DASH WIRING RETROFIT

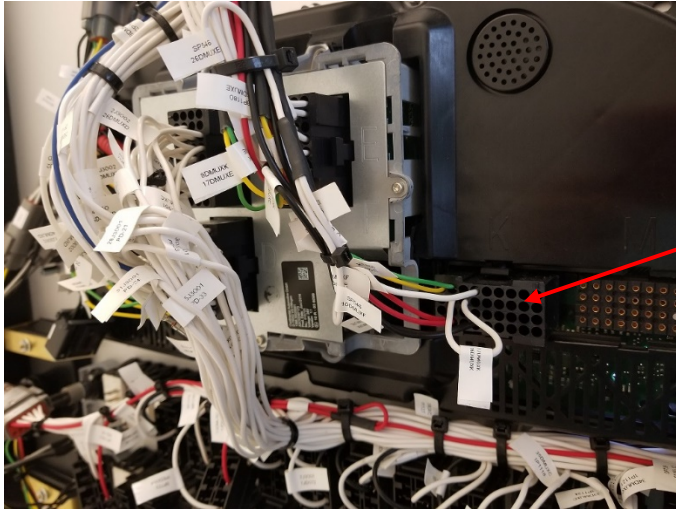
1. Perform the Proterra approved Lockout/Tagout procedure for safety. Refer to the Proterra Catalyst LOTO Safety Guide if you are unsure of the proper procedure.
2. Working underneath the driver's dash, locate the DMUXK connector shown in the following photograph. Disconnect this connector from the Dash.

3. Using a Pin Extractor Tool, remove the Pin and wire from Cavity 18 of the DMUXK Connector.
4. Insert the Pin that was removed from Cavity 18 into Cavity 17 of the DMUXK Connector.
Note: Perform a "Tug Test" to ensure that the pin is fully seated in the connector.
5. Reconnect the DMUXK Connector to the Dash.
6. Remove the Lockout/Tagout devices and power on the bus.
7. Return the bus to service after confirming that the Dash is operating correctly.
