Bulletin No.: PIP5240F
Published date: 07/25/2019

PIP5240F Mil On With DTC P0171 And / Or P1101

Brand:	Model:	Model Years:	VIN:		Engine:	Transmissions:
			from	to		
Buick	Encore	2013 - 2019	All	All	1.4L (LUV) (LE2)	All
Chevrolet	Trax	2013 - 2019	All	All	1.4L (LUV)	All

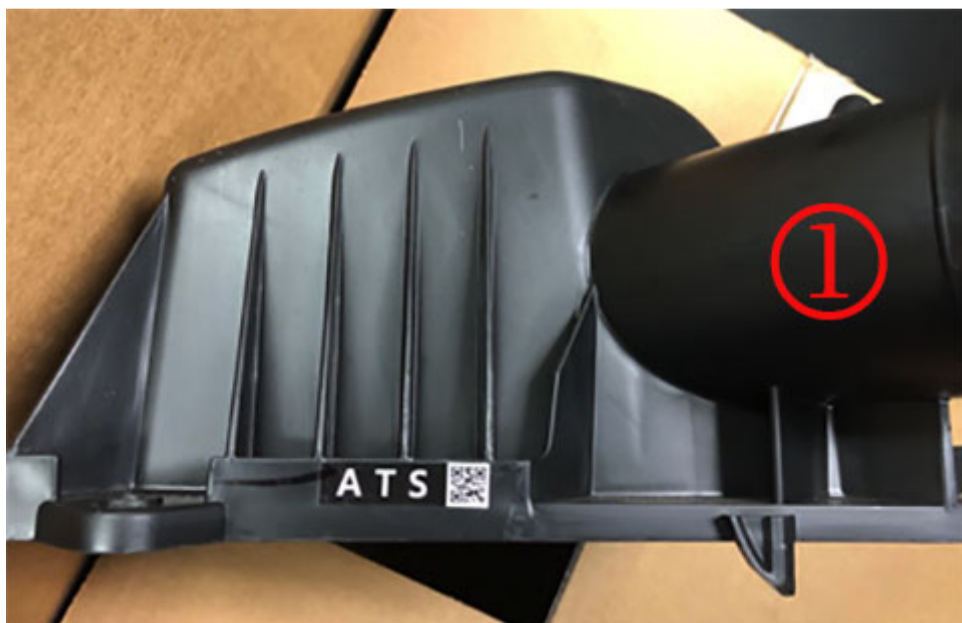
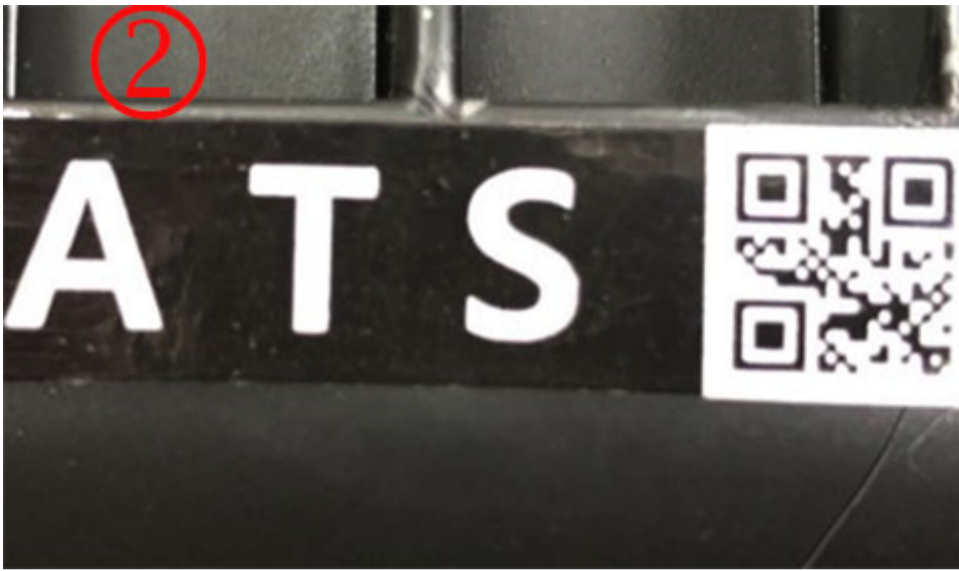
If the build date is 05-14-2018 or later, take a clear picture of the bar code on the air cleaner housing cover and attach to the warranty RO. (see pictures below)

If the air cleaner housing does not have the proper content for the engine application as shown, replace the Air Cleaner Housing with the latest part listed in the Electronic Parts Catalog.

NOTE: If the improper air cleaner housing cover is installed, then record the vehicle build date in VISS.

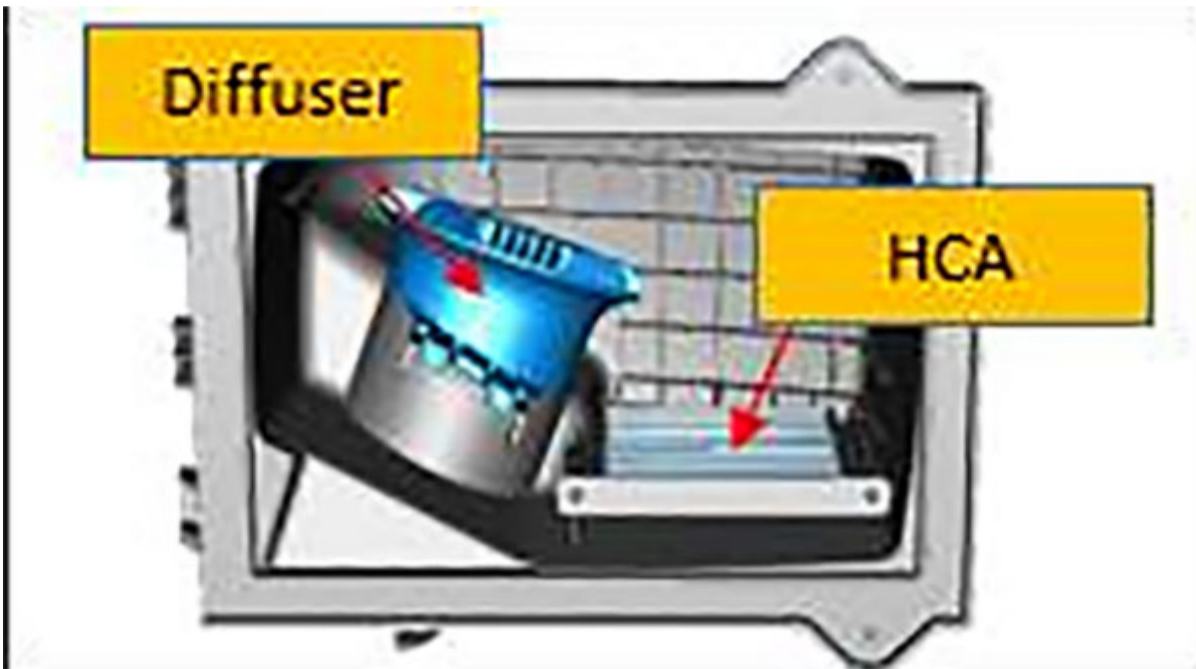
- LE2 has both HCA and Diffuser

If current SI diagnostics do not isolate the cause of the concern, inspect the Air Cleaner Housing for proper content as shown.

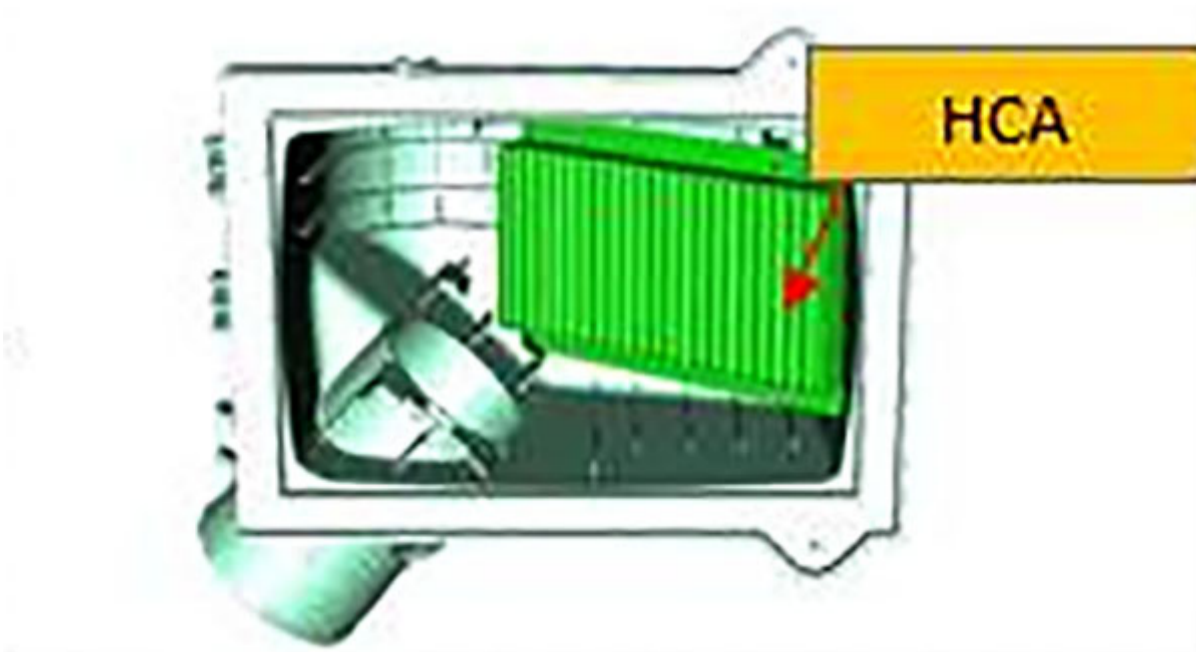
- LUV has ONLY HCA
