Latest Vehicle Concern Fixes

Broken / Cracked TPMS Valve Stems

17MY- Onwards RR Velar, Range Rover, RR Sport, RR Evoque, Discovery, Discovery Sport, E-PACE, F-PACE, I-PACE, F-TYPE, XJ, XE, and XF

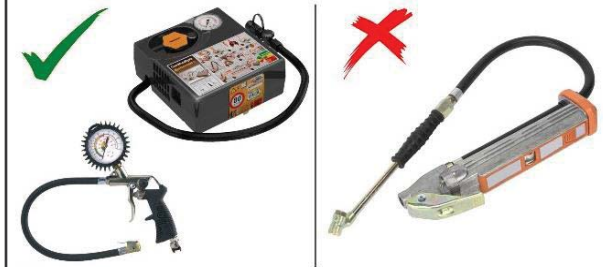
E197021

- The tire valve stem is broken or cracked.

- This damage may be caused by the use of an extended tire inflation chuck.

- Damage due to the use of the extended tire inflation chuck should not be claimed under warranty.
- Warranty will be calling back TPMS sensors and valve stems for inspection.
