Subject: i-ACTIVESENSE WARNING AND SBS INDICATOR LIGHTS ON WITH	Service Alert No.: SA-034/19	
DTC B14F9:00 STORED UNDER HOT WEATHER CONDITIONS	Last Issued: 08/09/2019

2019 Mazda3

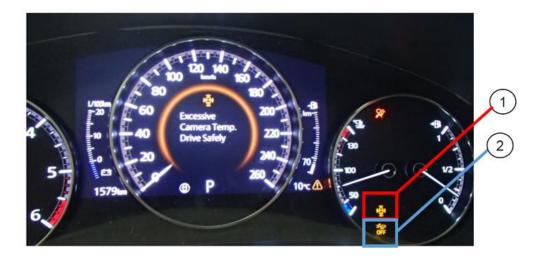
- i-ACTIVSENSE warning light ON (1)
- Smart Brake Support (SBS) indicator light ON (2)
- "Excessive Camera Temp. Drive Safely" or "Safety and Driver Support Systems Temporarily Disabled" warning messages
- DTC B14F9:00 stored in memory

DTC_B14F9:00 is falsely stored instead of DTC B14F0:4B. DTC_B14F0:4B [VCM] (Forward sensing camera (FSC) internal temperature abnormality) - FSC detects temperature higher than operation range.

- 2. Is DTC_B14F9:00 stored in memory?
 - Yes Go to MGSS DTC B14F0:4B [VEHICLE CONTROL MODULE]
 - No This service information does not apply. Go to MGSS for normal diagnosis.
