MBUX multimedia system: Map data do not match the data in the system.

Topic number	LI82.85-P-069961
Version	1
Function group	82.85 Navigation and Communication system (CNS, ICS, COMAND, FleetBoard)
Date	07-09-2019
Validity	Model series 177 with MBUX code 548/549 and code 365 Model series 167 with MBUX code 548/549 and code 365 Model series 118 with MBUX code 548/549 and code 365
Reason for change	
Reason for block

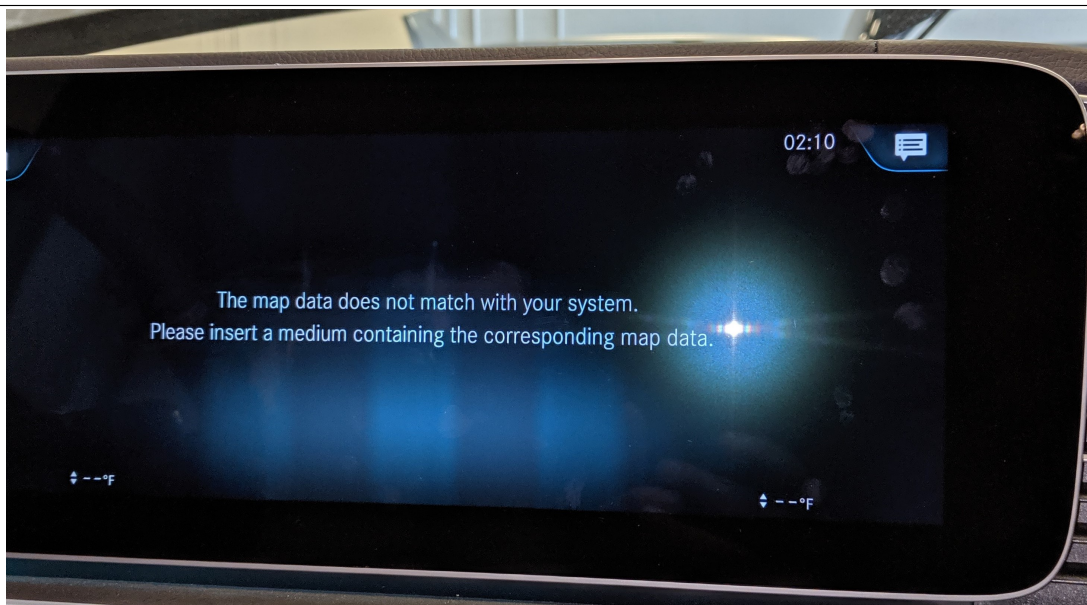
map data message.jpg:

Upon selecting navigation, the central display may show the following message: "Map data does not match with your system. Please insert a medium containing the corresponding map data"

Attachments	
File	Description
map data message.jpg	Map data error message

Please install the deletion database (DB) located in the attachment:

- Download the deletion DB and unzip to an empty USB flash drive (ensure ONLY the files are extracted to the drive, the files should not be in a folder).
- Connect the USB flash drive with deletion DB files to one of the forward USB ports in the center console.
- Start the deletion DB update. No activation code is required.
- Install the latest map version and test navigation for functionality.
