### PIP5407A Code P06DD No Or Low Oil Pressure

#### Models

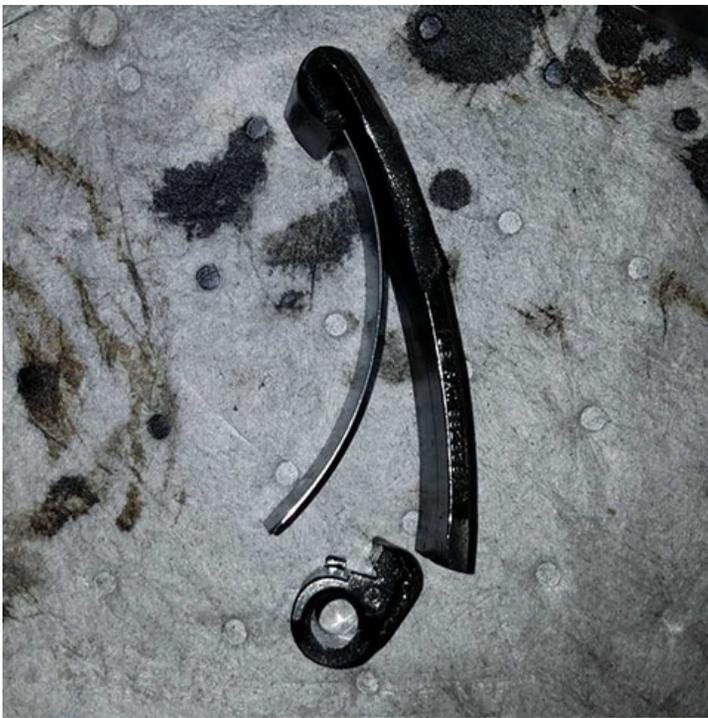
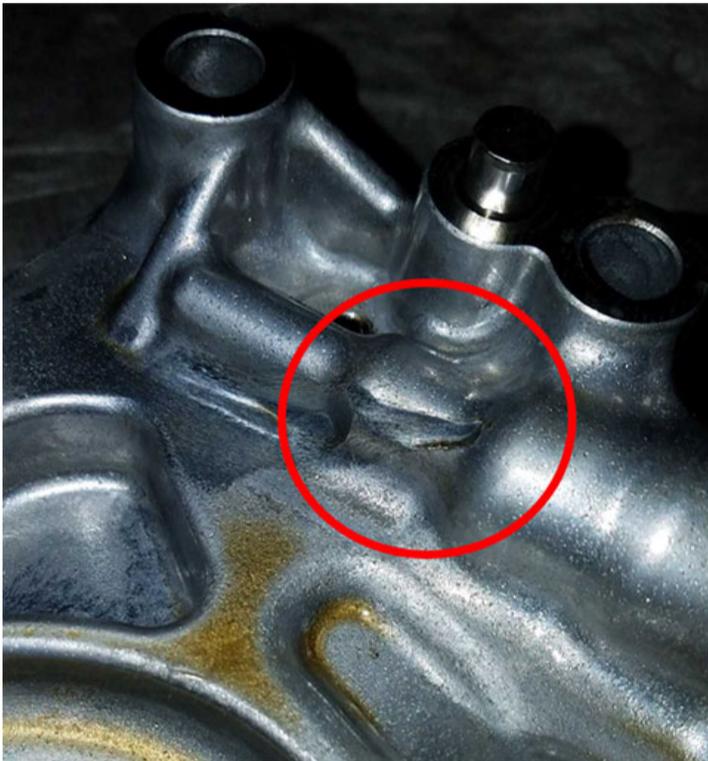
**Also a broken tensioner shoe may allow the spring to rub a hole in the oil pump.**

The hole in the oil pump

**If oil pump face is damaged and or worn thru replace oil pump.**

**Inspect bearings for damage wear due to debris from oil pump.**
