# Newmar Corporation

**TSB 547**  
**Aug. 22, 2019**

## TECHNICAL SERVICE BULLETIN

**Problem: Flickering ceiling lights in early-production 2020 coaches**

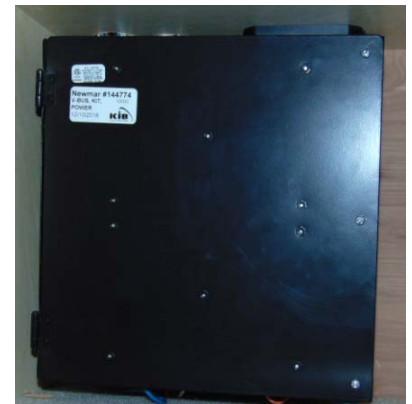
1. Turn off the battery disconnect.
2. Locate and open the KIB box (normally located in the rear closet area) by removing the three screws across from the hinges.
3. Locate the three circuit boards located in the KIB box. One is located on the door, and the other two are located on the back wall of the KIB box.
4. Mark the wire location for each board (suggestion L1- 4+ common and R1- 4+ common). You can also group the wires by putting a piece of tape around them or a zip tie. Take a picture for reference, just in case the wire markings come off.

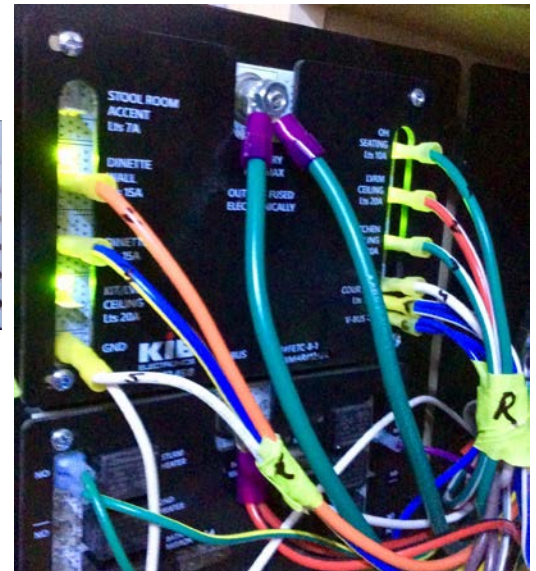
5. Remove the old boards gently, as they must be returned undamaged for credit. Save the cover, spacers, and screws to reinstall with the new board.
6. Verify that the replacement board has the same part number (i.e.: #144771-MOD replaces #144771).

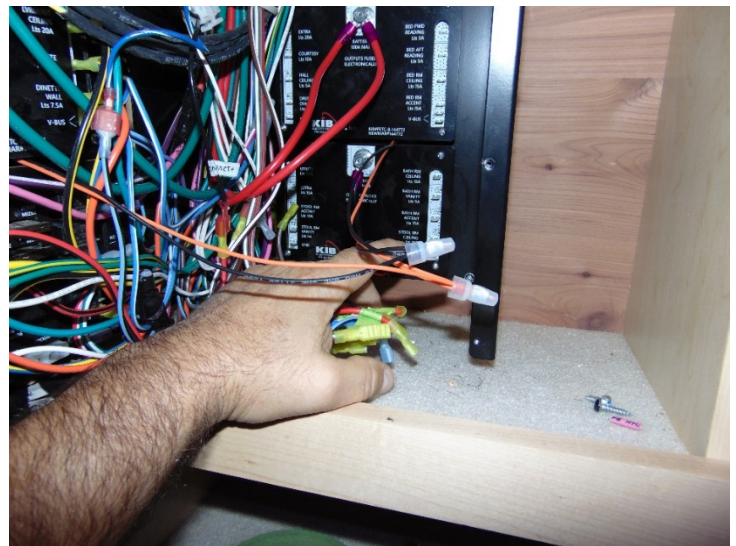
11. Repeat the process for the two remaining circuit boards.
12. Once all three circuit boards are mounted, take the orange wire at the bottom of each new board and connect them together with a bell cap. Then do the same for the black wires.

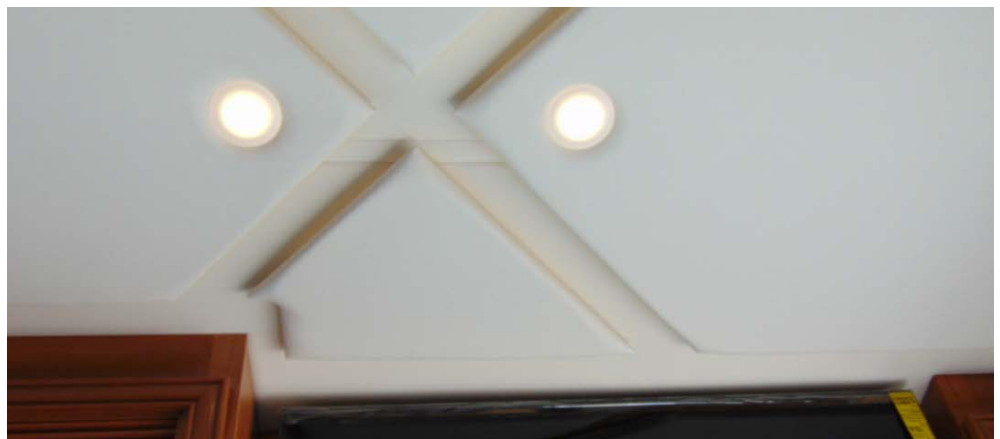
1. Depending on the coach and floor plan, replace either two or four lights. The ceiling lights that require replacement are determined by checking the ceiling light operation. They are the lights that operate automatically when the entry door opens and closes.

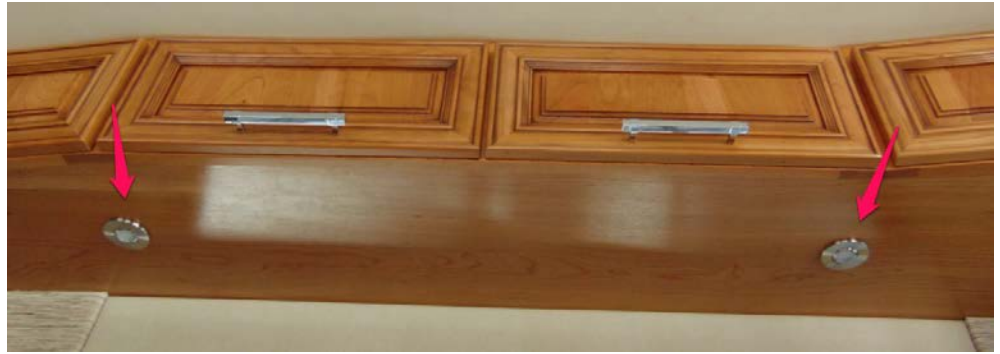
2. Replace the two eyeball lights (on coaches equipped with the recliner options). There are likely two lights in the overhead cabinet above the recliners that are dimmable.
