60-19-01TT Sunroof Cable Guide Clip Transfer After Sunroof Replacement

THIS IS A TECH TIP, NOT A TECHNICAL BULLETIN.

Applicable Vehicles						
Model(s)	Year	Eng. Code	Trans. Code	VIN Range From	VIN Range To	
Jetta	2019	All	All	All	All

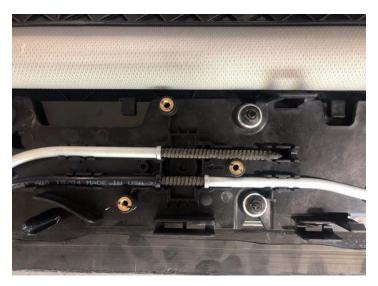
Figure 1

Reference the photos of the clip that must be transferred to the new sunroof frame. If this clip is not transferred, the drive cables may slip when in operation. Please note that figure one is without the clip and figure two is with the clip.

There is a sunroof cable guide clip that must be transferred when the sunroof frame is replaced.
