Service Bulletin

Bulletin No.: 18-NA-225

Subject: No Propulsion – MIL Illuminated with One or More Following DTCs P0ABC, P0AFA, P1AE6, P0D26, P0C78, P0ABB Set

Brand:	Model:	Model Year:		Build Date Breakpoint:		Engine:	Transmission:
		from	to	from	to		
Chevrolet	Bolt EV	2017	2019	—		—	—

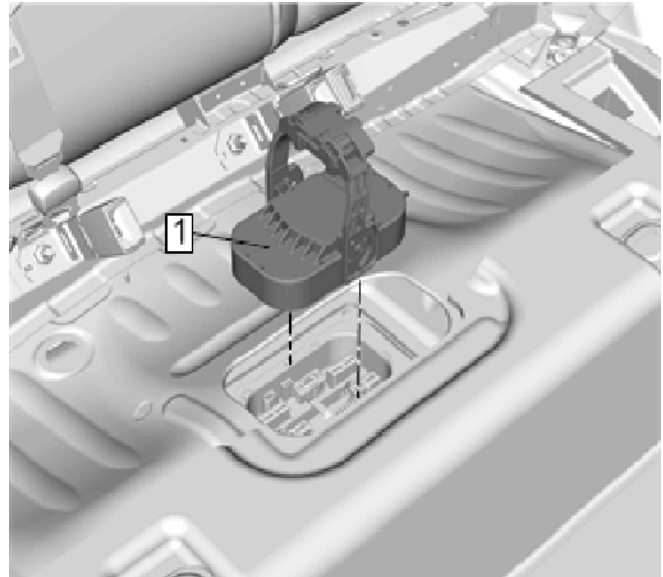
5087054

7. Remove the S15 Manual Service Disconnect (1).

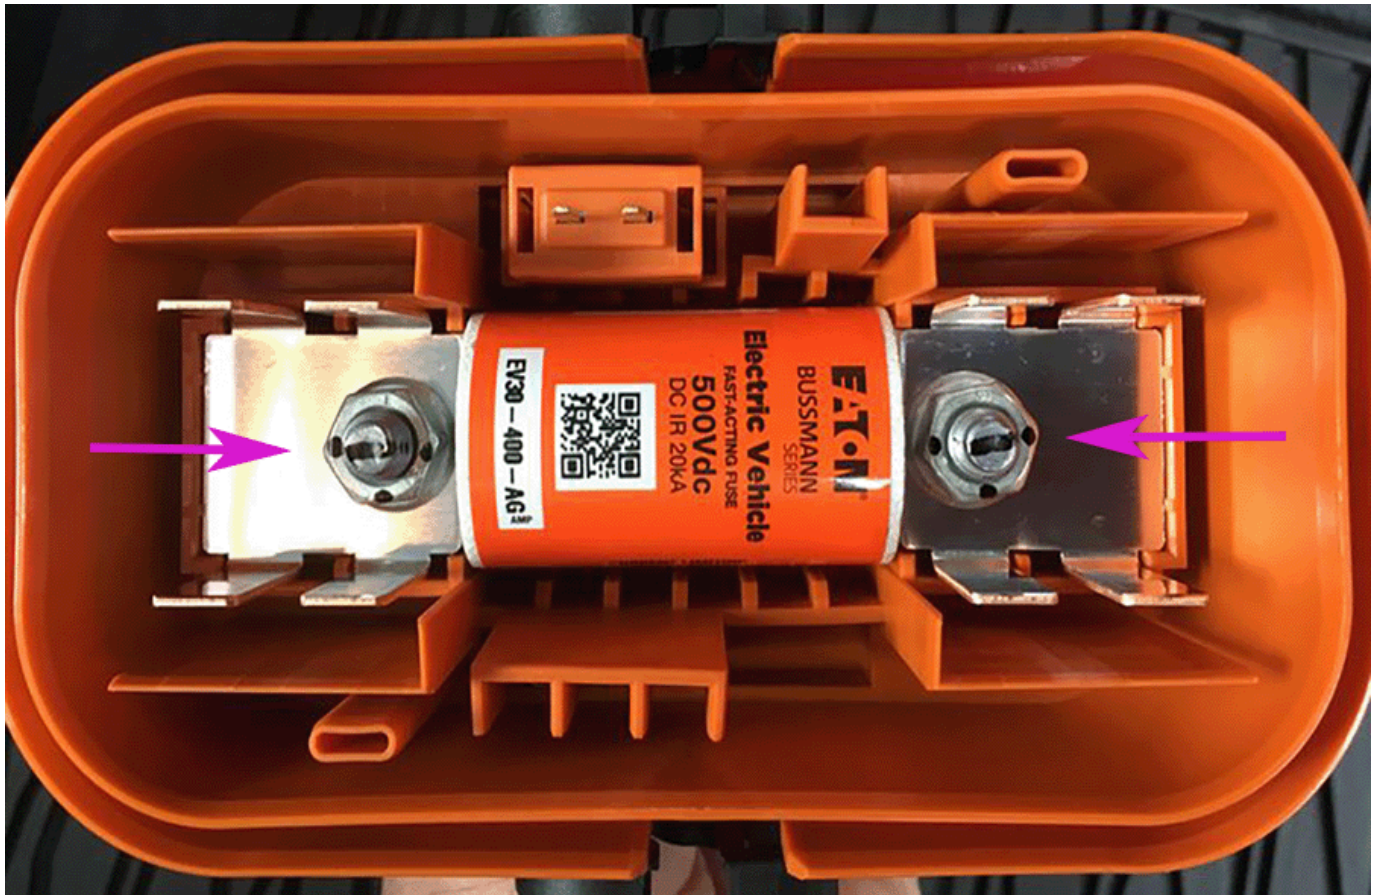
5087244

- 8. Test for less than 10 Ω across the S15 Manual Service Disconnect fuse terminals (the flat blades at each end). Refer to **Testing for Continuity** in SI.
 - ⇒ If the resistance measurement is 10 Ω or greater, replace the S15 Manual Service Disconnect.
