SS: 1034471 TBB Rear LED Markers Lights stays illuminate

EFX / HDX

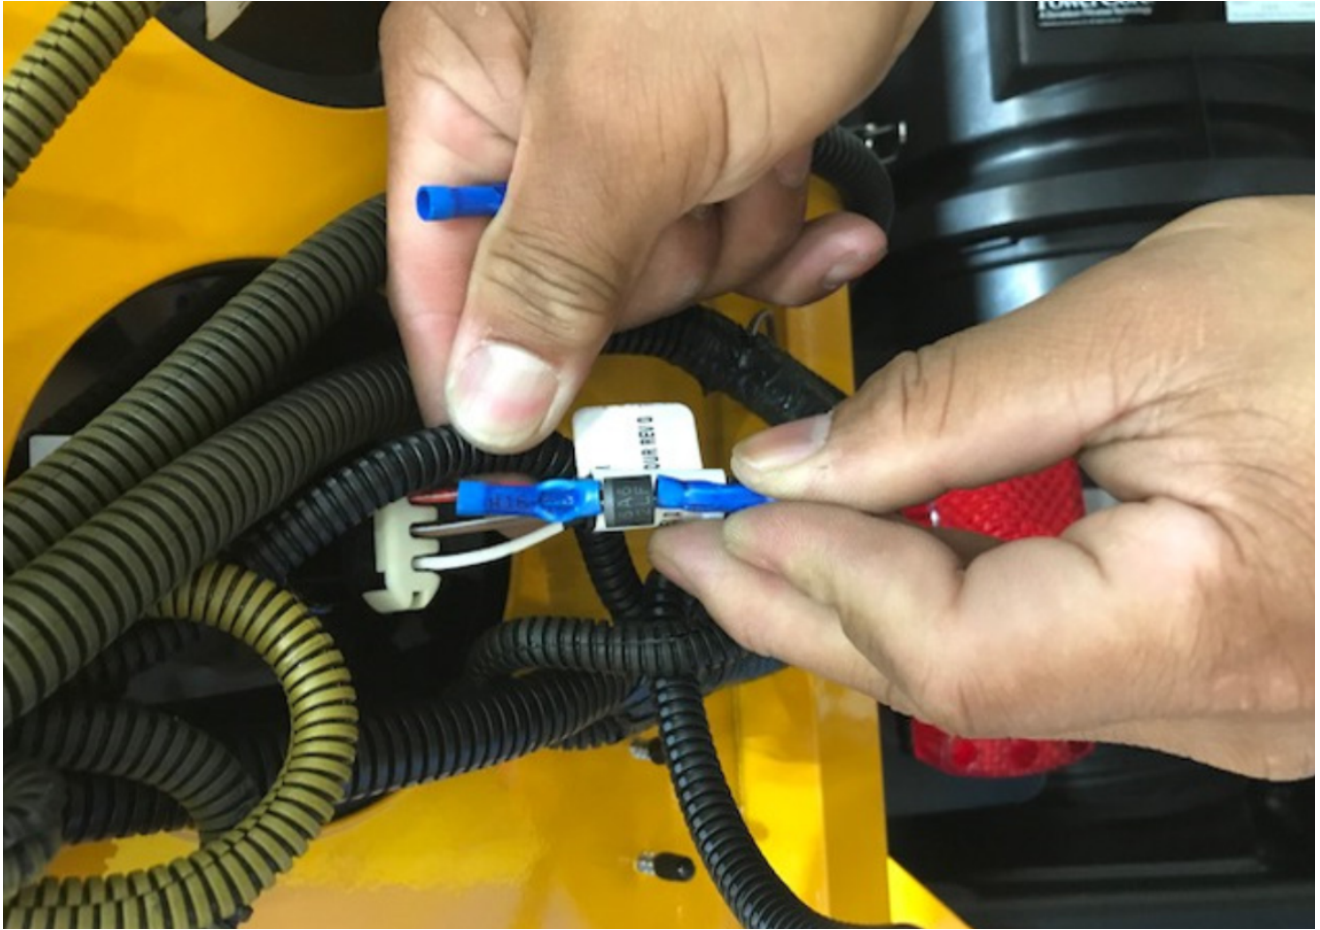
LED Rear marker lights illuminate

Battery Draw

Adding a Diode in the Marker light circuit the Brown wire, Diode toward the Light
