**FIELD SERVICE CAMPAIGN – 19104**

Switch Pack Assembly

International® LT®, RH™, and MV™ Series, LoneStar®, IC Bus® FE and SFC Series

A deformation in the center post of the switch pack housing may cause one or more of the switches to become loose and / or pop out when depressed.

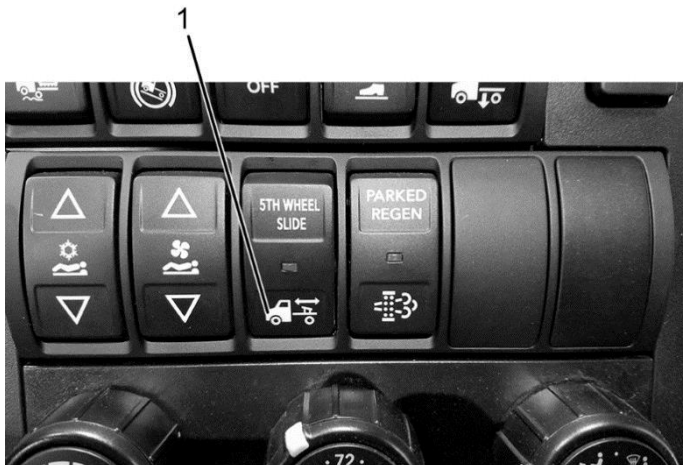
**Figure 1. 3rd Position Switch.**

1. Bottom half of switch

5. Press bottom half of 3rd position switch; third switch from left (Figure 1, Item 1).

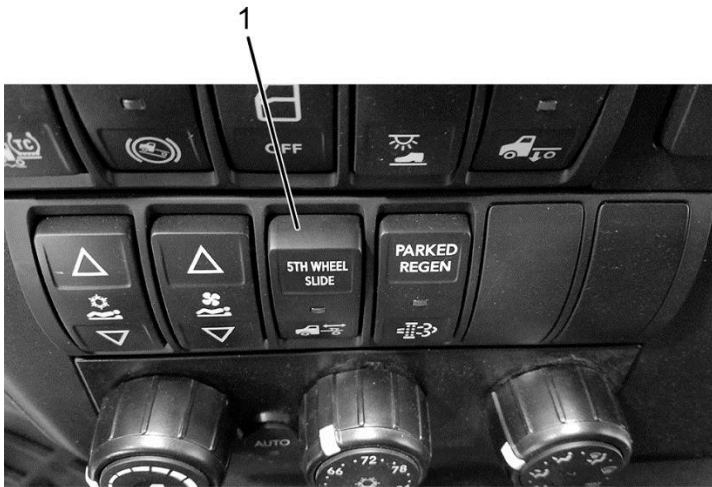
**Figure 2. 3rd Position Switch**

1. Top half of switch
6. Using fingers, grasp top half of switch (Figure 2, Item 1); try to pull switch out of socket.
  - a. If switch leaves socket, replace switch pack housing; refer to appropriate technician manual for detailed instructions. When switch pack housing has been replaced, proceed to Step 7.
  - b. If switch remains in socket, repeat Step 5 and Step 6 for each remaining switch.
7. Remove wheel chocks.
