Document ID: IK0500038

Title: Steering Shake, Shimmy, Shudder, Steering Vibration

Applies To: Prostar/Lonestar and LT/RH with 14k front weight rated axles and below

Steering intermittently goes into a shimmy after hitting a bump or during a curve.

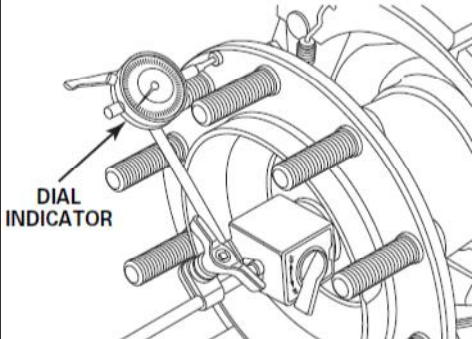
<p>DIAL INDICATOR</p>	<p>No: Replace or adjust the wheel bearings as needed and proceed to step 5.</p> <p>Refer to ConMet Service Manual</p>
---	---

<p>Measure wheel bearing for excessive end play</p> <p>Use a dial indicator to verify acceptable endplay of 0.001"-0.005".</p>

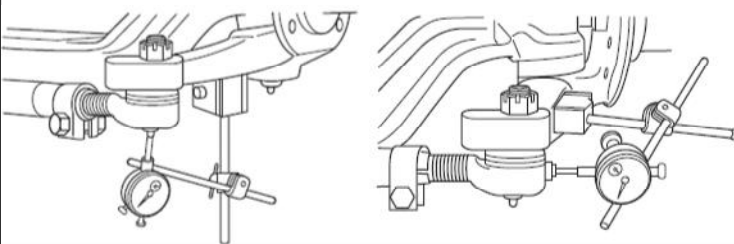
<p>Use a dial indicator and measure the vertical and horizontal end play of the tie rod ends and drag link ends.</p> <p>Spec: less than 0.030 inches.</p> <p>Are the drag link and tie rod ends within specification?</p>	<p>Yes: Please proceed to step 6.</p> <p>No: Replace the drag link and tie rod ends as needed and proceed to step 6.</p>

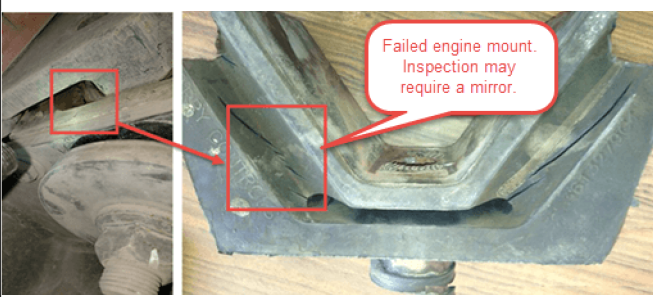
Step	Action	Decision
6	<p>DIAGNOSTIC: Spring Hangers, Cab Mounts, Engine Mounts and Frame Fasteners</p> <p>Inspect the spring hangers, shackles, and bushing for looseness, play and fastener torque.</p> <p>Inspect cab and engine mounts for excessive wear, being degraded and/or looseness.</p>

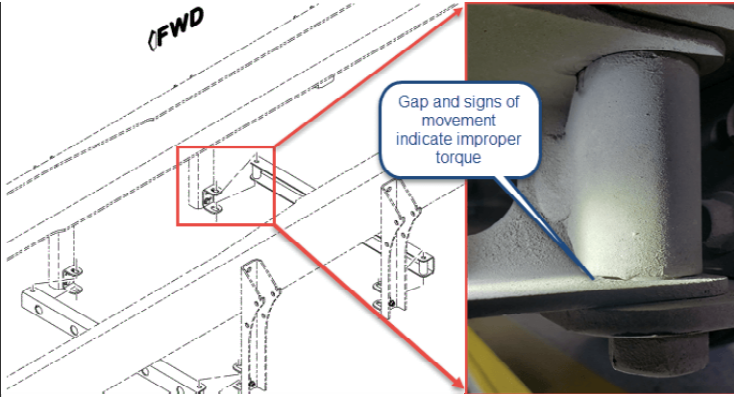
<p>Confirm fastener torque on all steering system, frame rail and crossmember, and fuel tank mounting brackets/supports.</p> <p>Example of a loose fuel tank support.</p>	<p>Yes: LT/RH refer to 0000885380</p> <p>Prostar/LoneStar refer to 0000863170</p> <p>Repair, torque, or replace fasteners and suspension components as needed and proceed to step 7.</p> <p>For A26 powered LT, the rear engine mounts should be replaced with a new part from the parts catalog if damage is found.</p> <p>For X15 powered LT, the rear engine mount should be replaced with 1664729C7 regardless if damage is found.</p> <p>No: Please proceed to step 7.</p> <p>For X15 powered LT, the rear engine mount should be replaced with 1664729C7 regardless if damage is found.</p>

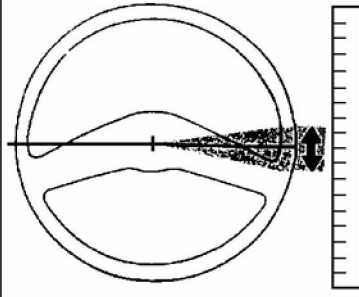
Step	Action	Decision
8	<p>DIAGNOSTIC: Steering System Lash</p> <p>With the engine off and the truck sitting on its tires, inspect for free play in the steering wheel. It should not exceed 2 inches of movement on an 18inch steering wheel with no movement in the tires.</p> <p>Inspect the steering shaft slip joint and u-joints for looseness.</p> <p>With a TRW gear: Verify steering gear lash per the TRW service manual.</p> <p>RH Sheppard gears are not adjustable and should not be tampered with.</p>

<p>Was anything found loose?</p>	<p>Yes: Replace any loose components and adjust the TRW steering gear lash as needed per the TRW service manual, then proceed to step 9.</p>
		<p>No: Please proceed to step 9.</p>

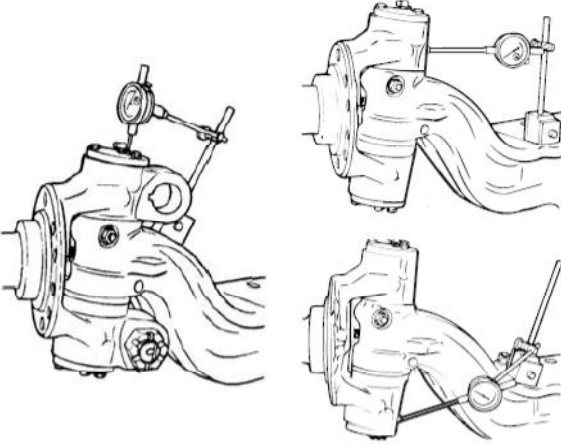
Step	Action	Decision
9	<p>DIAGNOSTIC: King Pin Vertical and Horizontal play</p> <p>Measure the king pin for excessive vertical horizontal end play.</p>

<p>Confirm the type of axle installed and use a dial indicator to verify acceptable play per supplier's specifications.</p> <p>Meritor: MM-2</p> <p>Dana: AXSM-0038</p> <p>Hendrickson: 17730-252</p> <p>Is King pin play out of specification?</p>	<p>Hendrickson:</p> <p>Yes: Install high friction composite kingpin service kit H60961628 per Hendrickson manual 59310-011.</p> <p>No: Install the high friction composite kingpin bearing only kit H60961629. If the service kit is not available, install the steering stabilizer H60961167 can be installed in its place per the below resolution.</p> <p>Proceed to step 10</p> <p>Dana:</p> <p>Yes: Install a king pin service kit and the high friction composite king pin kit 2520702C9.</p> <p>No: Install the high friction composite king pin kit 2520702C91. If the service kit is not available, install the steering stabilizer H60961167 can be installed in its place per the below resolution.</p> <p>Proceed to step 10</p> <p>Meritor 12K:</p> <p>Yes: Install high friction composite kingpin service kit 2519548C91 per TP1873.</p> <p>No: Install the high friction composite kingpin bearing only kit 2520213C91. If the service kit is not available, install the steering stabilizer H60961167 can be installed in its place per the below resolution.</p> <p>Proceed to step 10</p> <p>Meritor 13/14K:</p> <p>Yes: Install high friction composite kingpin service kit 2519476C91 per TP1873.</p> <p>No: Install the high friction composite kingpin bearing only kit 2520212C91. If the service kit is not available, the steering stabilizer H60961167 can be installed in its place per the below resolution.</p> <p>Proceed to step 10</p>

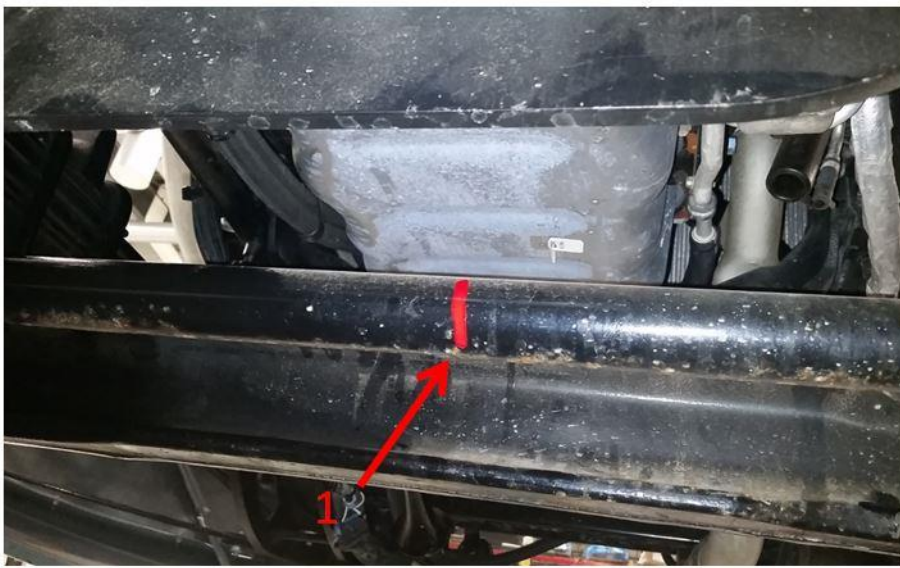
Figure 1: Tie rod assembly

Item 1: Tie rod assembly centerline

1. Bring vehicle into the shop and park on flat hard surface.
2. Shift transmission to Park or Neutral, set parking brake, and install wheel chocks.
3. Remove the front U-bolt from the passenger side steer spring and discard.
4. On the tie rod assembly, measure the distance between the right and left grease zerks.
5. Divide your measurement from step 4 by two. (This will help locate the centerline of the tie rod assembly)
6. Mark the centerline of the tie rod assembly per figure 1 & 2.

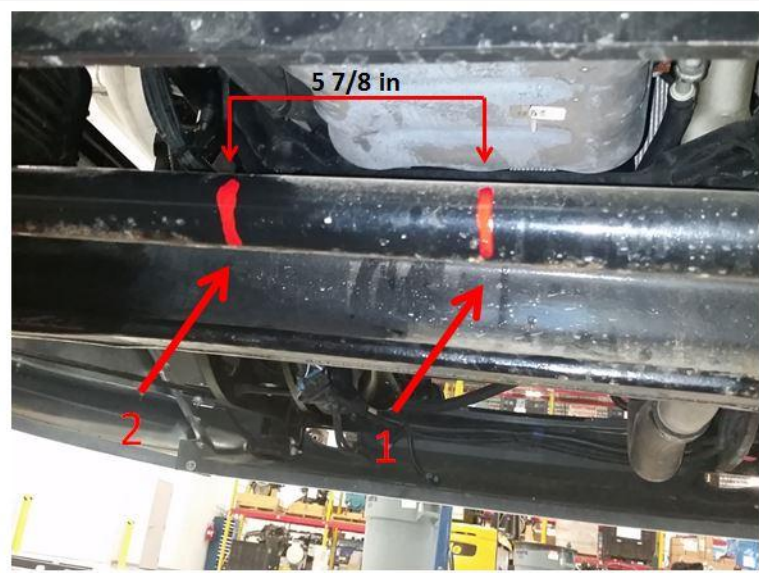
Figure 3: Tie rod assembly

- Item 1: Tie rod assembly centerline (first mark)
Item 2: 5 7/8 from tie rod assembly centerline (second mark)

7. From the tie rod assembly centerline, make a second mark $5 \frac{7}{8}$ in towards the driver's side per figure 3. This will be the mounting location of the tie rod mounting plate.
