## TECHNICAL SERVICE BULLETIN

### 5.0L - Rattling Sound From The Transmission Bellhousing Area - Built On Or Before 12-Feb-2019

**19-2230**  
19 July 2019

<b>Ford</b> 2018-2019 F-150
--------------------------------

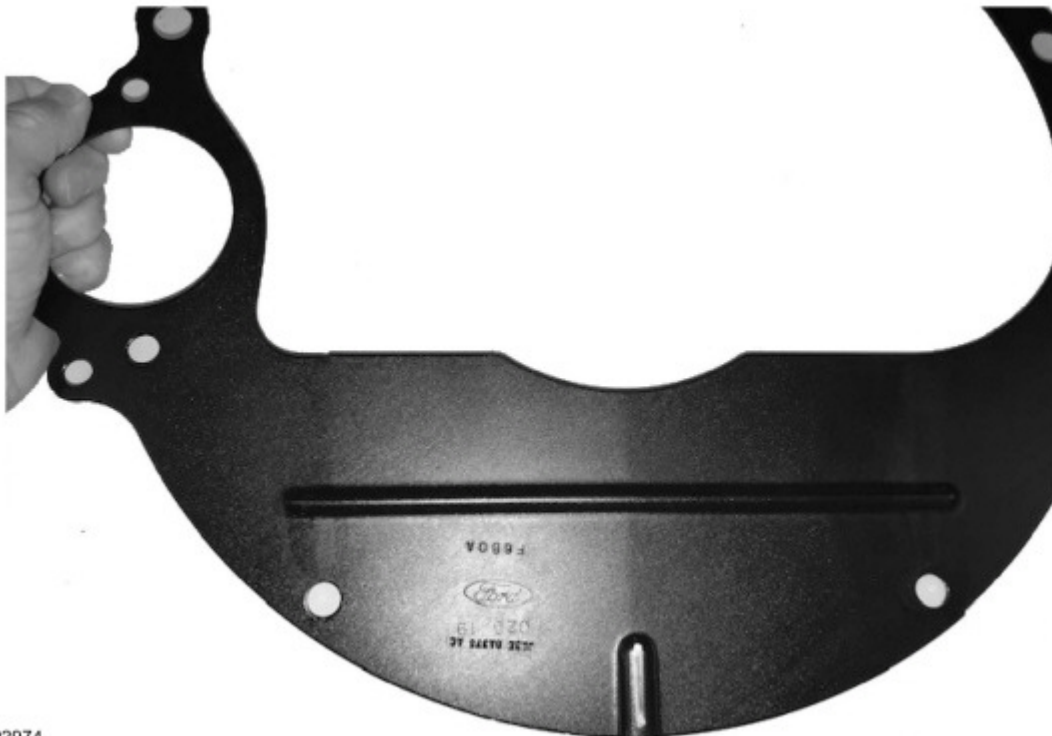
Figure 1

**Issue:** Some 2018-2019 F-150 vehicles equipped with a 5.0L engine built on or before 12-Feb-2019 may exhibit a rattling sound coming from the transmission bellhousing area. This may be due to the torque converter studs contacting the engine to transmission spacer plate. To correct the condition, follow the Service Procedure steps to replace the engine to transmission spacer plate with a new engine to transmission spacer plate that includes a bend for additional clearance.

1. Remove the flexplate. Refer to Workshop Manual (WSM), Section 303-01D.
2. Replace the engine to transmission spacer plate. (Figure 1)

3. To install, reverse the removal procedure.

(1). Reuse the transmission fluid cooler tube bracket bolt. Clean the threads and install a small patch of Motorcraft® Threadlock and Sealer or equivalent.
