### PIT5493C Diagnostic Aid, Fuel Gauge Will Not Read Above OR Below a 1/2 Tank

Brand:	Model:	Model Years:	VIN:		Engine:	Transmissions:
			from	to		
Chevrolet	Colorado	2015 - 2020	All	All	All	All
GMC	Canyon	2015 - 2020	All	All	All	All

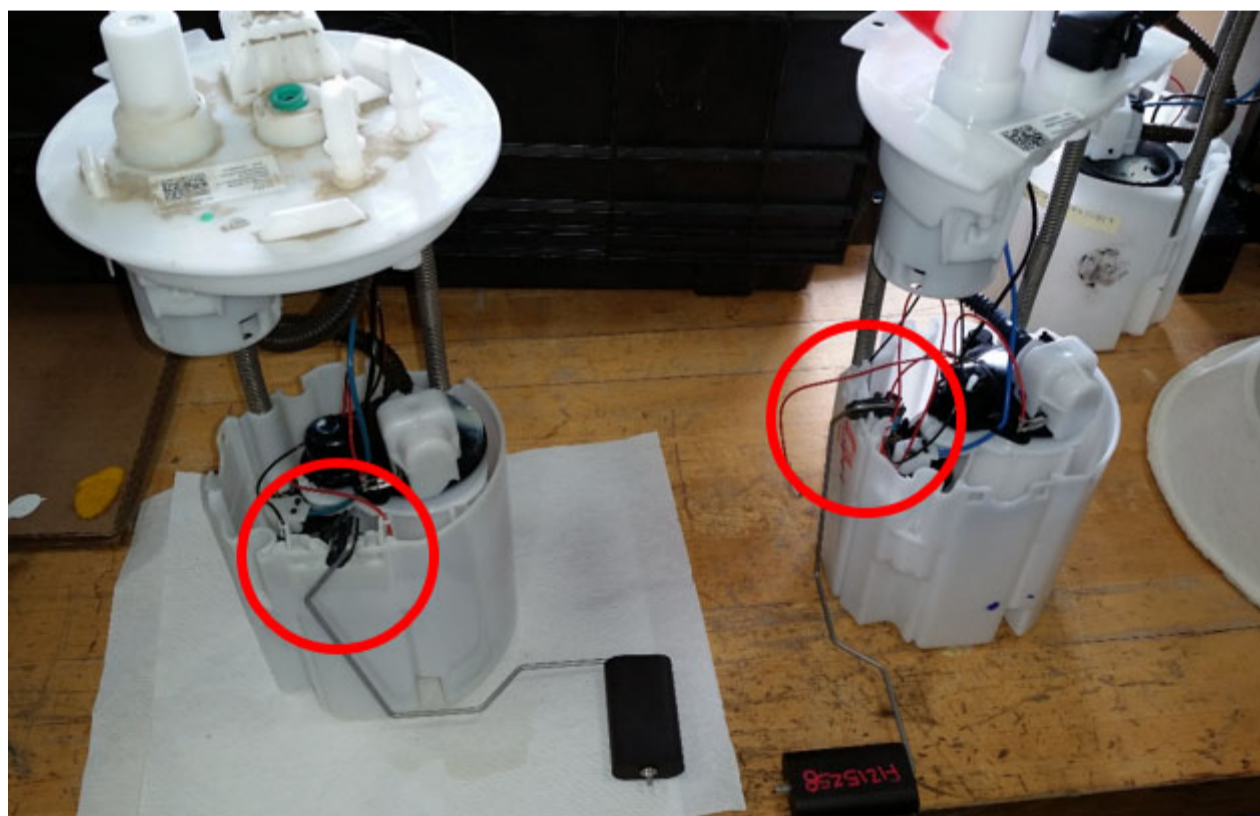
**Inspect the fuel level sender and verify it is in the correct slot of the fuel module. In the picture below, the left fuel module reflects the correct location whereas the right fuel module reflects the incorrect position. Install sender in correct slot to repair.**

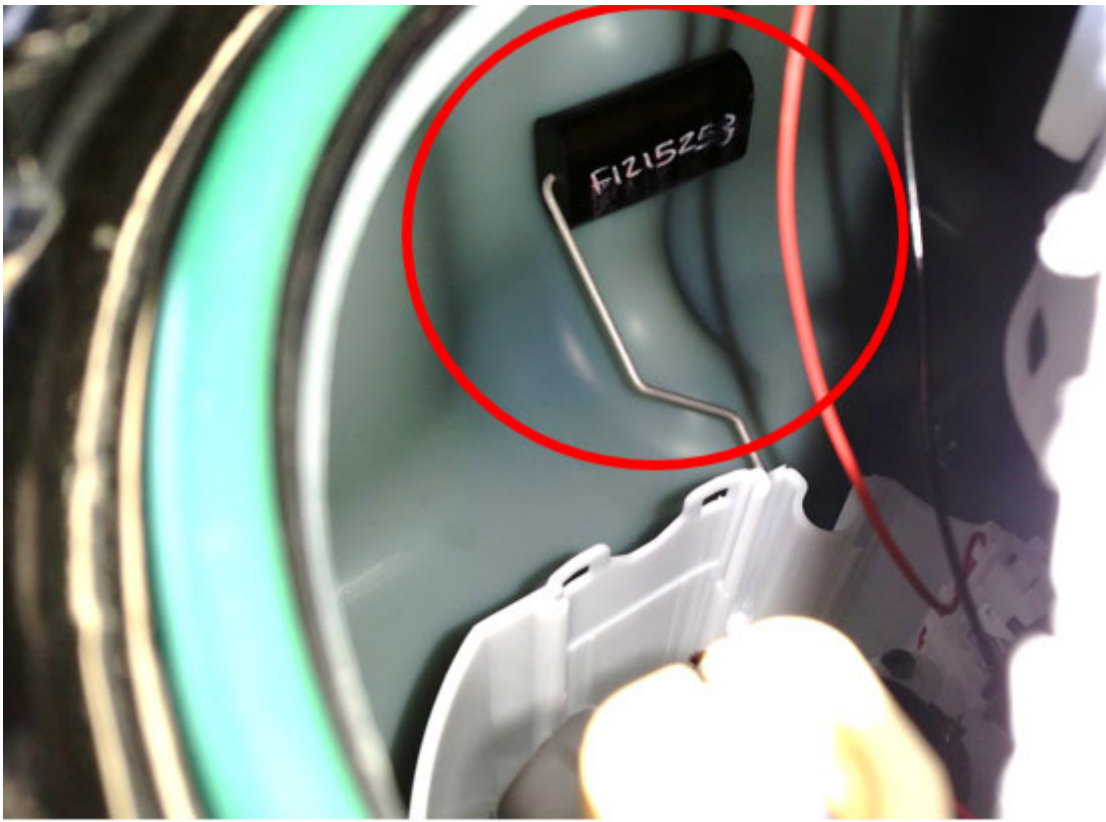
**The picture below is a cut away of the right fuel module indicating the level sender contacting the side of the fuel tank.**
