Special Coverage Adjustment

17336 Combi-Cooler Air Conditioner Refrigerant Leak

Reference Number: N162080780

Revision: 05

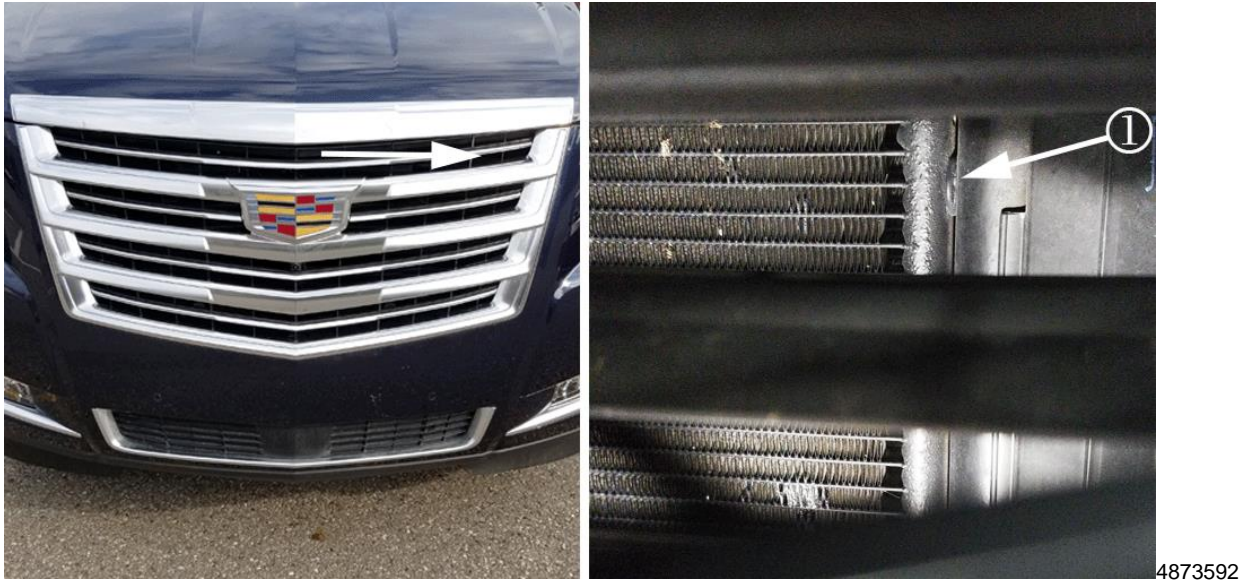
Cadillac Escalade shown. Other models are similar.

1. Locate the coupler (1) on the air conditioning condenser by looking through the identified area of the radiator grille.

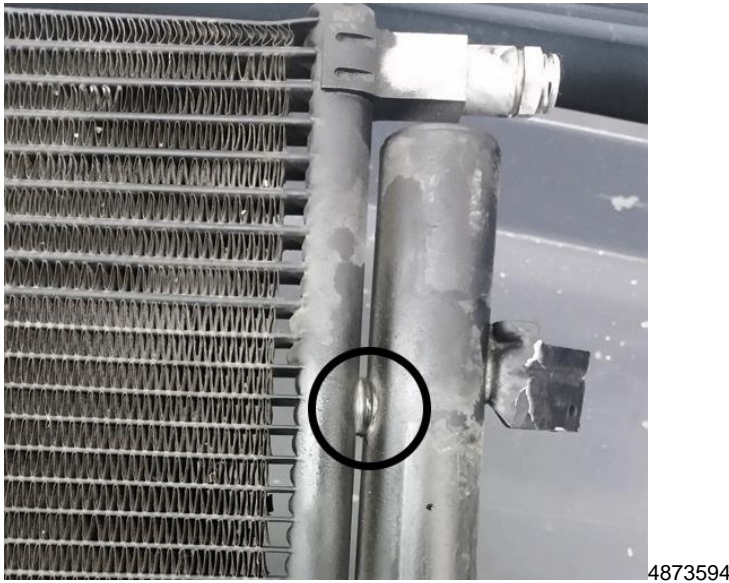
Note: General Motors vehicles are manufactured with fluorescent dye installed in the A/C refrigerant system.

2. Verify the air conditioning condenser is leaking in the specific area identified above. Refer to the appropriate diagnostic information in SI.
 - If the air conditioning condenser is NOT leaking in the specific area identified above, no further action is required. Inform the customer that any additional diagnosis and repairs are not covered under this special coverage.
 - If the air conditioning condenser is leaking in the specific area identified above, proceed to the next step.

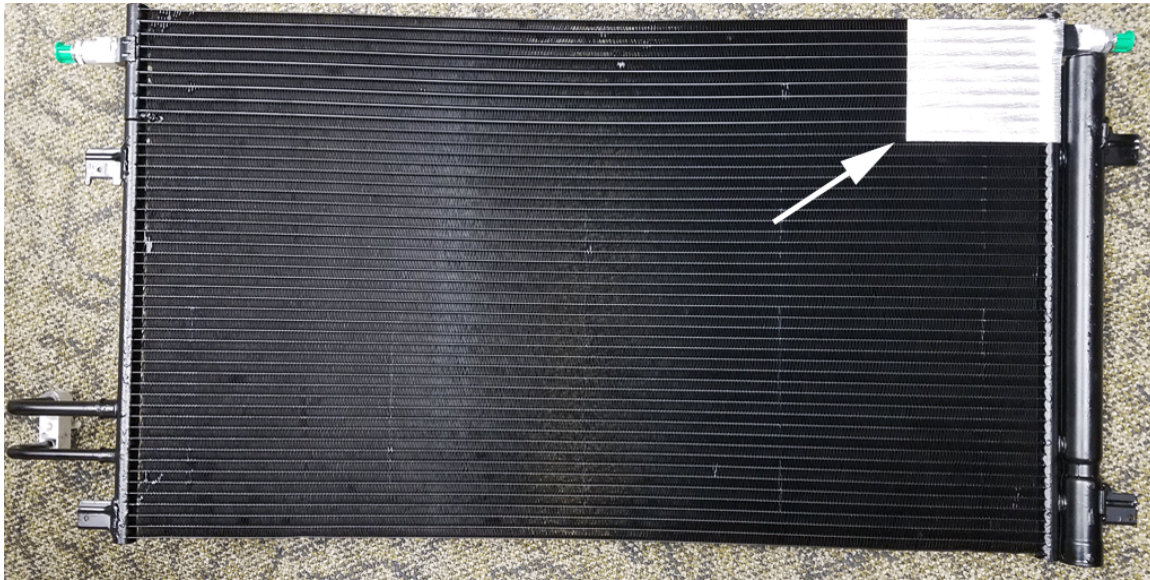
4892394

4. Verify if an air conditioning condenser shield assembly is installed on the NEW air conditioning condenser as shown above.
 - If an air conditioning condenser shield assembly is installed, proceed to the next step.

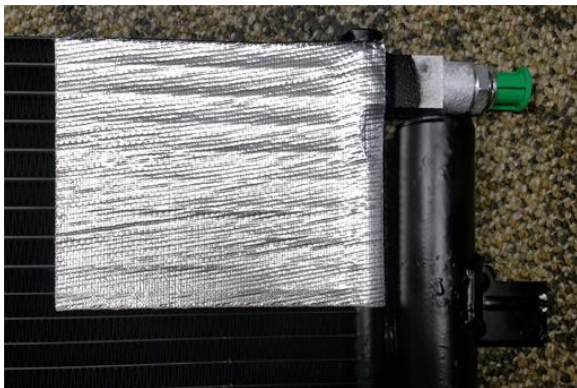
4892397

- If an air conditioning condenser shield assembly is NOT installed, install the air conditioning condenser shield assembly as shown in the picture above.
5. Remove one of the plugs from the transmission fluid auxiliary cooler fitting.
 6. Fill the transmission fluid auxiliary cooler full of transmission fluid.
 7. Install the plug back into the transmission fluid auxiliary cooler fitting.
 8. Install the NEW air conditioning condenser. Refer to *Air Conditioning Condenser Replacement* or *Air Conditioning Condenser Replacement (L83 L86)* in SI.
 - Discard the old sealing O-rings and install new O-rings when installing the new air conditioning condenser.
