Technical Service Bulletin

SUBJECT:			No: TSB-19-42B-005
UPDATE TO BODY REPAIR MANUAL UNDERCOAT APPLICATION LOCATIONS - SMR			DATE: September 2019
			MODEL: 2017 Mirage G4
CIRCULATE TO:	<input type="checkbox"/> GENERAL MANAGER	<input type="checkbox"/> PARTS MANAGER	<input checked="" type="checkbox"/> TECHNICIAN
<input checked="" type="checkbox"/> SERVICE ADVISOR	<input checked="" type="checkbox"/> SERVICE MANAGER	<input checked="" type="checkbox"/> WARRANTY PROCESSOR	<input type="checkbox"/> SALES MANAGER

This TSB updates the Corrosion Protection section of the affected Body Repair Manual, to add undercoat application locations.

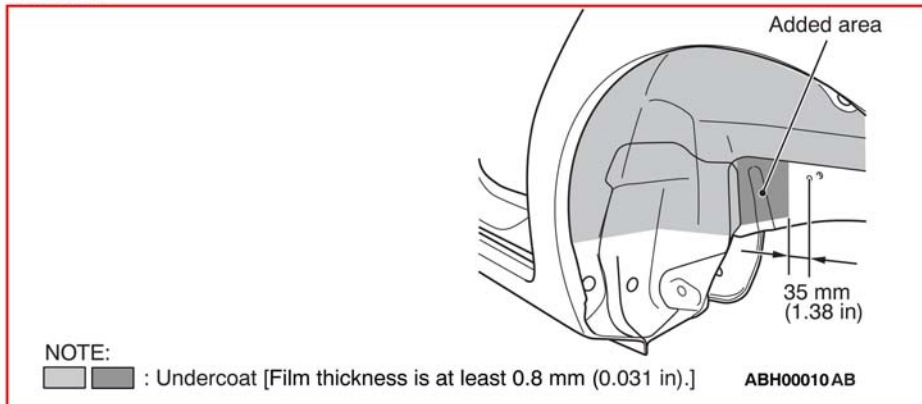
ABF00428AB

: Undercoat [Film thickness is at least 0.8 mm (0.031 in).]

<Added>
