EMISSION RECALL BULLETIN

Subject: **Emission Recall 12C3 REV1**
EPA07/EPA10 DD13 Emission Labels In Cascadia 113” Day Cab Chassis

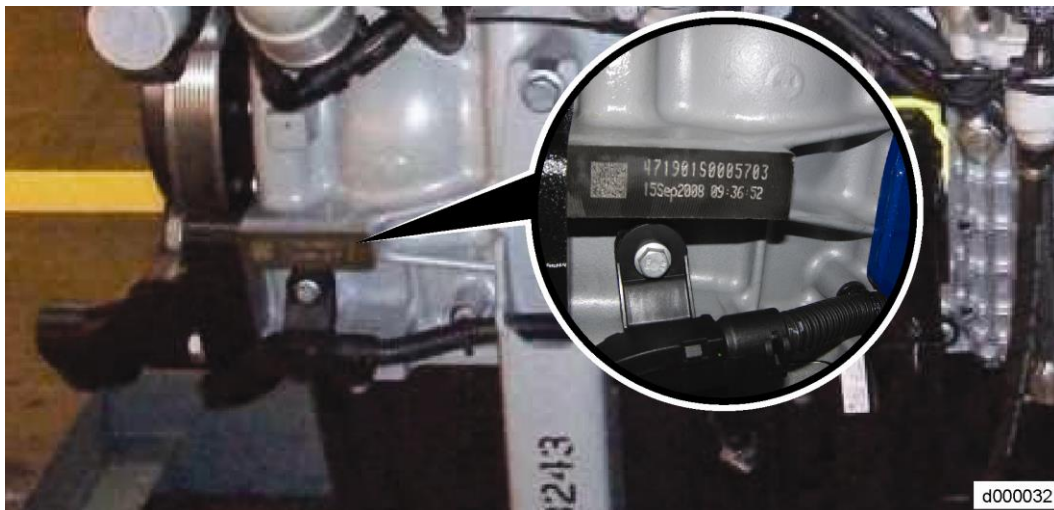
Figure 1- Engine Serial Number Location on Engine Block

1. Apply the parking brake, chock the wheels, and perform any other applicable safety steps.
2. Compare the serial number on the secondary emission label with the engine serial number stamped on the left front corner of the engine block. Refer to Figure 1 to locate the engine serial. If the engine serial number and the serial number on the label match proceed to step 3. If the engine serial on the block and the label do not match do not install the label, please call the Detroit Customer Support Center at 1-800-445-1980 for further assistance.

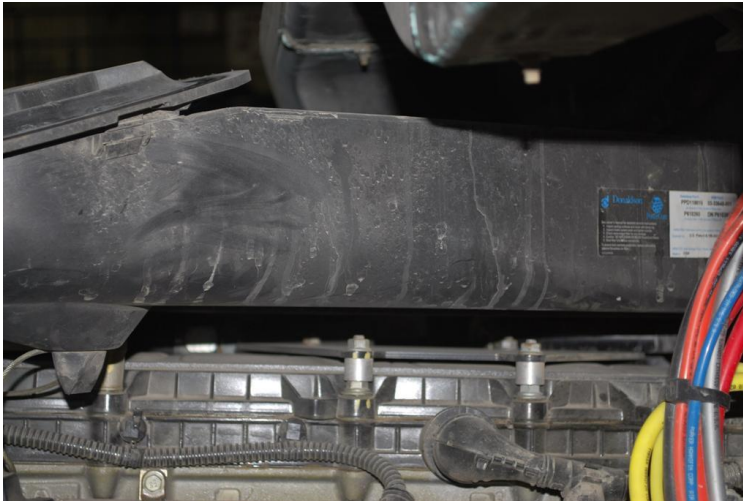
Figure 2 - Left Side Engine Air Filter Housing

3. Use a suitable cleaner to clean dust, dirt, grease or oil from an area on the side of the air filter housing large enough to accommodate the secondary emission label. Use rubbing alcohol as a final wipe to remove any residue that might inhibit the label adhering. Do not use Brake-Kleen or a similar solvent for the final cleaning. Refer to Figure 2.

4. Allow the cleaned surface to dry completely.
5. Peel a portion of the backing from the label and stick it on the cleaned area of air filter housing oriented so the print is vertical to permit ease of reading the label. Slowly peel the backing off of the label while smoothing it onto the engine air filter housing. NOTE: do not attempt to remove the label once it has adhered to the housing. It is intended to be destroyed if removal is attempted.
6. Installation is complete, remove the wheel chocks and return the vehicle to service.
