## Latest Vehicle Concern Fixes

| F TYPE Idle Instability at a Stop | 2019/2020 F TYPE equipped with AJ133 |

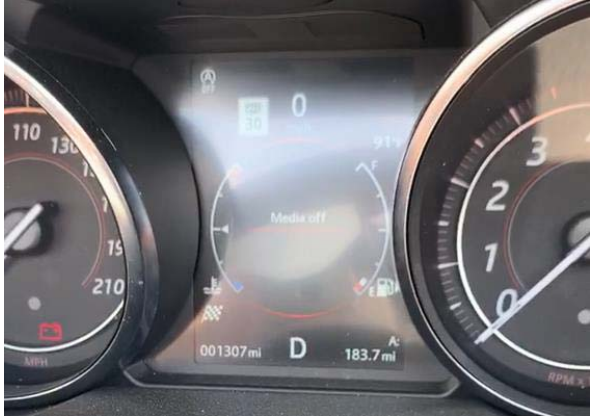
| F TYPE Idle Instability at a Stop | 2019/2020 F TYPE equipped with AJ133 |
|---|---|
| <p><b><u>Customer Voice:</u></b></p> <ul style="list-style-type: none"><li>• The vehicle felt like it would stall when slowing down.</li><li>• The vehicle stalled at a stop and I could restart it.</li></ul> <p><b><u>Technical Description:</u></b></p> <ul style="list-style-type: none"><li>• The condition has been logged when approaching a stop.</li><li>• No relevant PCM DTCs are stored, rectification of DTCs stored in other control modules have not resolved the stalling complaint.</li><li>• The vehicle can be restarted on the next ignition cycle.</li></ul> <p><b><u>Status:</u></b></p> <ul style="list-style-type: none"><li>• This topic is under investigation.</li><li>• Road test the vehicle from cold through operating temperature while performing multiple stops during this time. Complete diagnosis and repair of any PCM DTCs that may be stored. If no DTCs are stored, raise a TA for assistance.</li></ul> | A photograph of the instrument cluster of a Jaguar F-Type. The central digital display shows '0' in the speedometer position, 'Media off' in the center, and '001307mi' and '183.7mi' at the bottom. The tachometer on the right shows a needle around 1500 RPM. The left side shows a tachometer with a needle around 1500 RPM and a speedometer with a needle around 110 mph. |
