# Service Bulletin

Bulletin No.: 19-NA-207

**Subject: Temperature Display Above the Physical Controls Becoming Faded**

Brand:	Model:	Model Year:		Breakpoint:		Engine:	Transmission:
		from	to	from	to		
Cadillac	XT4	2019	2020	-	-	-	-

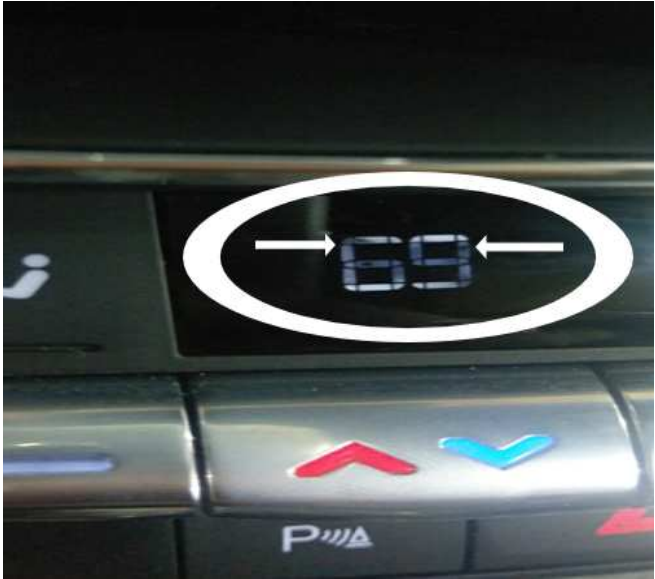
<p style="text-align: right; font-size: small;">5404212</p> <p>Some customers may comment on the temperature display located above the physical controls becoming faded, as shown in the picture above.</p>
Cause	This condition may be caused by the customer touching the display or the graphic icons next to the display.
Correction	The customer should understand that they have to use the chrome toggles to activate the HVAC Faceplate (or the other options ex: ICS). Pressing the display or graphic icons will not activate the HVAC system.
