Title	Mack Chassis - Equipped With An Automated Manual Transmission Model D or F (mDrive, AMT-D, AMT-F) - Transmission Oil Leakage From Transmission Input Shaft Seal Or Output Shaft Seal - US10 And Newer Emissions, Common Model Years 2010 And Newer
-------	--

**\*\* SOLUTION \*\***

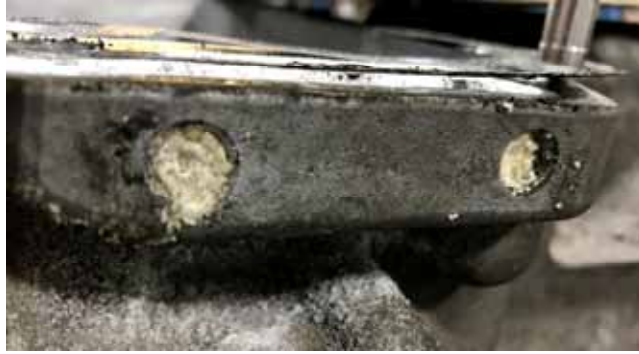
Cause	Accumulation of debris in the left side vent ports of the transmission main case (corrosion, road salt, dirt, etc) may result in oil leaks present at the transmission input and output shaft seals.
-------	--

Blockage of these ports allows pressure to build to a point that it forces oil past the input and output shaft seals. In extreme cases, the pressure buildup can be high enough that operation can be affected. Excessive internal pressure caused by blocked vents may result in slow or sluggish gear shifts.

Clogged vent ports

1. Check the vent ports on the upper left side of the the main gearbox housing for any sort of blockage or obstruction.

2. Clean out any debris that is observed during the inspection. (see inspection and cleaning below)
3. Check the transmission oil level in the gearbox.
  - **If the lube level is excessively low:** Proceed to the next section.
  - **If the lube level is at an acceptable level:** Fill the transmission oil to the correct level and check operation.

Due to the location of the vent ports it is very difficult, in most applications, to see the vents. An inspection mirror and flashlight can be used to see if there is a buildup of roadsalt or other debris in the ports.

If the ports are clogging then use a small screwdriver or similar tool to break up the deposits in the ports.

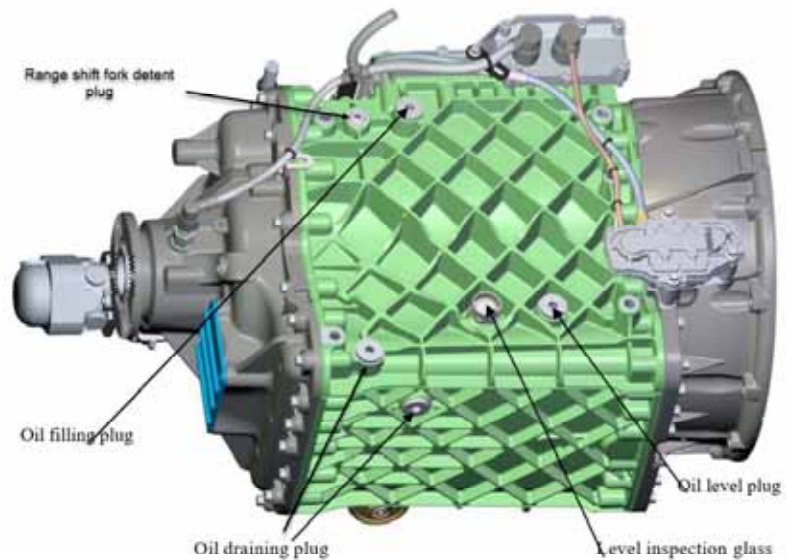
Figure 29. Position of oil plugs and level inspection glass

Clean and remove the upper oil fill plug from the main case on the right side of the gearbox.

Wrap a clean rag around an air nozzle and blow air into the case. Use proper eye protection. A complete seal is not needed. All you want to do is create enough pressure to force the debris from the vents on the left side of the case.
