**Title:** WorkStar Hybrid Mount to Pad Mount A/C Compressor Retrofit

**Applies To:** WorkStar

A/C compressor update from hybrid mount to direct mount to engine.

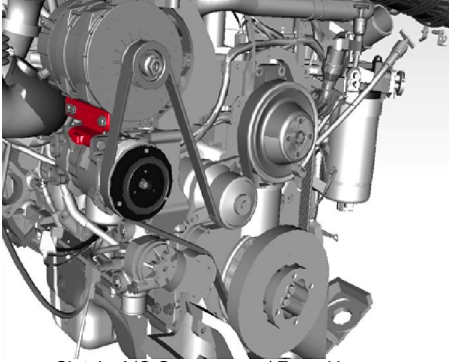
1. Open Hood
2. Remove Fender, Front / Right
3. NOTE: Use Appropriate SRT for AIR CONDITIONING SYSTEM RECOVER, EVACUATION AND RECHARGE
4. Evacuate Air Conditioning System /of Refrigerant
5. Remove Belt, Serpentine / A/C Compressor
6. Remove Air Conditioning System / Belt from Engine
7. Disconnect Hose, Compressor To A/C Dryer / Accumulator /Install Red Cap
8. Disconnect Hose, Compressor To Condenser / At Compressor Install Red Cap
9. Remove Bracket, A/C Compressor / Cutting Two Zip Ties and Removing One Nut
10. Remove Bracket, A/C Compressor / From A/C Compressor Mounting Bracket Four Bolts
  - The upper bracket is not re-used and can be discarded (Identified in RED below)
  - The alternator mounting bolts will be re-used with a new bracket during installation
