## 2014 UH200A Speedometer and Tachometer Needle Adjustment

**Affected Models:** 2014 UH200A (Burgman 200)

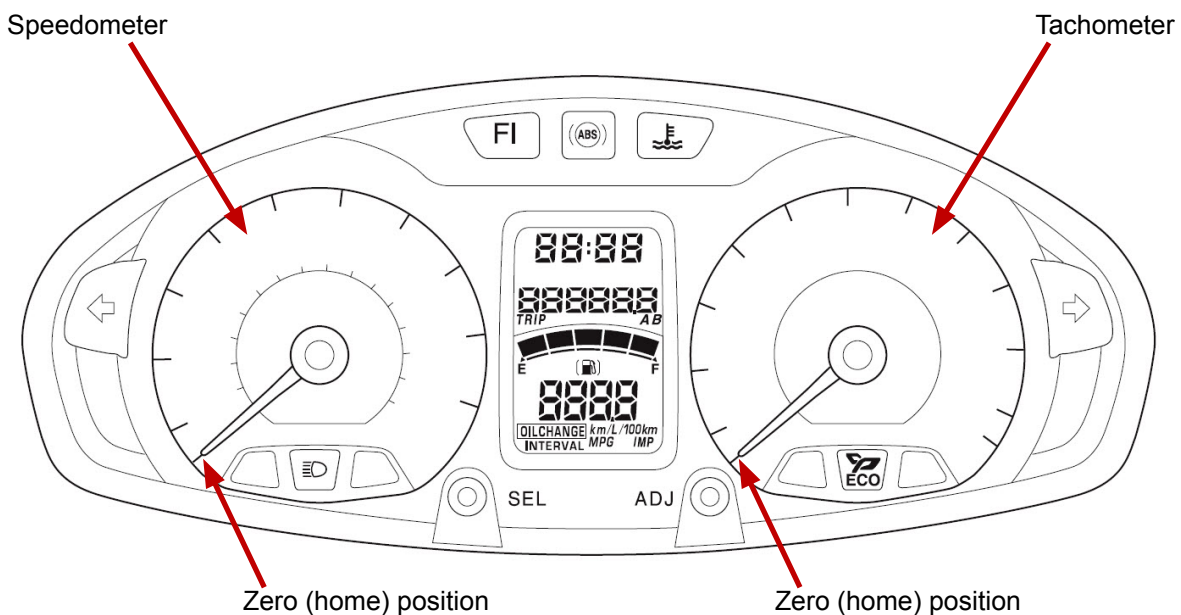
If a customer brings a UH200AL4 (Burgman 200) to your shop complaining that the speedometer and/or tachometer needle does not fully return to zero (home), it is possibly caused by one of two things:

- The unit has experienced an impact, which has jolted the needle within the speedometer assembly.
- The ignition has been turned ON, and while the system is still initializing it is abruptly interrupted by the ignition being turned OFF.

To correct this, adjust the needle as follows:

- 1) Turn the ignition switch to **OFF**, then turn it **ON** again.
- 2) If the needle does not return to the zero (home) position, repeat this procedure until it functions normally and returns to zero.
- 3) If the procedure above does not correct the problem after several attempts, replace the speedometer assembly.
