SERVICE BULLETIN

AT16-001m NTB16-110m October 1, 2019

2013-2017 ALTIMA AND 2014-2017 ROGUE; 4 CYLINDER WITH DTC P17F0, P17F1, P0776, P2813, P1715, AND/OR P0841 STORED

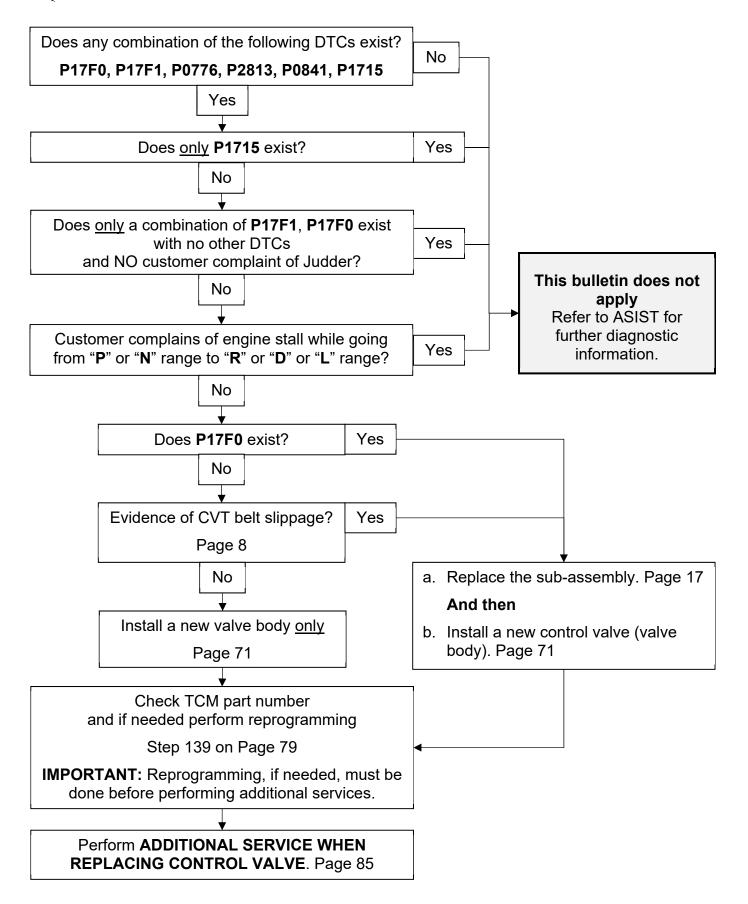
See Repair Flow Chart on page 2 to confirm if this bulletin applies.

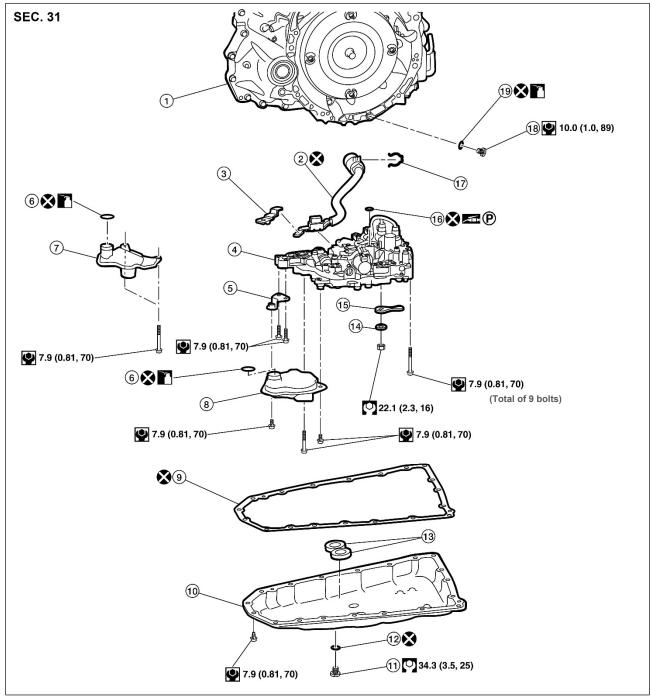
Figure 9

- Transaxle assembly 1.
- 4. Control valve
- 7. New-style oil strainer assembly
- 10. Oil pan
- Magnet 13.
- 16. Lip seal
- O-ring

- 19.
- : Always replace after every disassembly.
- : N·m (kg-m, ft-lb)
- : N·m (kg-m, in-lb)

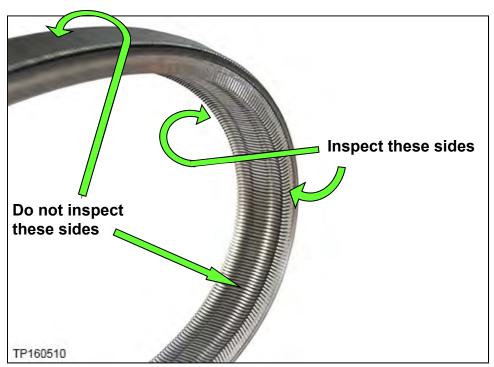
Figure 15

- Using borescope J-51951 with mirror attachment, inspect the entirety of the two sides of the belt that come in contact with the pulleys (see page 12, Figure 15).
 - Reference the Figures on pages 12 through 16 for comparison of an OK and NG belt condition.

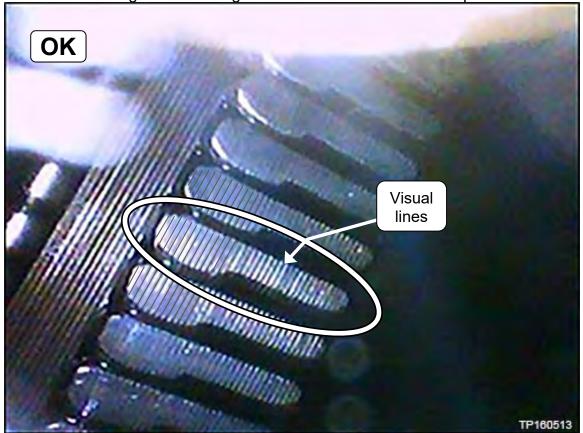
Figure 18: Belt is OK

Pictures in Figure 18 and Figure 19 were taken with borescope J-51951.

- 7. <u>If the belt inspection result is **OK**</u>, replace only the valve body, and then reprogram the TCM if applicable.
 - For valve body replacement, go to page 71, Control Valve (Valve Body) Strainer and Pan Installation.
 - Check TCM part number (step 139 on page 79) and if needed perform reprogramming (step 139 on Page 79) if applicable.

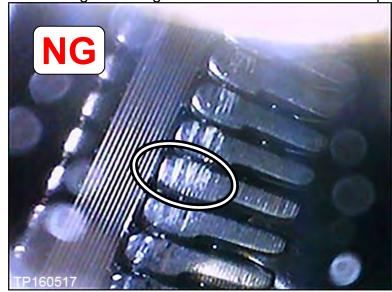
Figure 22: Example of NG belt

Pictures in Figure 22-Figure 24 were taken with borescope J-51951.

- 8. <u>If the belt inspection result is **NG**</u>, replace the CVT sub-assembly and valve body, and then check step 139 on page 79 to confirm if a TCM reprogram is available.
 - Go to CVT Assembly Removal, page 17.

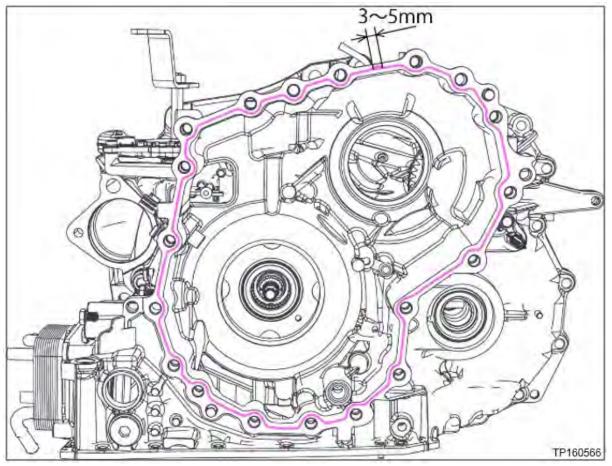
Figure 88

67. Apply one continuous 2.0 mm diameter bead of sealant along the center of the CVT case side mating surface (Figure 88).

CAUTION: Be careful not to contact or contaminate the sealant. If the sealant has been disturbed or contaminated in any way before case assembly, thoroughly clean the mating surfaces of the CVT case and re-start from step 67.

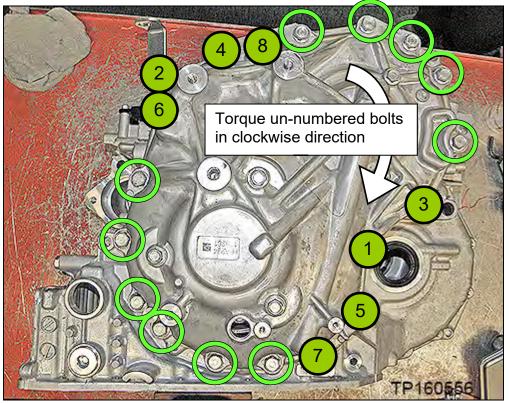
- 77. Install the new side cover bolts for sub-assembly to the CVT case (Figure 102).
 - Torque the first eight (8) bolts marked as in the sequence numbered in Figure 102 below, and then torque the rest of the bolts in a clockwise direction.
 - ➤ Bolt torque: 45 N•m (4.6 kg-m, **33 ft-lb**) 19 pieces.

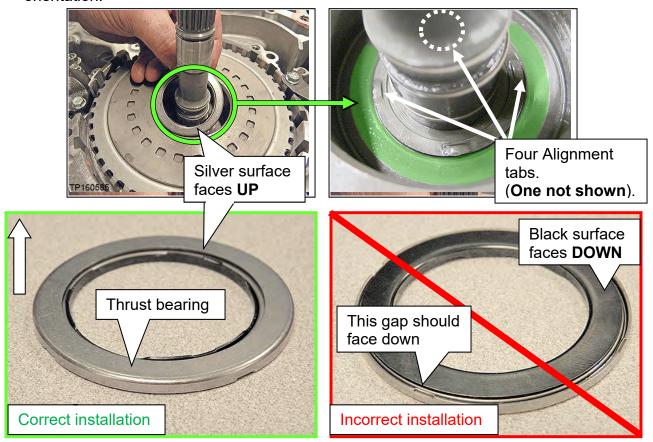
Figure 116

- 92. Install the thrust bearing flush to the clutch assembly bore as shown in Figure 116.
 - Install thrust bearing in area shown in green so that it is centered by the four tabs. **CAUTION:** The thrust bearing has two sides. See image below for appropriate orientation.

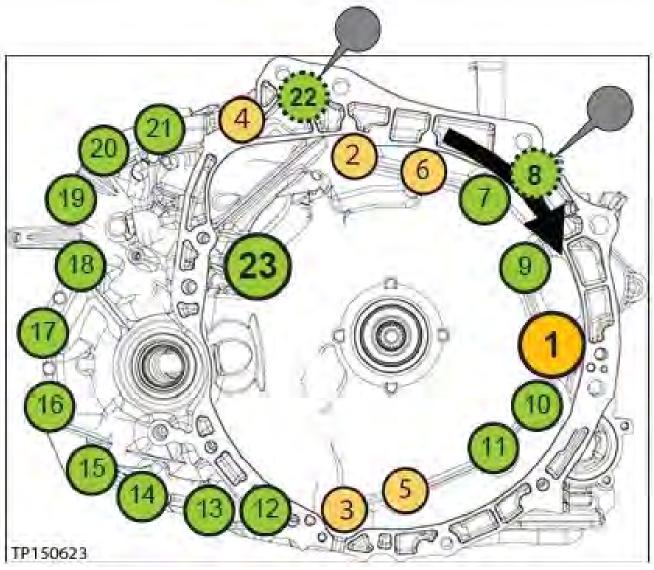
Figure 138

- Install new bolts (23).
 - a. Torque the first six (6) bolts with symbol in numbered sequence (see below).
 - b. Torque the remaining bolts with symbol in numbered sequence (see below).
 - Use a short socket on the bolts indicated by this symbol:
- - > All bolts are 30 mm (1.2 inches) in length.
 - ➢ Bolts torque: 45.0 N•m (4.6 kg-m, 33.2 ft-lb.)
 IMPORTANT: Make sure to torque the bolts in the sequence shown (Figure 138).

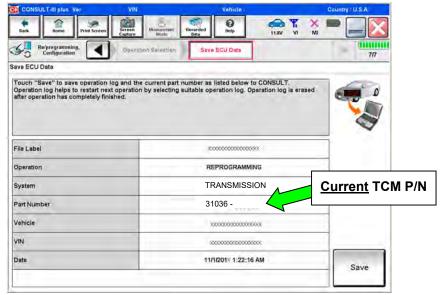
- 138. Follow the on-screen instructions and navigate the C-III plus to the screen shown in Figure 156 on the next page.
- 139. When you get to the screen shown in Figure 156, confirm reprogramming applies as follows.
 - A. Find the TCM **Part Number** and write it on the repair order.
