2018 ALTIMA AND ROGUE: DTC P17F0, P17F1, P0776, P2813, P1715, AND/OR P0841 STORED

NTB19-076

APPLIED VEHICLES: 2018 Altima (L33) 2018 Rogue (T32)

APPLIED ENGINE: QR25DE (4 cylinder only)

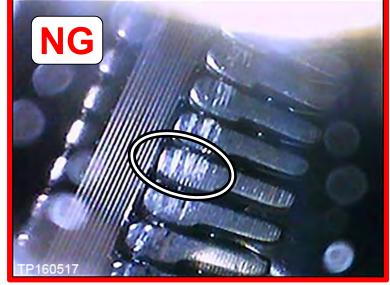
Figure 22: Example of NG belt

Pictures in Figure 22-Figure 24 were taken with borescope J-51951.

- > If the inspection result is **OK**, inspect the other side of the belt in step 8.
- If the inspection result is NG, replace the CVT sub-assembly (page 18), control valve (page 76) and, if applicable, reprogram the TCM (page 83).

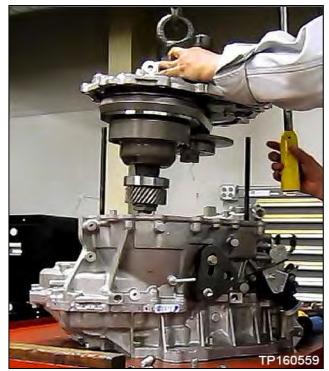
Figure 91

66. Raise the Lifting Fixture to remove the "side cover with pulleys and belt subassembly" (sub-assembly) from the CVT case (Figure 91).

To avoid damage to the primary speed sensor, make sure it is removed from the sub-assembly.

- The speed sensor <u>will</u> be reused.
- **<u>DO NOT</u>** discard the speed sensor.
- This sub-assembly <u>will not</u> be reused.
