Preliminary Information

PIT5714 One or More Courtesy Lamps Illuminated at all Times

Brand:	Model:	Model Years:	VIN:		Engine:	Transmissions:
Dialiu.			from	to	Eligilie.	Transmissions.
Cadillac	XT6	2020	All	All	All	All

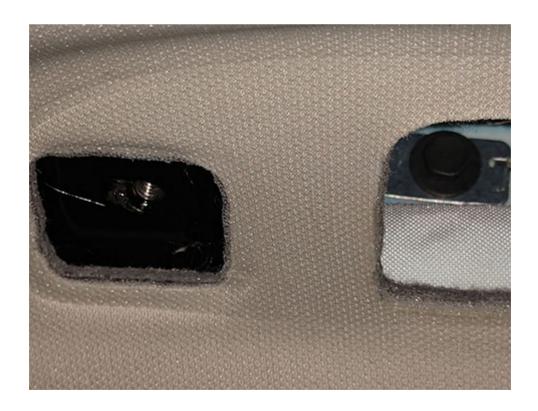
Remove the grab handle located above the left side second row seat.

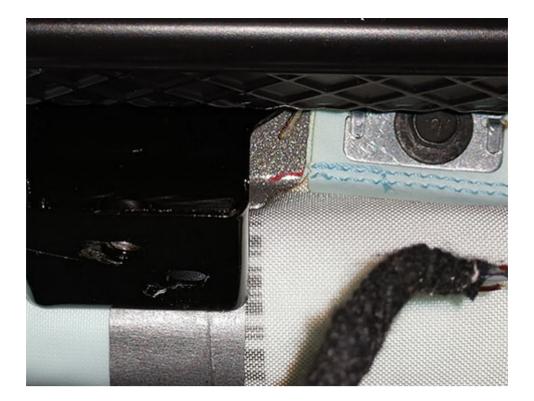
Inspect the harness above the headliner for damage.

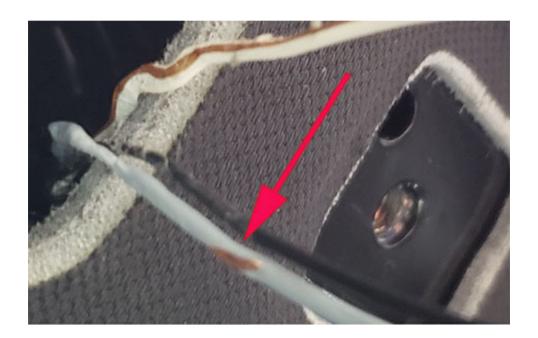
Involved Region or Country	North America
Condition	A vehicle may exhibit a concern where the courtesy lamps are illuminated and will not turn off.
Calice	Circuit 157 may be shorted to circuit 650 or to ground above the grab handle located on the driver's side of the vehicle at the second row seat.

If damage is found on circuit 157 or 650 repair the circuit(s) following appropriate SI procedure found in "Wire and Connector Repair"
