### PIT5447C Buzz / Rattle Noise From Dash Or Front Of Vehicle

#### Models

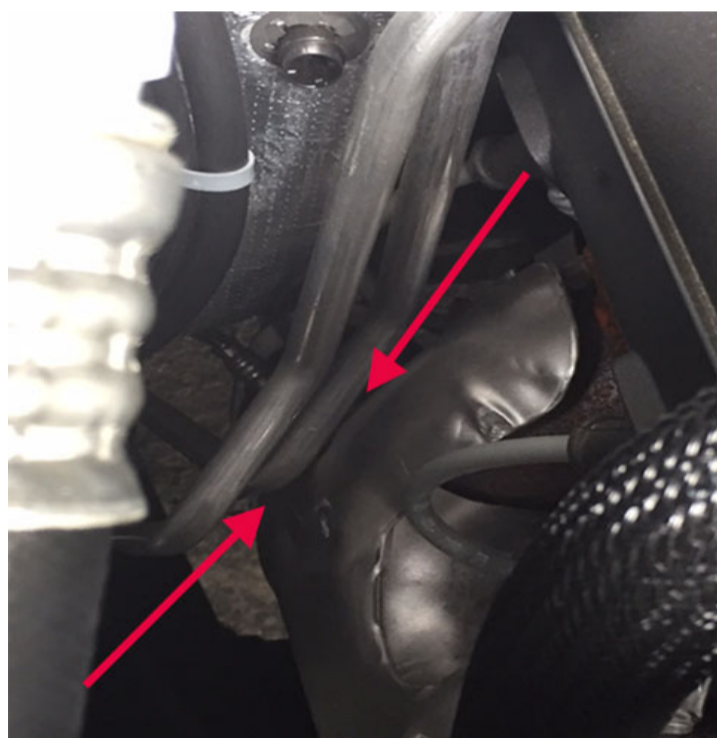
**Inspect for the rear heater pipes contacting the passenger side exhaust manifold. If the rear heater pipe is found to be contacting the exhaust manifold (as shown below), reposition the heater pipe so it no longer makes contact.**

Labor Operation	Description	Labor Time
4480348 *	Reposition The Rear Heater Pipe	0.4 hr.
* This is a unique labor operation for bulletin use only.
