# Customer Satisfaction Program

## N192264211 Enable Diesel Engine Block Heater – US Only

Release Date: October 2019

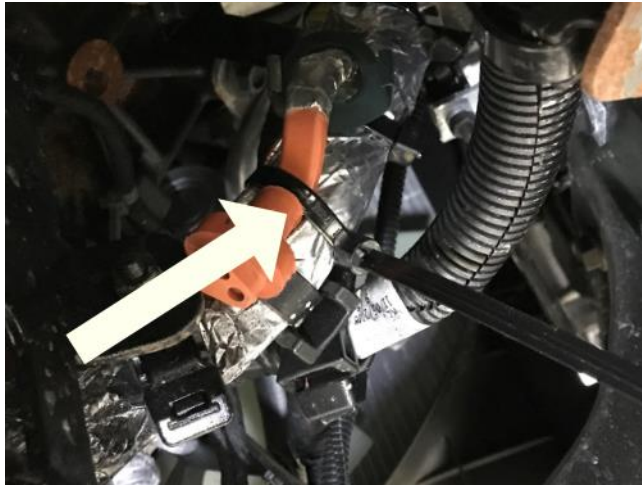
5340516

1. From underneath the vehicle, locate the engine coolant heater power cord. It is on the front passenger side of the engine block. Cut the wire tie securing the engine block heater power cable. Remove and discard the wire tie. (Shown without the shrink tube installed).

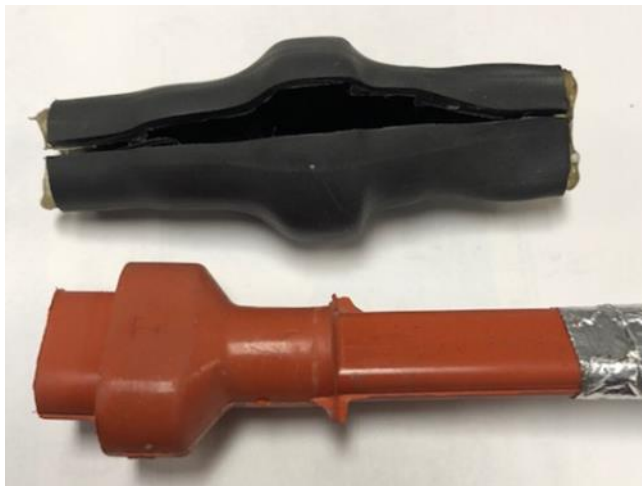
5415696

2. Using an appropriate cutting tool, carefully slice the shrink tube from the power cord. Use care to cut away from the harness itself to ensure that you do not cut into the harness or body of the connector.
3. Inspect the connector cavities and mating surface for any heat shrink tube adhesive. Carefully remove the adhesive if required.
