November 12, 2019

Version 2

Front and/or Rear Brakes Squeal When Applied at Low Speeds

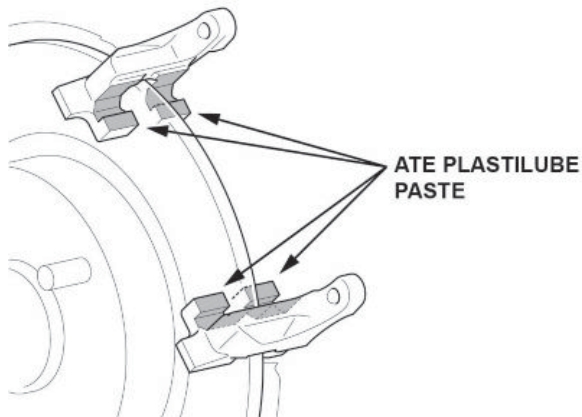
- The 2019-20 RDX is equipped with FNC brake discs. These brake discs cannot be machined or refinished.
- Make sure to apply the ATE Plastilube paste included with the rear brake pad set.

1. Do the electric parking brake disengagement procedure, and replace the rear brake pads. Refer to the service information.
