Service Bulletin

Bulletin No.: 19-NA-237

Subject: Diagnostic Tip - Diesel Exhaust Fluid System Contamination

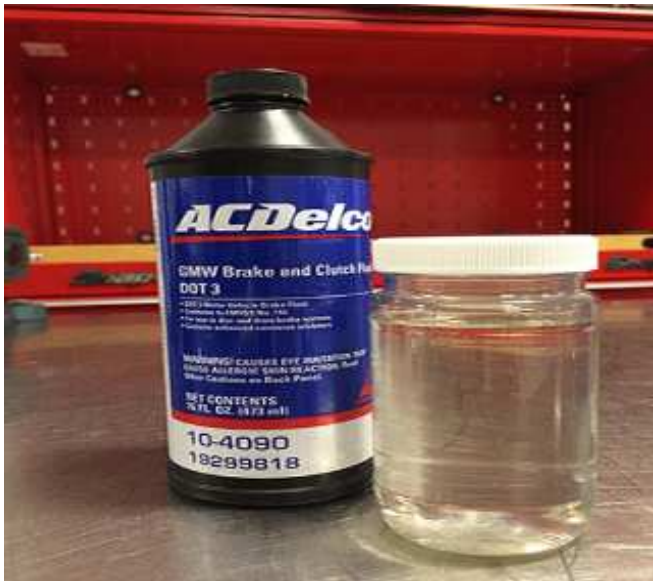
4373640

Diesel Exhaust Fluid (DEF) mixed with Brake Fluid.

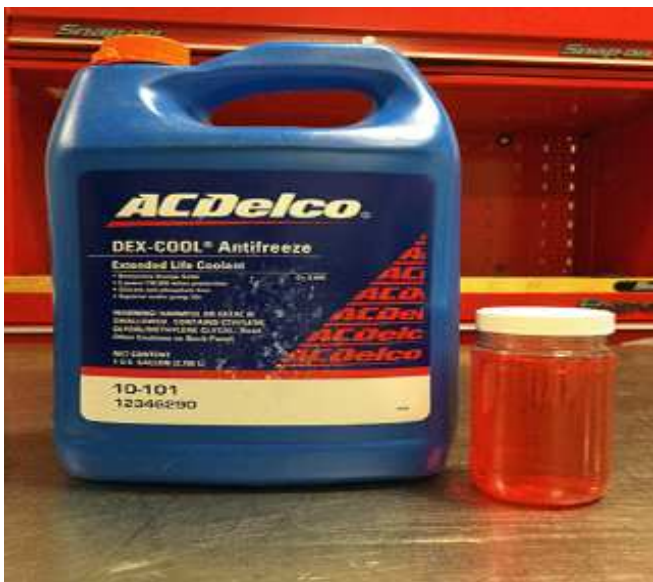
4373641

Diesel Exhaust Fluid (DEF) mixed with Dexcool.

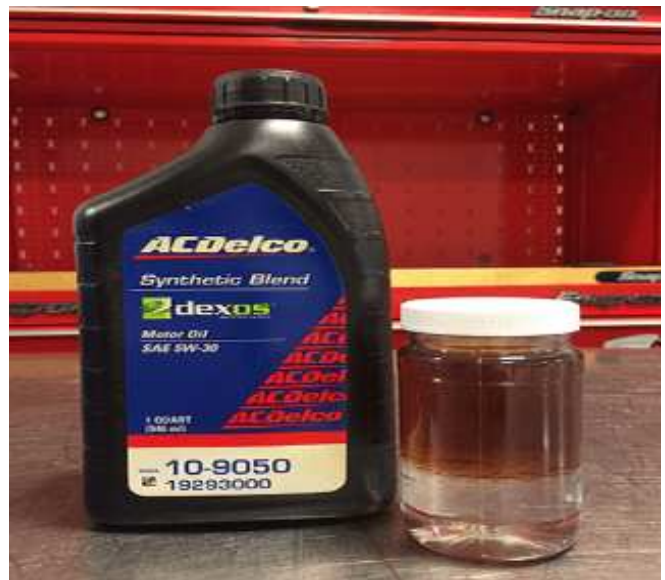
4373644

Diesel Exhaust Fluid (DEF) mixed with Engine Oil.

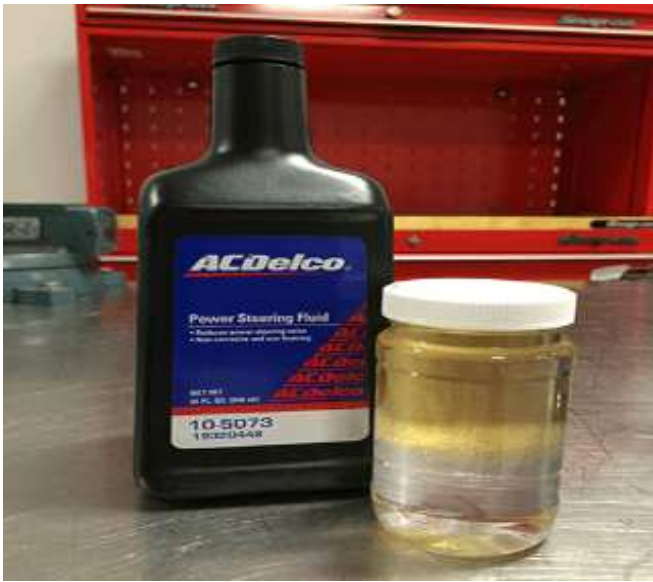
4373645

Diesel Exhaust Fluid (DEF) mixed with Power Steering Fluid.

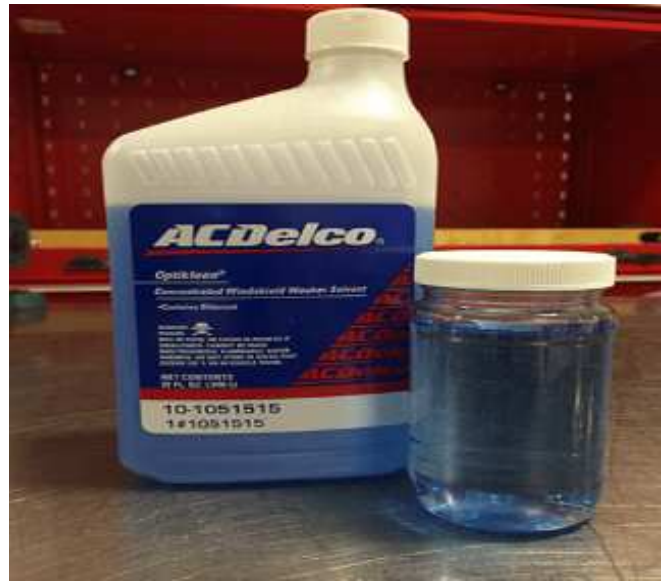
4373647

Diesel Exhaust Fluid (DEF) mixed with Windshield Washer Fluid.

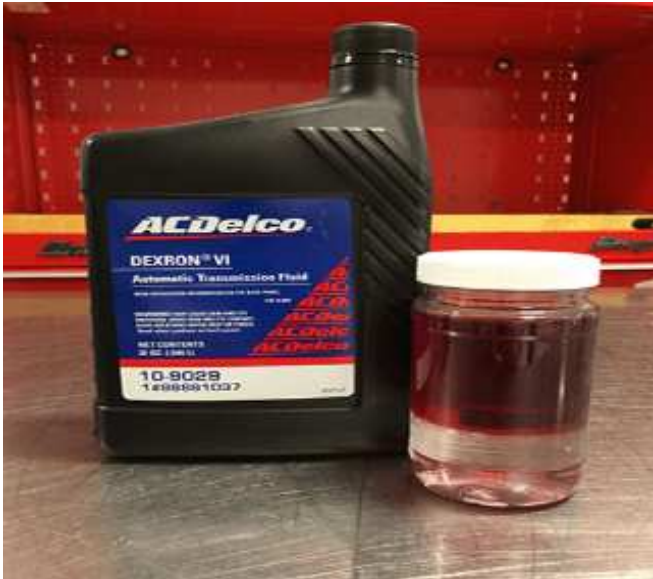
4373646

Diesel Exhaust Fluid (DEF) mixed with Transmission Fluid.

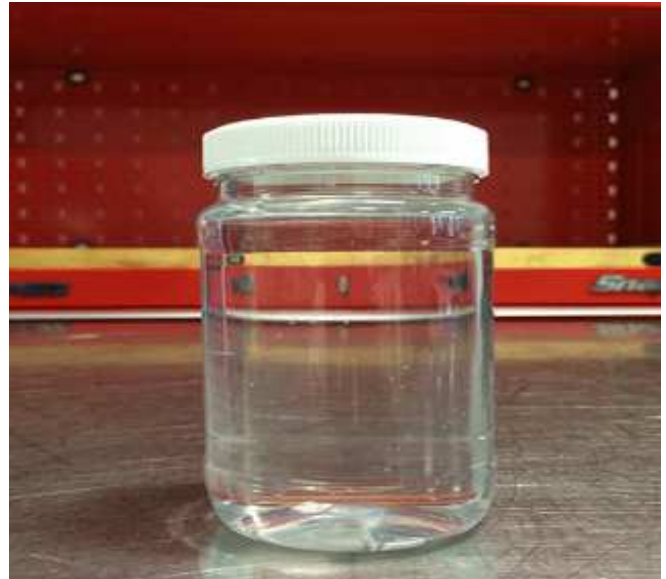
4373648

Diesel Exhaust Fluid (DEF) mixed with Water.
