# TECHNICAL INFORMATION

Bulletin no.	Date	Page
MAS002024	31/10/2019	1/2

**SERVICE CAMPAIGN # 383**

**SUBJECT: Water Pump Replacement**

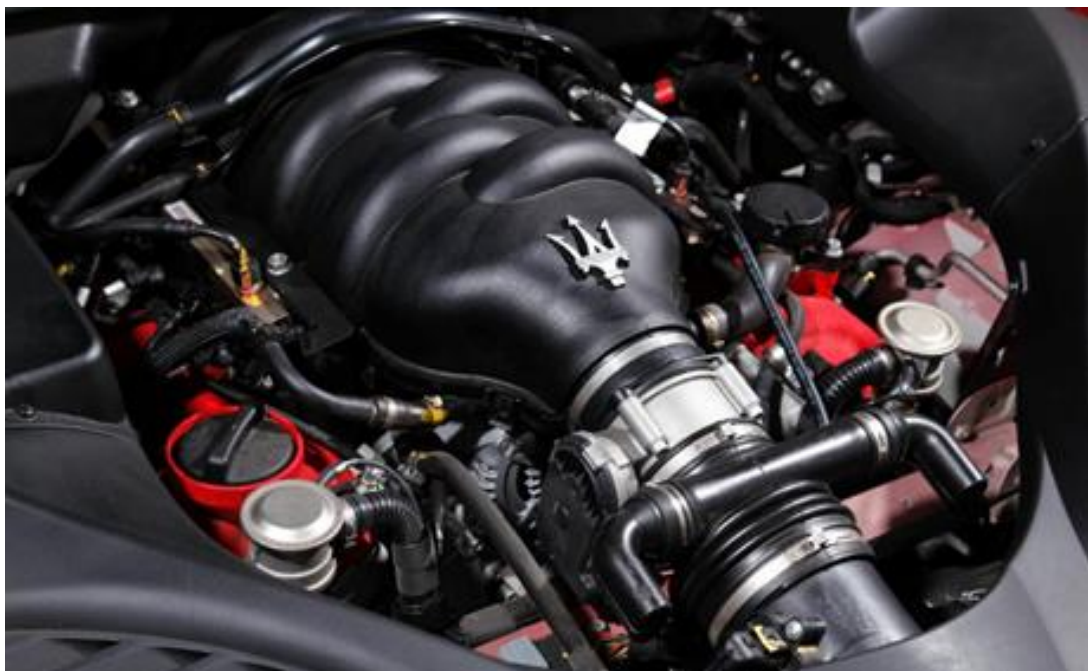
**Maserati Levante M161 vehicles equipped with V8 Petrol Engine and listed in the attachment are involved in a Service Campaign concerning the replacement of the water Pump.**

This action is needed because in a limited batch of V8 engines it was installed a not conform Water Pump that could fail. The defective batch has been identified and all the vehicles in the Car Park attached must be reworked with the Water Pump Replacement.

1. Check if the vehicle is involved in the action and if the campaign has not been previously performed.
2. Replace the Water Pump, following the dedicated procedure in Tech DOC.  
*01.72.001.00 WATER PUMP - Replacement*  
**NOTE.** *Coolant must be Reused following the procedure in Tech Doc.*  
*00.20.021 – ENGINE COOLANT-System Emptying – Filling*
3. The Procedure is completed
