NUMBER: 09-003-19

GROUP: 09 - Engine

GEN-2 and GEN-3 - 3.0L Oil Filter Cartridge Identification Differences

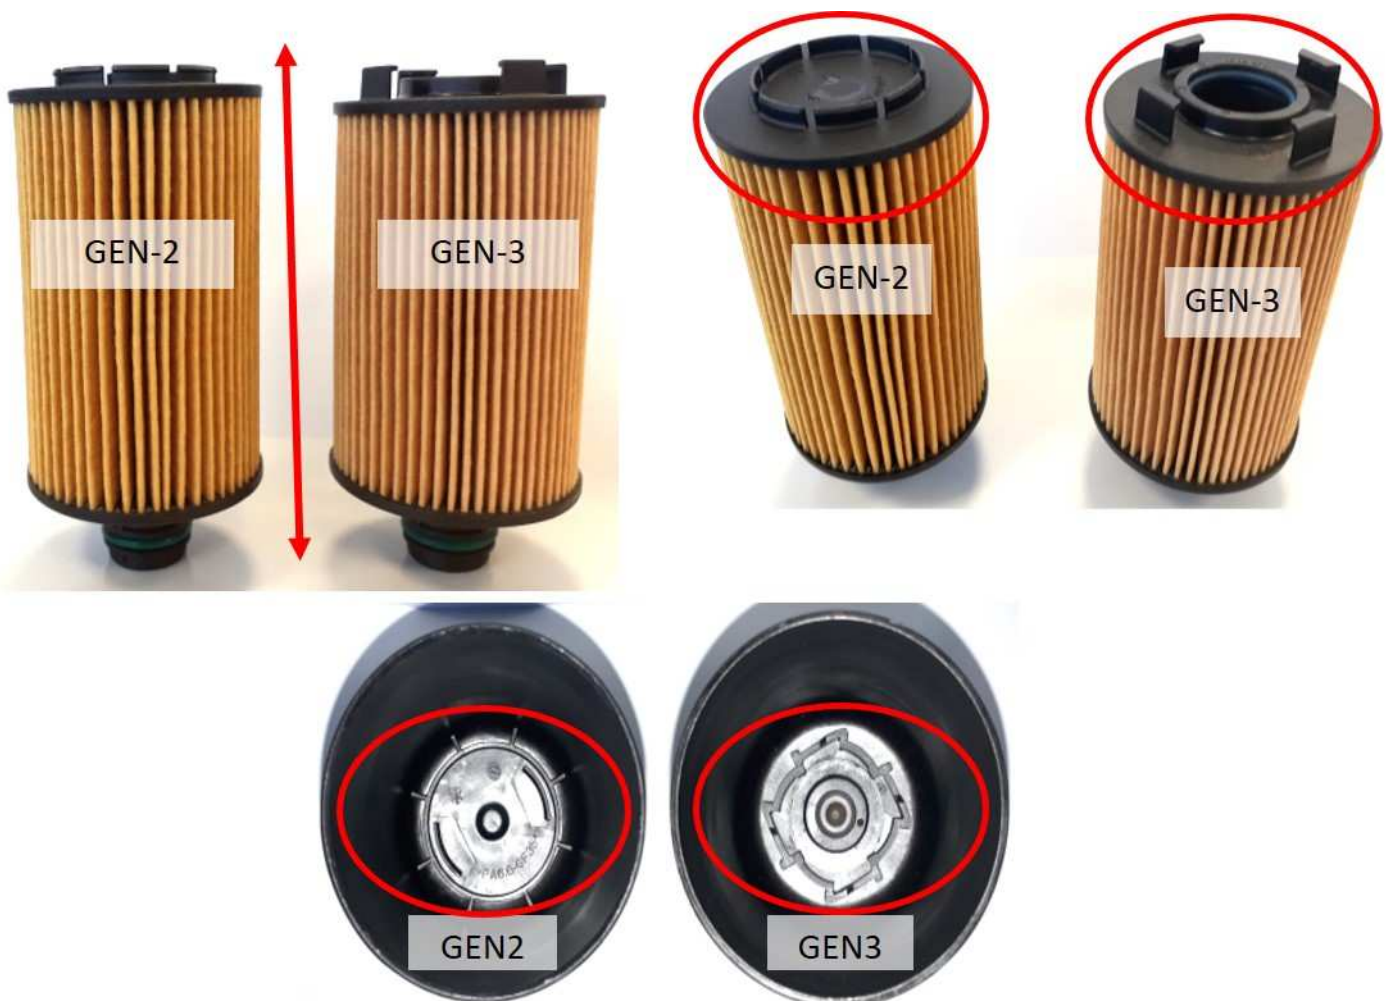
Fig. 1

The key differences between GEN-2 and GEN-3 engine oil filter cartridge assemblies include (Fig. 1) :

- GEN-2 oil filter element replaced separate from the cap. While GEN-3 is meant to be replaced as a cap and element in one.
- Length of the oil filter element.
- Bypass valve integrated into the GEN-3 filter cap and element instead of the filter housing on GEN-2.
- New clamping fittings in the cap on GEN-3 designed to capture the element.

Physical Differences in the Oil Filter Cartridges

NOTE: Although you may be able to remove the filter element from the cap on the GEN-3 design filter, it is designed to be replaced as a set. DO NOT remove the oil filter element from the cap when servicing any oil filter on a GEN-3 engine.

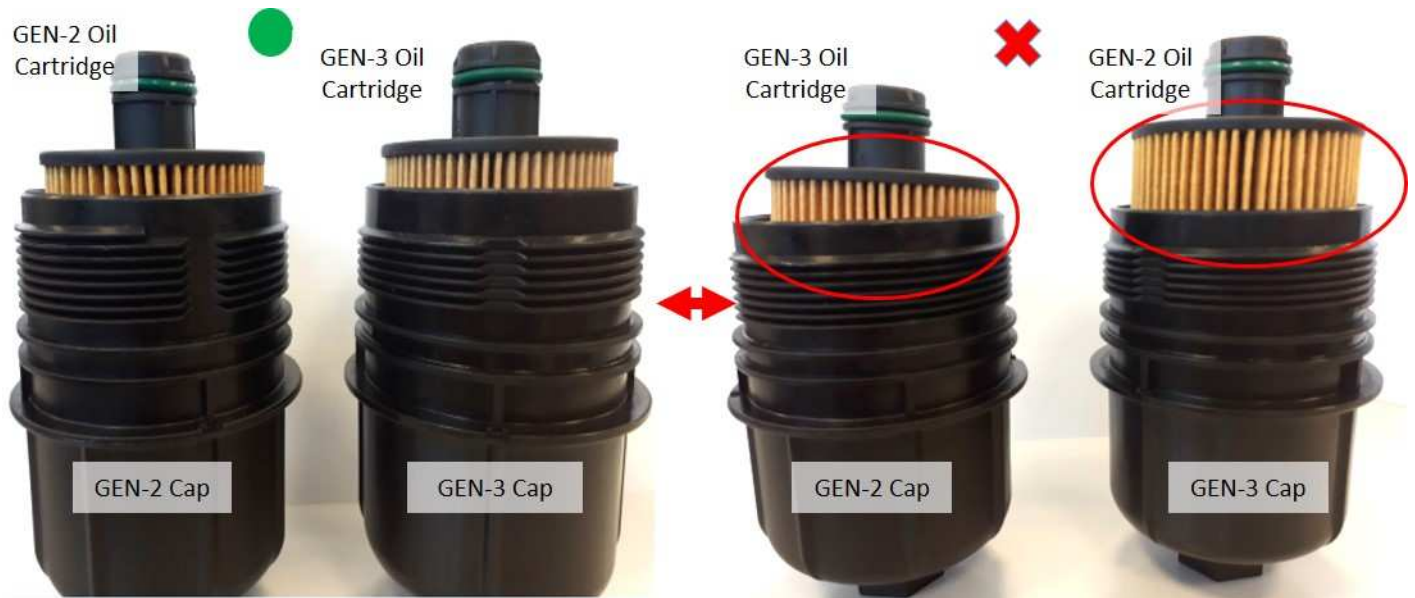
If a GEN-2 engine design filter element is used in a GEN-3 engine filter cap, or the GEN-3 engine element is used in a GEN-2 engine filter cap, it will lead to unfiltered oil to be circulated through the engine leading to premature wear (Fig. 2) :

- Correct fitment of the cartridge in green.
- Incorrect fitment of the cartridge RED X.

Fig. 2
Fitment of Oil Filter Cartridges in the Cap

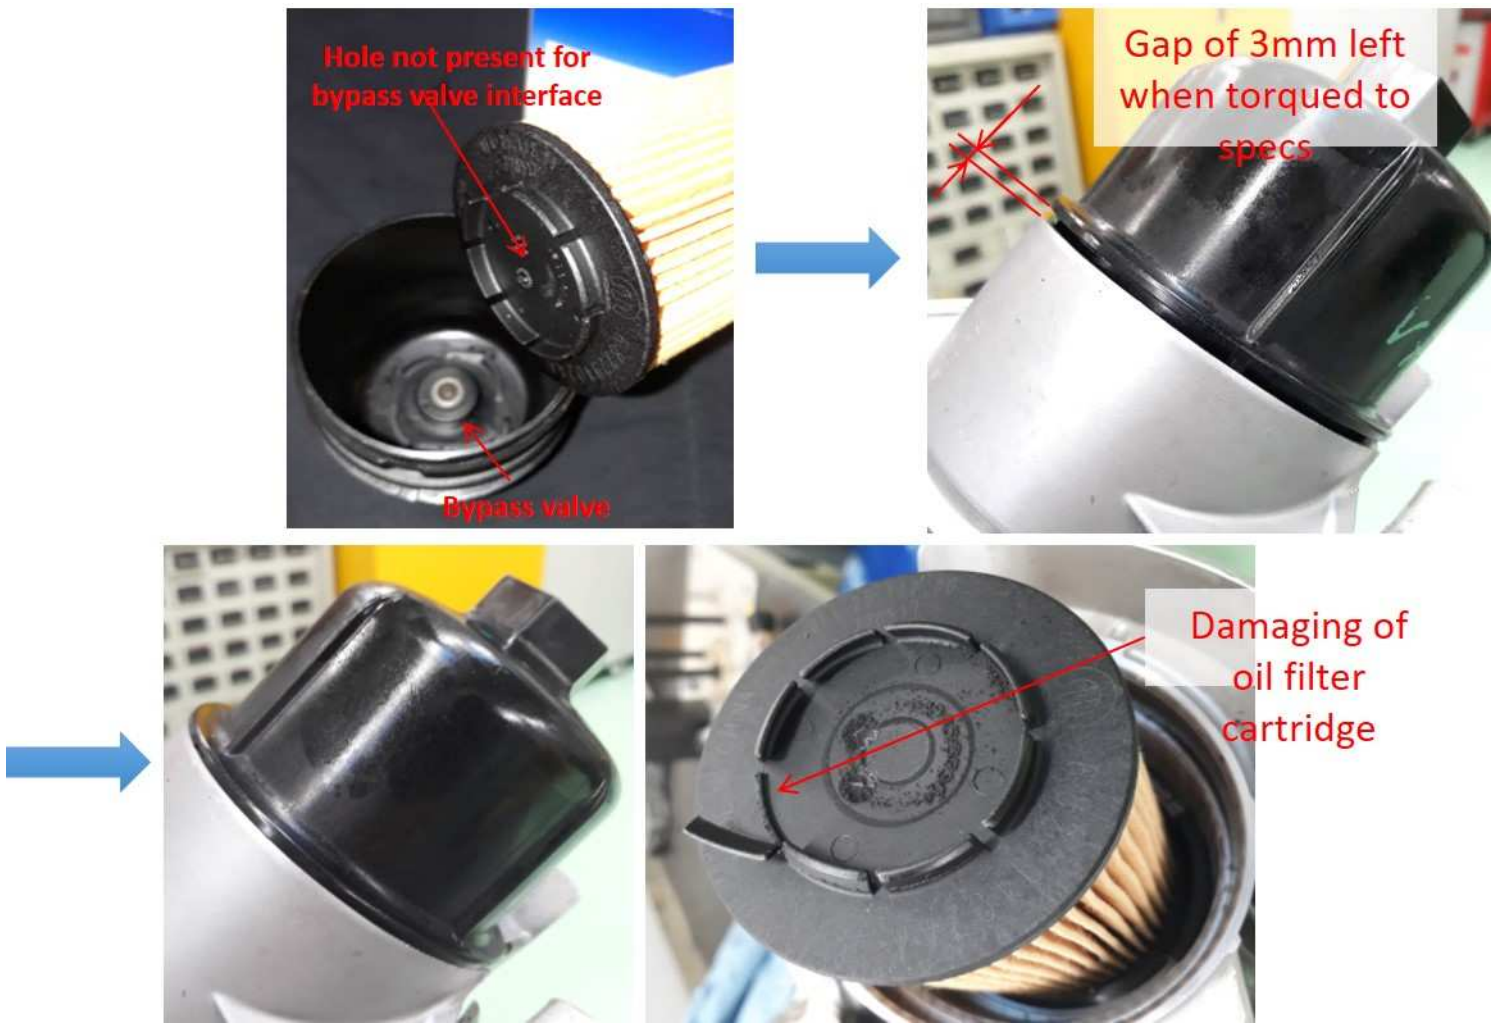
Damage will occur to the incorrect oil filter cartridges when installed into the wrong cap (Fig. 3) .

Fig. 3
Damage to the Oil Filter Cartridges
