Steering Wheel Alignment at PDI

RR Velar 18 – 20MY

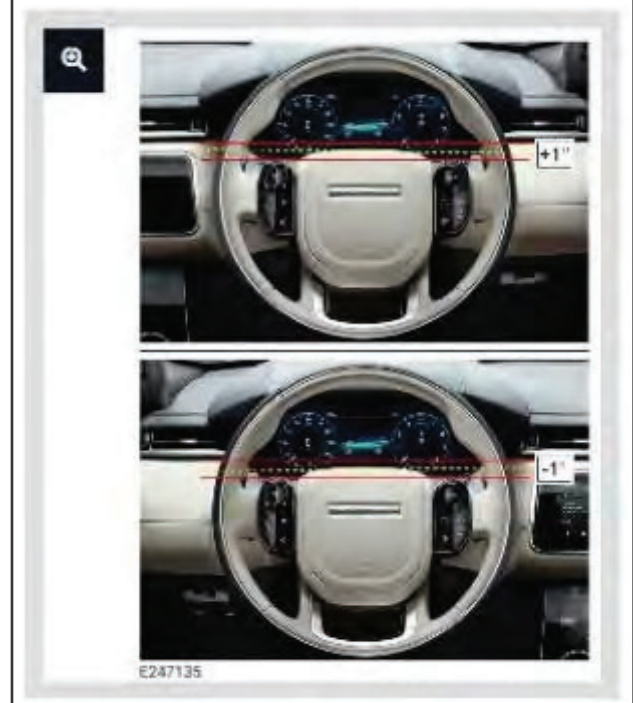
- The steering wheel may be perceived to be out of alignment when performing a PDI due to the design layout of the instrument panel.

- Enhanced alignment instructions have been added to the Workshop Manual to guide technicians what is and is not within design specification.
- Please refer to the wheel alignment diagnosis section in TOPIx prior to making adjustments to the vehicle. If a wheel alignment is required at PDI to correct a concern, please submit an ePQR with pictures of the alignment and the before and after alignment readings.
