## Front Seat Cushion Deteriorating

F-PACE & XF 17 – 19MY

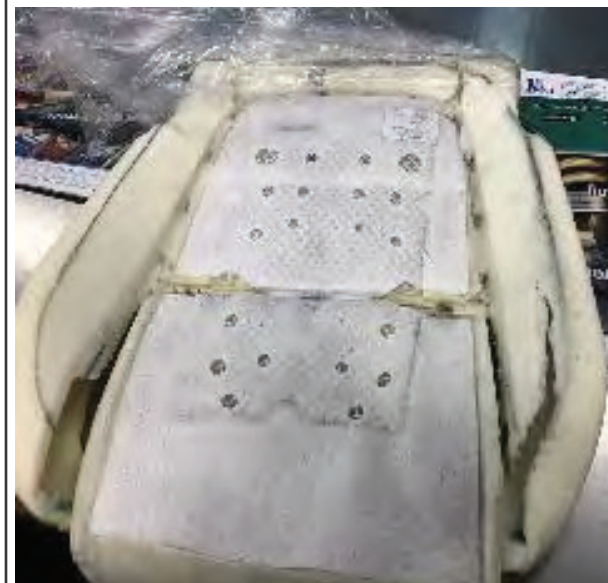
- The seat cushion foam has become torn or damaged by the seat frame work and requires replacement.

- This issue is currently under investigation.
- Should this concern be found, please submit an EPQR for the vehicle with pictures of the seat foam assembly to aid in the investigation.
