### PIT5410B Diagnostic Tip - Unable to Change HVAC Mode Defrost or Recirc Position

Brand:	Model:	Model Years:	VIN:		Engine:	Transmissions:
			from	to		
Chevrolet	Express	2012 - 2020	All	All	All	All
GMC	Savana	2012 - 2020	All	All	All	All

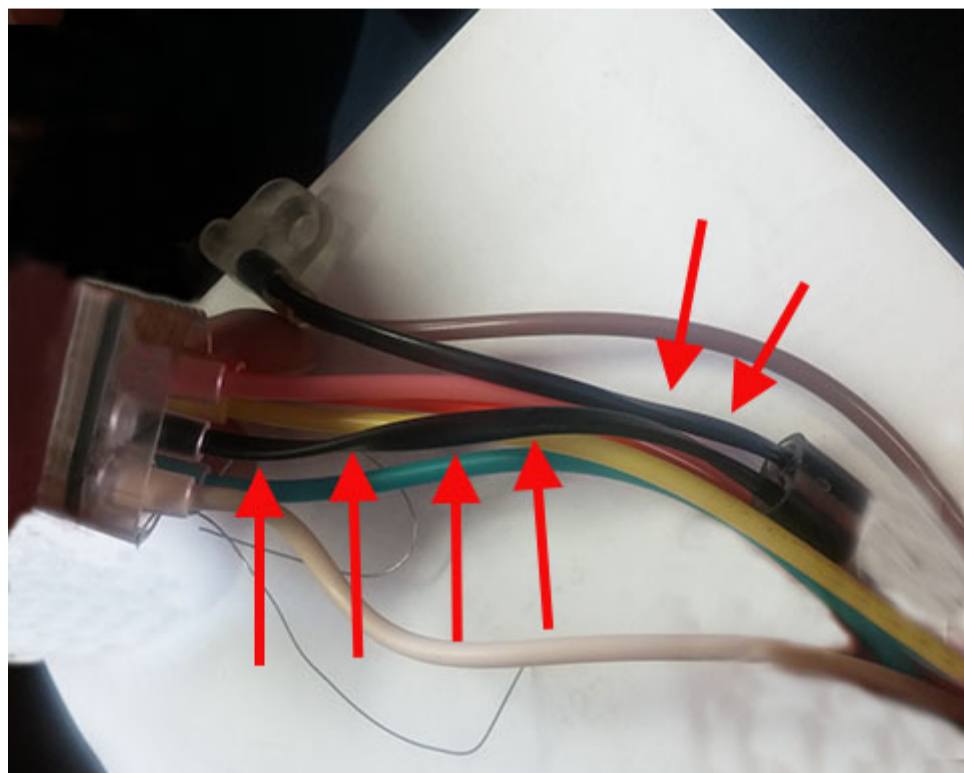
**Some customers may comment that they cannot change HVAC Mode, Defrost or RECIRC positions.**

**NOTE: Most issues are located near the HVAC Control Head as shown below**

**These vehicles use vacuum actuators to operate the HVAC Mode, Defrost, and Recirc doors. Inspect vacuum lines from HVAC Control to affected actuator for being pinched causing a restriction or open in the line.**
