## PIP5658A Heat Shrink Hose Clamp Information

| Brand: | Model: | Model Years: | VIN: | | Engine: | Transmissions: |
|---|---|---|---|---|---|---|
| Chevrolet | Silverado 4500HD 5500HD 6500HD | 2019 | All | All | 6.6L L5D | All |

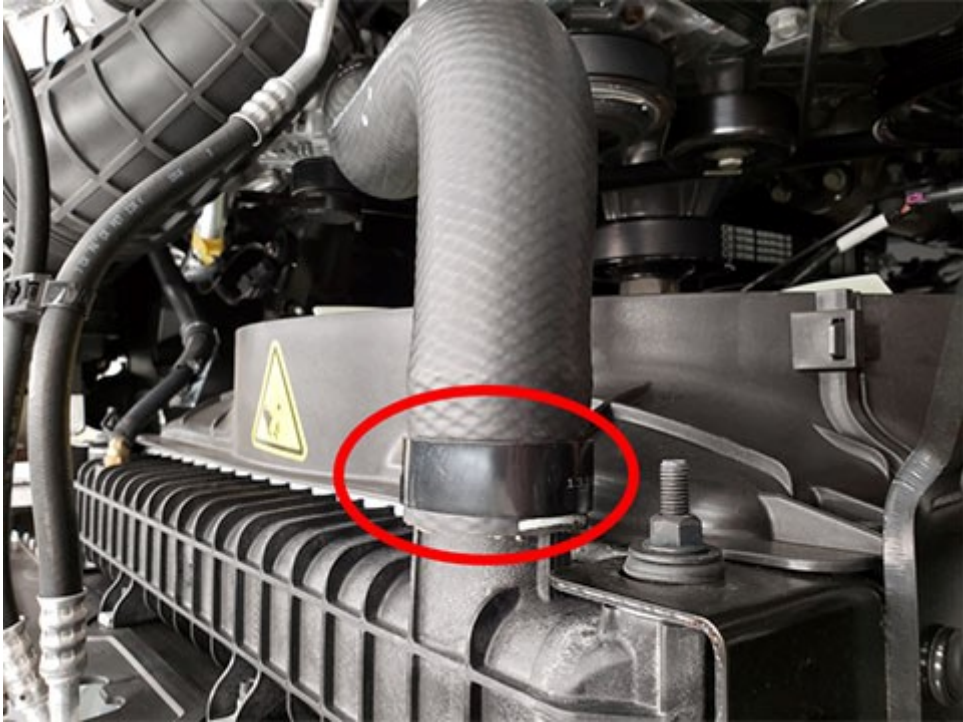
### Heat shrink clamp

| Condition | There may be a concern where coolant heat shrink clamps need to be replaced for a coolant leak and/or for a service repair. |
| Cause | Difficult to get the heat shrink clamps to seal the coolant hose. |

When possible use the heat shrink clamps in the places that they are called for.

There may be location that may not be accessible to get a heat gun to.

For locations that are inaccessible to a heat gun, use hose clamp p/n 19404911, torque @ 9-11 Nm (79 - 97 lb in).
